Date : 08/11/2025
Project No : 2025C160
Client Company : Artisan
Arrival Time : 08/11/2025 08:00
Onsite Hours : 03:00

ASEC Report ID : 84238
Name of the Project : Rockmart Township - 115 Felton Drive
Project Location : Rockmart
Weather : overcast/raining
Departure Time : 08/11/2025 11:00
ASEC Technician Name : Sean Willett

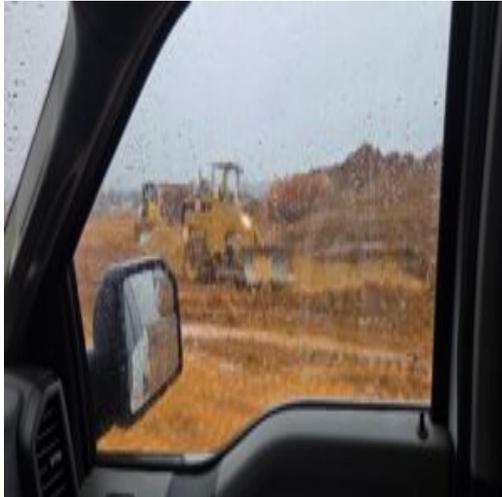
Our representative density tested this area. Test results did not meet job specifications for compaction. After approximately 2 to 3 feet of fill was placed, it began to rain. The contractor quickly filled the hole with thickened lifts to prevent water build up. Our representative will density test this area on the next available work day and will recommended that the contractor excavate this area and properly install the lifts. Water management is a priority for the contractor in this area.

filling the hole in the rain

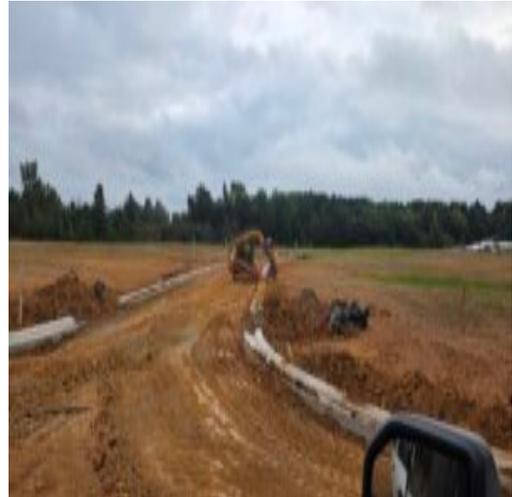
The contractor continued backfilling curbs located on phase 1.

backfilling curbs on ph1

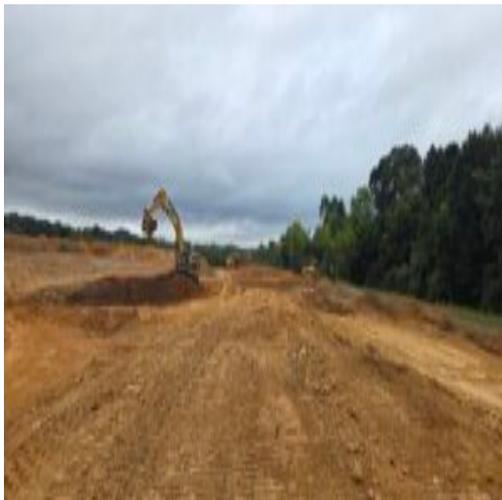
topsoil removal from roadway

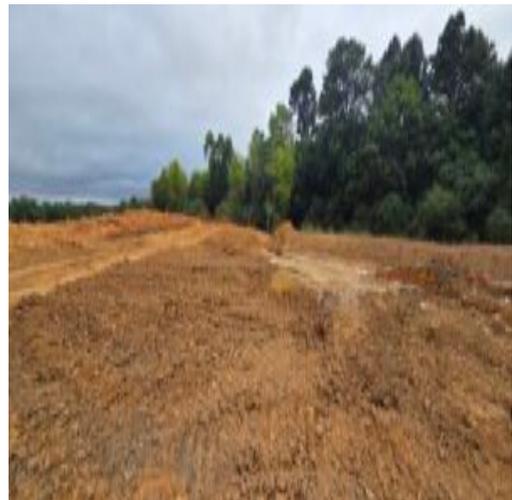
topsoil placement in greenspace

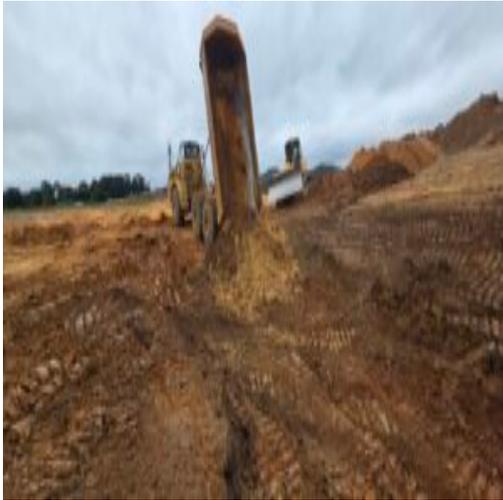
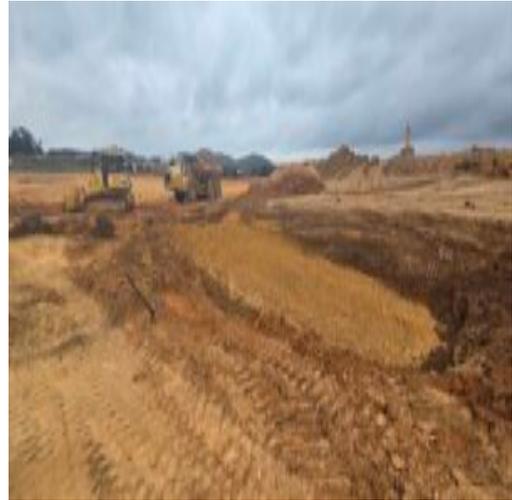
Our ASEC representative was on site as requested by the contractor (Wilbanks) for the observation/testing of the placement of fill/backfill. The contractor excavated topsoil from the roadway of Lots #188 and #189. Topsoil was placed along greenspace located on Lots #50 through #45. The contractor requested a proof-roll of this area. The proof-roll showed some pumping/rutting. The contractor excavated approximately 59 feet x 16.5 feet x 5 feet deep until stable subgrade soils were present. The contractor then began placing soil lifts of approximately 12 inches in thickness in the roadway and compacted via a sheep-foot roller and loaded tandem-axled dump truck.

roadway excavation/fill
