Date : 09/08/2025
Project No : 2025C160
Client Company : Artisan
Arrival Time : 09/08/2025 08:00
Onsite Hours : 04:00

ASEC Report ID : 85360
Name of the Project : Rockmart Township - 115 Felton Drive
Project Location : Rockmart
Weather : Sunny
Departure Time : 09/08/2025 12:00
ASEC Technician Name : Sean Willett

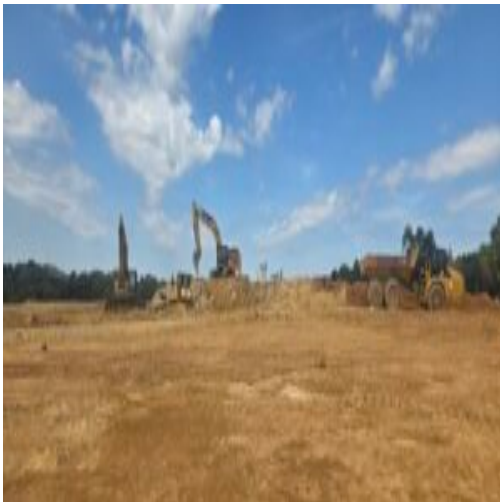
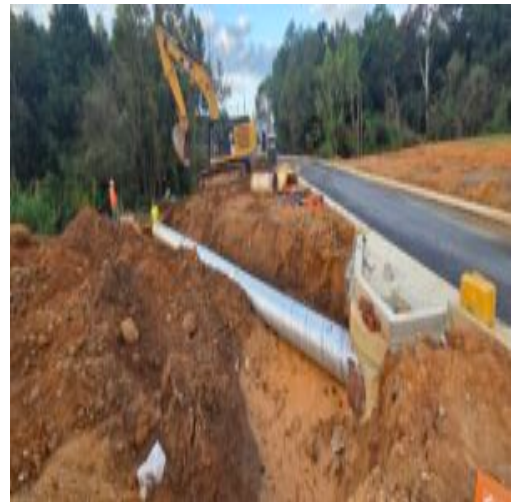
Contractors are expanding/redoin the headwall located at main entrance way.

headwall at main entrance
