Date : 03/27/2026
Project No : 2025C186
Client Company : CWM
Arrival Time : 03/27/2026
Onsite Hours : N/A

ASEC Report ID : 91863
Name of the Project : Tom B. David Airport - Rehab Parallel
Taxiway & Terminal Apron
Project Location : Calhoun
Weather : overcast
Departure Time : 03/27/2026
ASEC Technician Name : Russell Hendrix

As requested, the site was visited by our AS Engineering and Consulting (ASEC) representative for the purpose of providing quality control inspection and testing services. Visual observation techniques were employed to verify compliance with project drawing/specifications, applicable codes, and materials submittals. The following observations were observed on site this day:

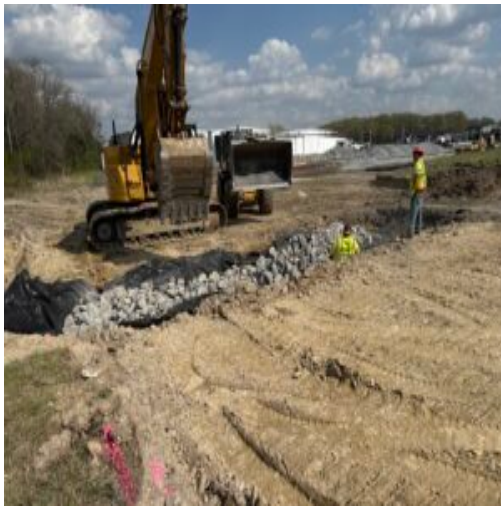
During proof-rolling, the subgrade was determined to be unacceptable, and the dump truck became mired adjacent to the duct bank. Organic material was observed at the subgrade surface. It was agreed that in an approximate 40-foot by 15-foot area parallel and adjacent to the duct bank, organic material would be removed to a depth of approximately 4 feet below the previously remediated elevation (approximately 6 feet below proposed finished asphalt grade) (see photos).

Large recycled rock placed into approximately 4 foot deep excavation on top of Geofabric. 40 x 15 feet

The UES representative recommended placement of geotextile fabric followed by recycled concrete rock (sourced on-site) up to subgrade elevation. This would be overlain with 12 inches of No. 4 stone and 12 inches of GAB. No Geogrid was requested.

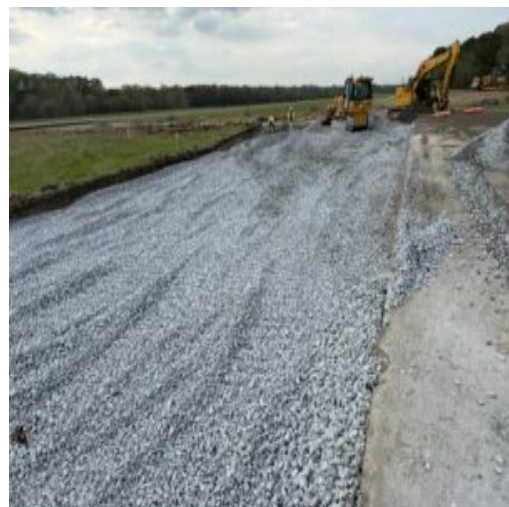
It was observed that geogrid (installed with approximately 2-foot overlaps), along with geotextile fabric in the wetter areas, was placed within the connector between Taxiways A3 and A4. Placement of approximately 12 inches of No. 4 stone followed; however, this work was not completed across the entire connector on this date.

#4s placed between A3 and A4 connector. Picture facing North.

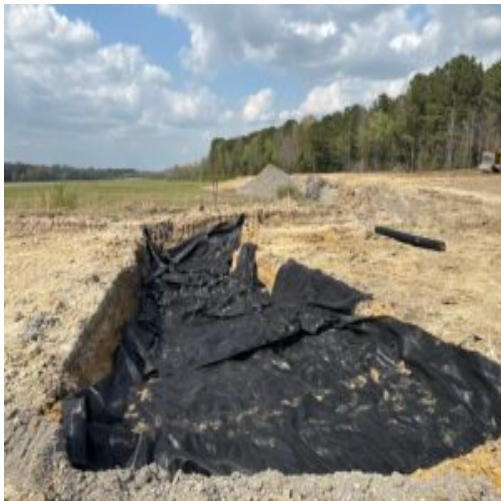
Geofabric placed inside approximate 4 foot hole due to large organics. 40 foot x 15 foot

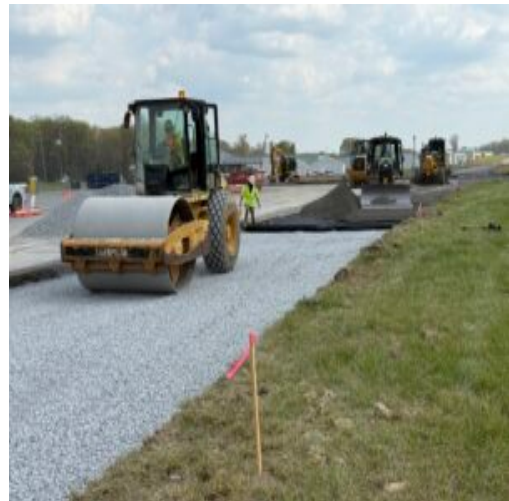
No. 4 stone placed throughout the project was compacted using a smooth drum vibratory roller (see photo) prior to placement of GAB. Following consolidation of the No. 4 stone in the connector area, geotextile fabric was placed, and GAB was subsequently installed above.

#4s being consolidated on connector between A3 & A4. Picture facing South

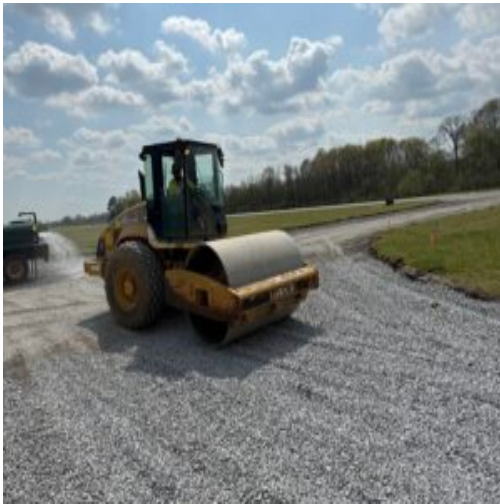
#4s being consolidated at A3 & connector

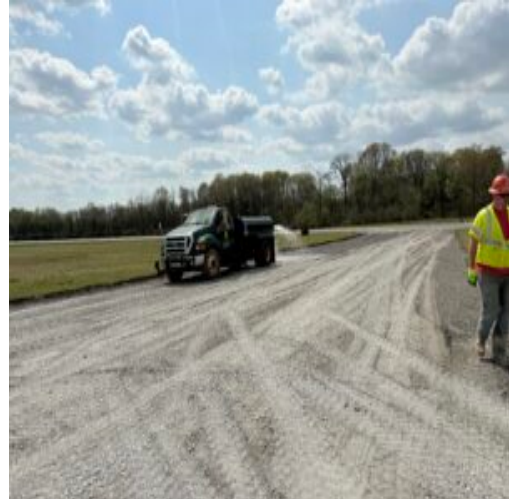
Placement of GAB on Taxiway A3 and the A3 extension was completed, with water applied to aid in compaction.

Graded Aggregate Base placed and increasing moisture with water truck.

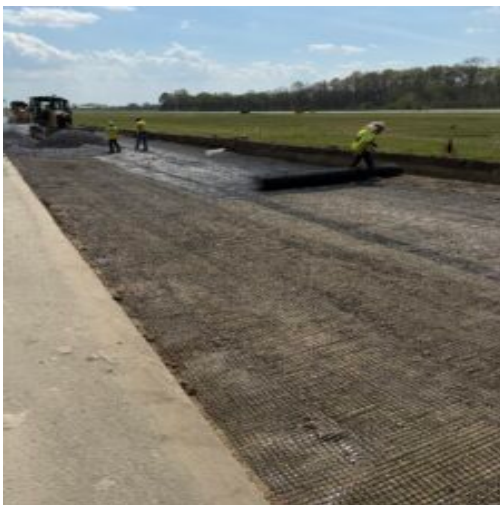
Geogrid being placed between A3 and A4 on connector

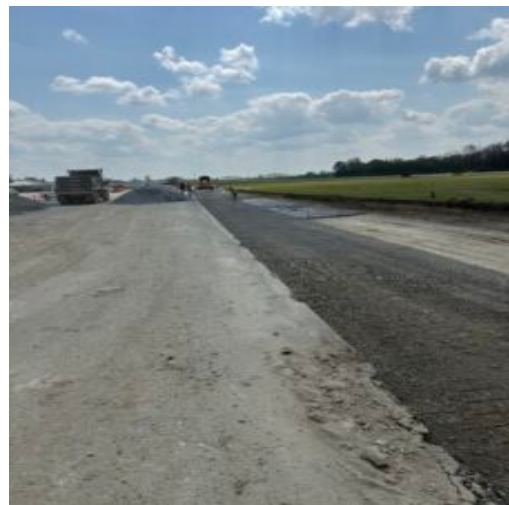
Geogrid bring placed between A3 & A4 on connector

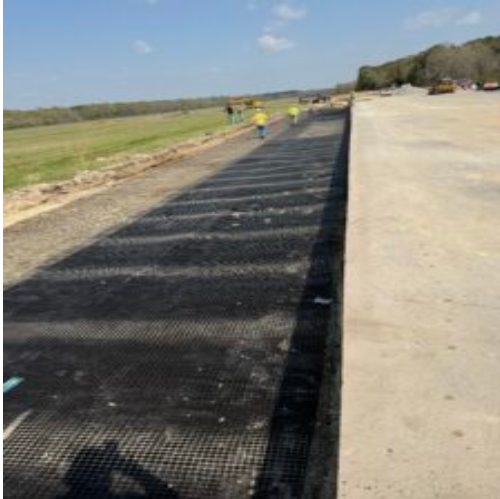
Geogrid placed on connector between A3 &A4.
Picture facing North.

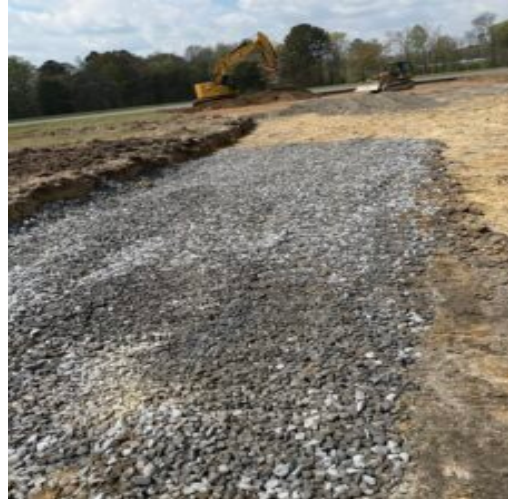
Additionally, an area measuring approximately 30 feet by 17 feet located between the duct bank and storm drain pipe was identified as having soft subgrade soil conditions. It was requested that this area be excavated an additional 12 inches and remediated accordingly.

#4s placed on additional remediation area undercut
an extra 12 inches below other remediation.

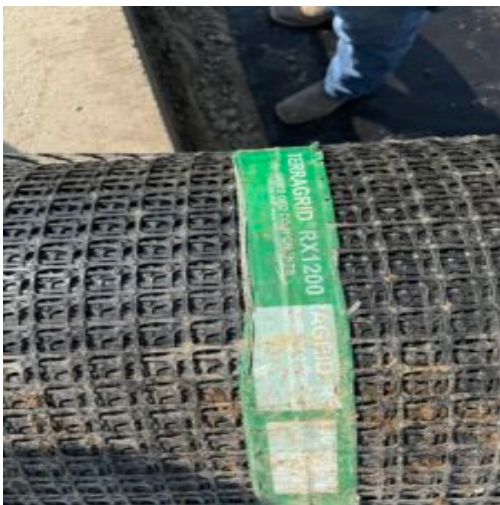
Geogrid being used on this project

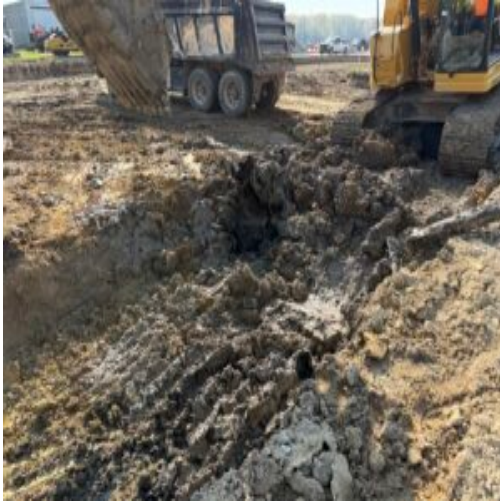
Excavation of Pit area with large organics.

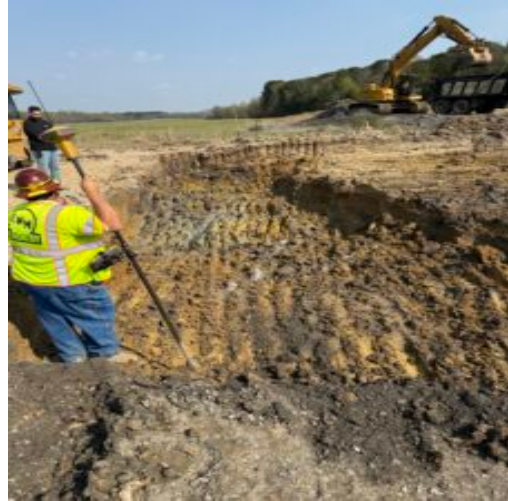
Excavation of pit area.

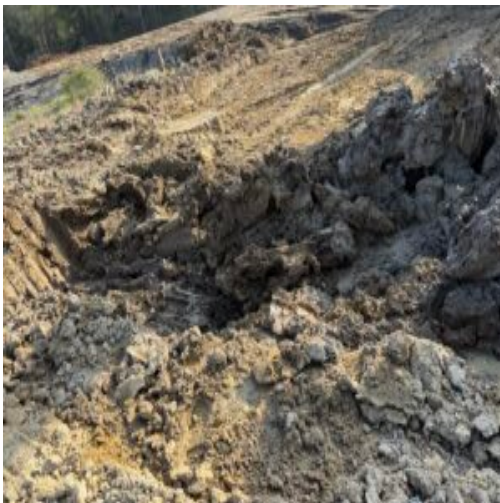
Excavation of pit area with organics

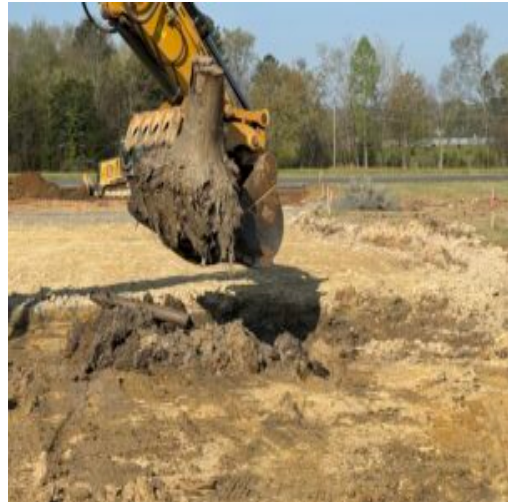
Excavation of pit area (Large tree stump shown being removed)

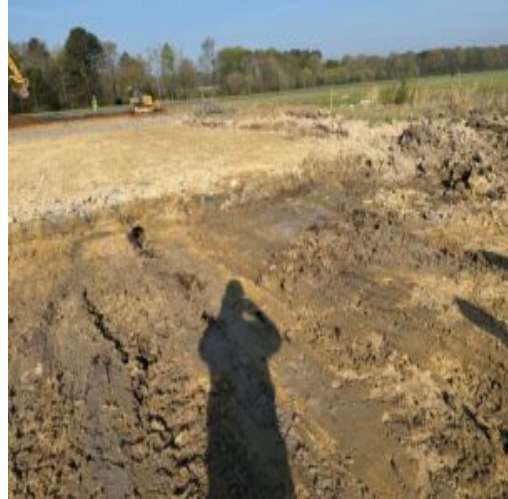
Bury pit area before excavation.

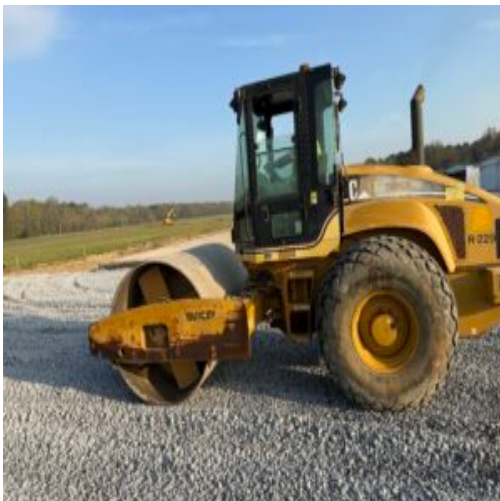
#4s consolidated

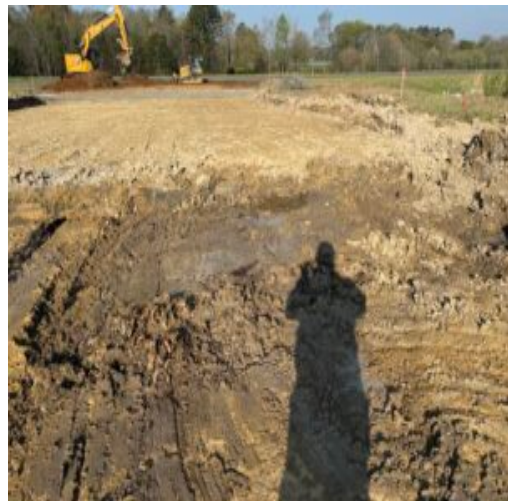
Bury pit area before remediation.
