Date : 11/07/2025
Project No : 2025C211
Client Company : Pulte
Arrival Time : 11/07/2025 08:00
Onsite Hours : 07:00

ASEC Report ID : 87644
Name of the Project : Haley's Bluff - Philadelphia Rd.
Project Location : Jasper
Weather : sunny
Departure Time : 11/07/2025 15:00
ASEC Technician Name : Sean Willett

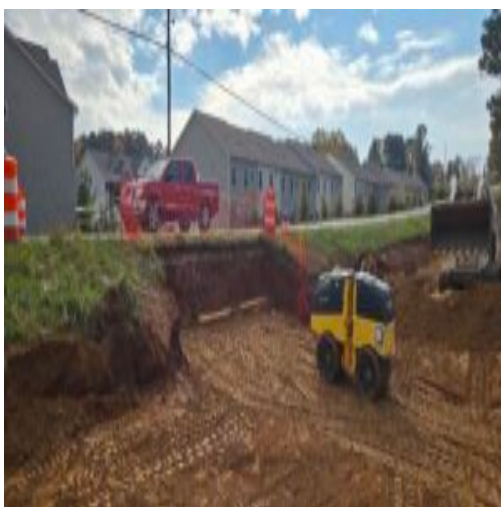
boring under roadway location

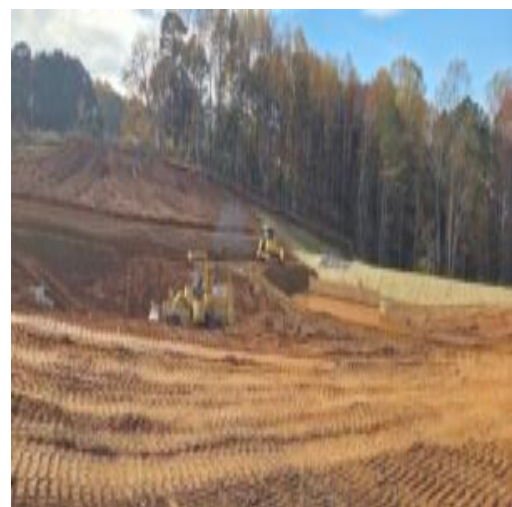
Our ASEC representative was on site for the observation/testing of the placement of fill/backfill. The contractor continued placement of fill in approximately 6-inch lifts along the back and edge of Lots #3 and #4. ASEC performed density testing approximately every 2 feet and provided all test results to the contractor. ASEC watched as loaded dump trucks rolled across the compacted lifts. There were no signs of severe pumping or rutting.

fill on bank of lots #3 - #5

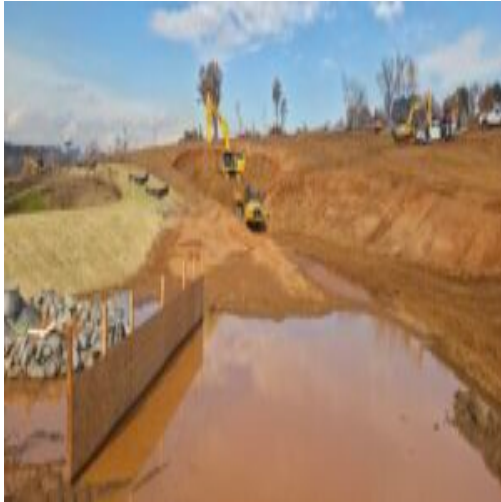
front pond by decel lane

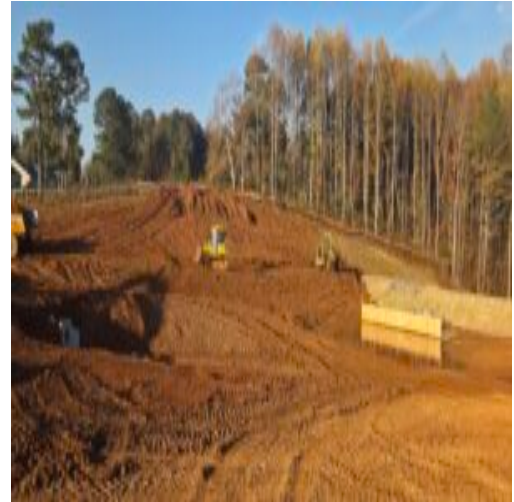
filling on bank of lots #1 - #5

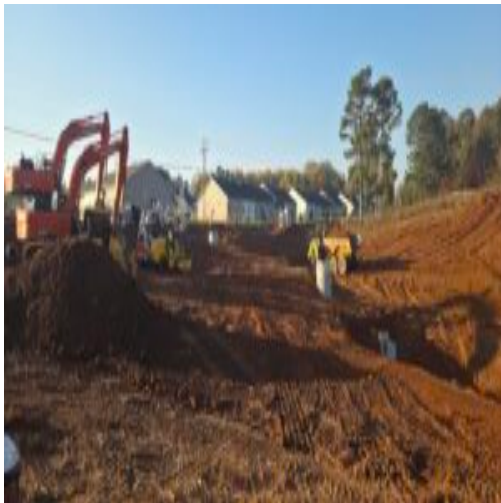
decel lane

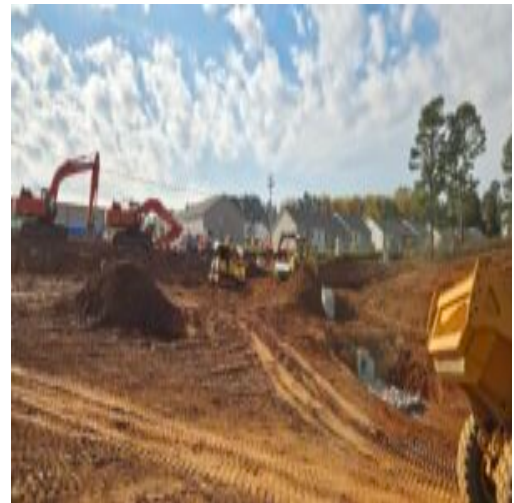
decel lane

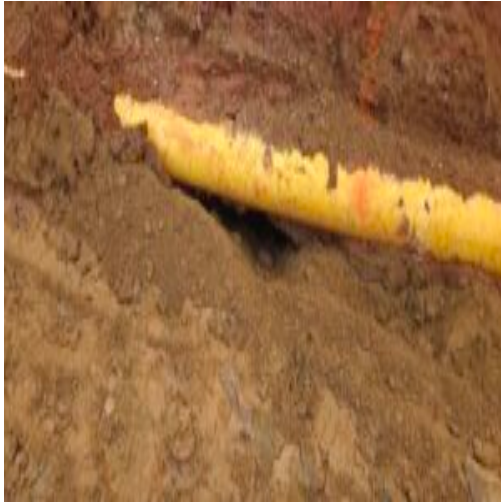
void that was filled under gas line
