Date : 11/11/2025
Project No : 2025C211
Client Company : Pulte
Arrival Time : 11/11/2025 07:45
Onsite Hours : 07:15

ASEC Report ID : 87679
Name of the Project : Haley's Bluff - Philadelphia Rd.
Project Location : Jasper
Weather : Sunny
Departure Time : 11/11/2025 15:00
ASEC Technician Name : Sean Willett

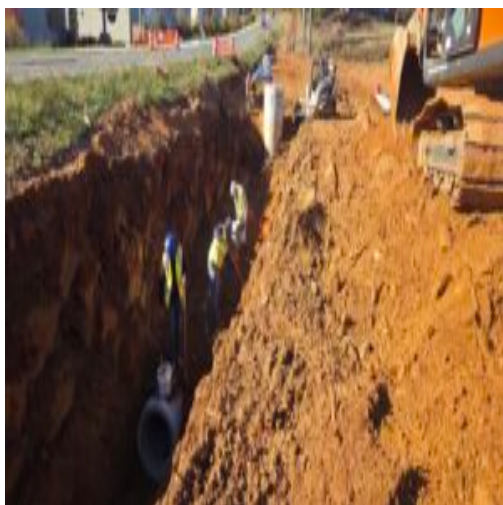
pipeline BC4 to BC5

The contractor continued placing pipe to structure BC5 in deceleration lane. Once the contractor backfilled approximately 2 feet over pipeline, ASEC performed density testing. All test results were provided to the contractor, and any failing tests were addressed. It was recommended by ASEC to the contractor to keep the lift size to approx. 8 inches to 12 inches during the backfill of the pipeline. Once the contractor reaches approximately 2 ft to 3 ft of fill over the pipeline, it was recommended to use a small sheeps-foot roller to finish out the compaction of the backfill. The small walk behind trench roller does not appear to be able to provide proper compaction on lifts exceeding approx. 6in. The contractor agreed.

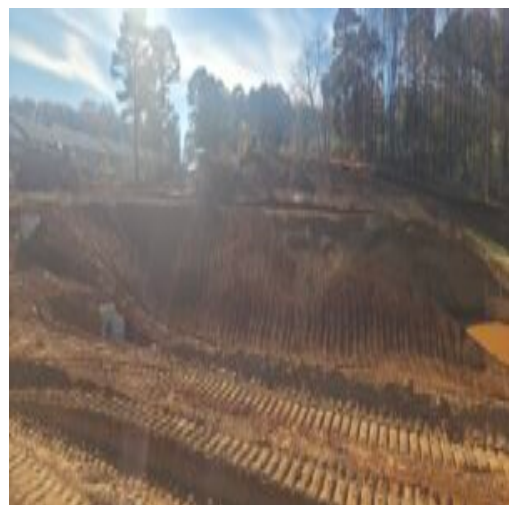
bank of lots #1 - #4 area

Our ASEC representative was on site for the observation/testing of the placement of fill/backfill. The contractor continued to place structural fill long Lots #1 through #4 area. Fill was installed in approximately 8-inch to 12-inch lifts and compacted with a HAMM vibrating sheep's foot roller. As loaded trucks rolled across the lift, ASEC watched for any signs of pumping/rutting. There were no signs of severe pumping/rutting, and the lifts appear to be stable. Density testing was performed, and all test results were provided to the contractor. Any failed tests were addressed. Topsoil that was stockpiled on the upper slope above Lots #1 through #4 and was moved to the slope of the main pond (in front of site by deceleration lane). The topsoil was rolled in with a dozer.

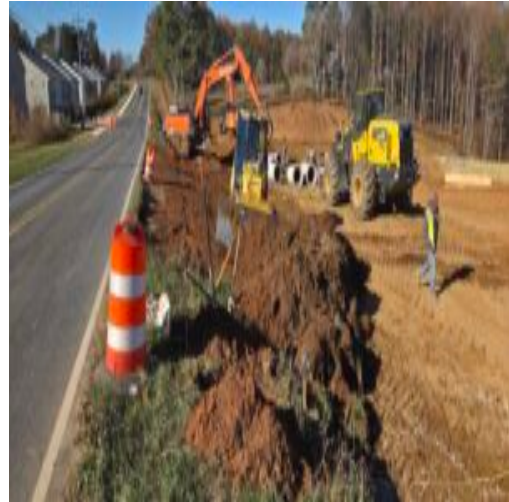
removing topsoil/grass from decel lane

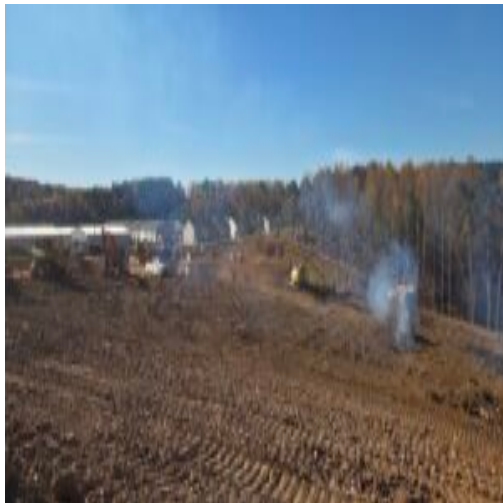
site picture of cleared brush / burning

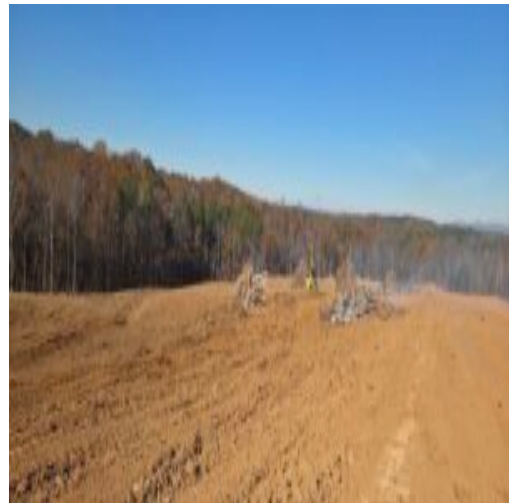
cleared brush / burning
