Date : 11/14/2025
Project No : 2025C211
Client Company : Pulte
Arrival Time : 11/14/2025 07:30
Onsite Hours : 07:00

ASEC Report ID : 87823
Name of the Project : Haley's Bluff - Philadelphia Rd.
Project Location : Jasper
Weather : Sunny
Departure Time : 11/14/2025 14:30
ASEC Technician Name : Sean Willett

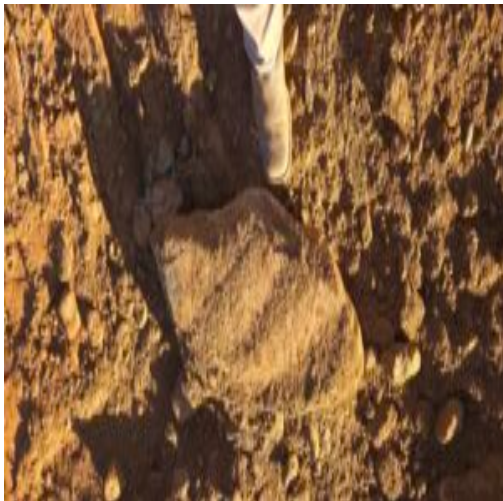
large rocks in fill

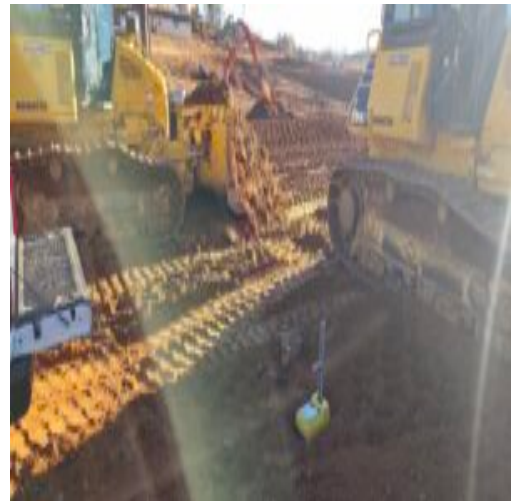
ASEC has requested multiple times to stop equipment/give proper space when testing with a nuclear density gauge. It is recommended to give ASEC at least 50 feet in all directions while using a nuclear density gauge as per safety requirements. Besides being a safety precaution, it also helps prevent any false readings during testing due to vibrations from equipment. The contractor has not been following the requests of our field representative. As displayed in the photos below, the contractor will operate their equipment within 10 feet of ASEC during testing with a nuclear density gauge. The contractor has stated "they do not want to stop equipment if they do not need to". ASEC supervisors have discussed this with Daniel and Tyler (Foreman with NG Grading). The contractor said they will maintain a safe distance and allow ASEC to safely conduct their testing.

operating equipment around ASEC during testing

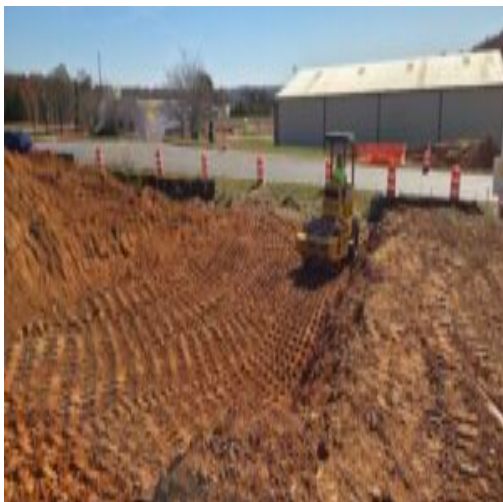
The contractor continued placing lifts approximately 6 inches to 8 inches across Lots #1 through #4 and the deceleration lane in-between BC4.0 and BC4.1. The lifts were compacted using an 815 sheeps-foot roller and a smaller HAAM vibrating sheeps-foot roller. ASEC performed density testing in this area and provided all test results to the contractor. ASEC watched as loaded trucks rolled across the lifts to check for stability. There were no signs of severe pumping or rutting present. Some of the trucks appeared to be bringing in rocks larger than 2 feet in diameter mixed in with the fill. Our representative recommended to remove any large rocks from the fill being placed in the top 4 feet of final grade. The contractor requested an ASEC supervisor to visit the site to discuss rock size in lifts and topsoil installation. The contractors and ASEC reviewed site plans together. At this time, there did not appear to be any specifications in the site plans about rock size. ASEC recommended that we maintain keeping any rocks larger than 2ft in size out of the top 4ft of final grade unless otherwise specified and as per the geotechnical subsurface report recommendation.

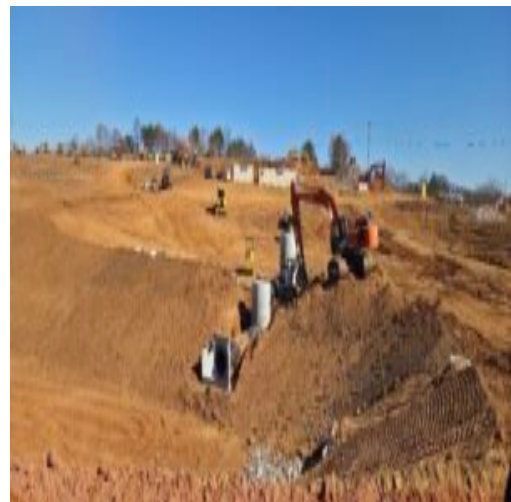
Our ASEC representative was on site for the observation/testing of the placement of fill/backfill. Upon arrival to the site, ASEC observed the contractor excavating topsoil from the slope of the detention pond to install a headwall BA1 to BA2. ASEC discussed with the contractor about the backfilling of this structure and recommended to use structural fill to backfill to at least 2 feet above the pipeline. The contractor said that the excavated topsoil from the bank was structural fill. This is incorrect, as this topsoil was stripped from the Lots #1 through #4 area and contains a large amount of organics such as root matting and large branches and roots. ASEC informed the contractor that structural fill should be used around the pipeline to prevent any settlement around the pipe. Once they are 2 feet over the structure, they could resume using topsoil in the slope. ASEC observed the contractor placing topsoil around the structure and actively attempting to compact the topsoil around the structure. ASEC performed probe rod testing around BA1 and BA2. Probe rod testing showed unstable soils around these structures (as shown in the pictures below).

installation of BA1 to BA2

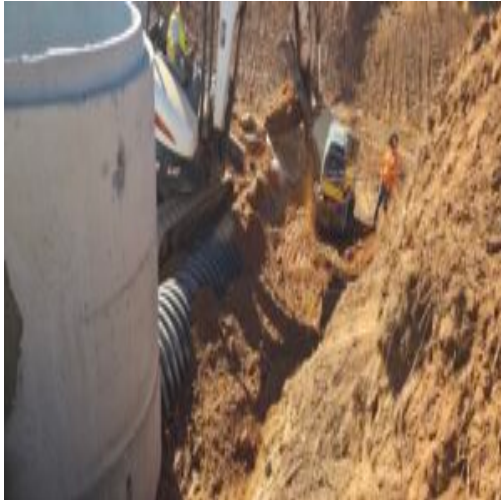
topsoil used as backfill around BA1 to BA2

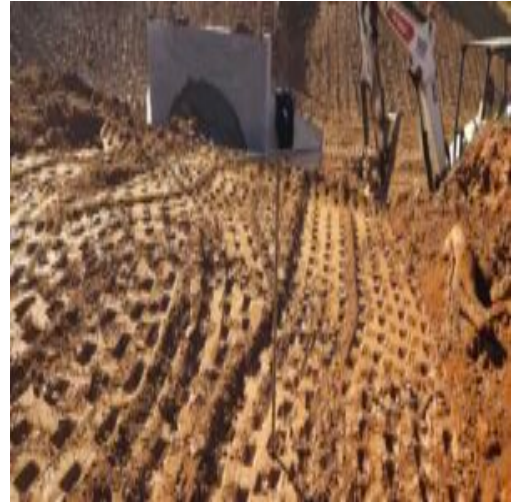
topsoil used as backfill around BA1 to BA2 failing
probe rod test

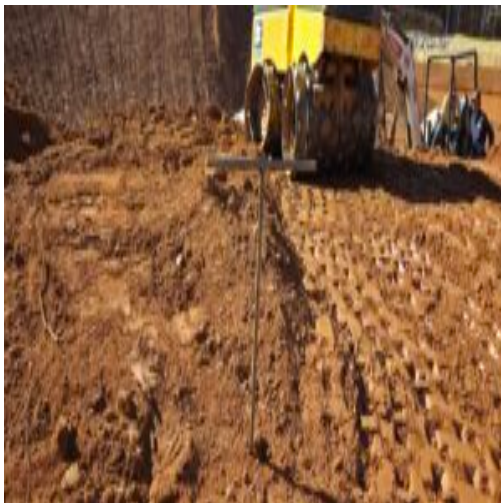
topsoil used as backfill around BA1 to BA2 failing
probe rod test

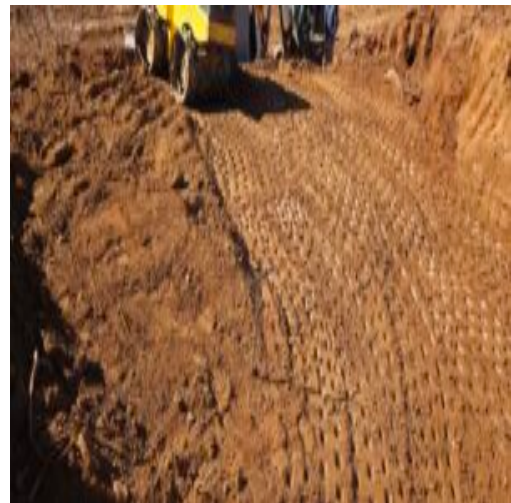
topsoil used as backfill around BA1 to BA2 failing
probe rod test

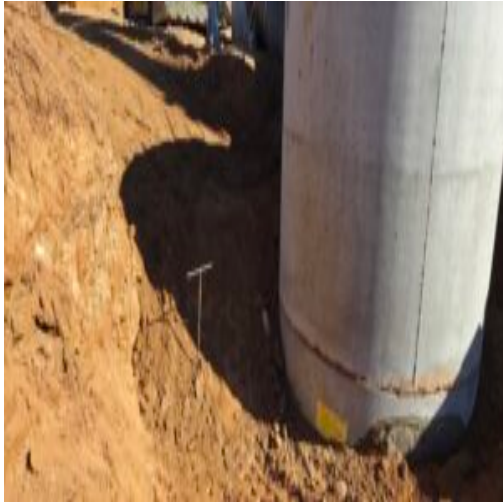
topsoil used as backfill around BA1 to BA2 failing
probe rod test

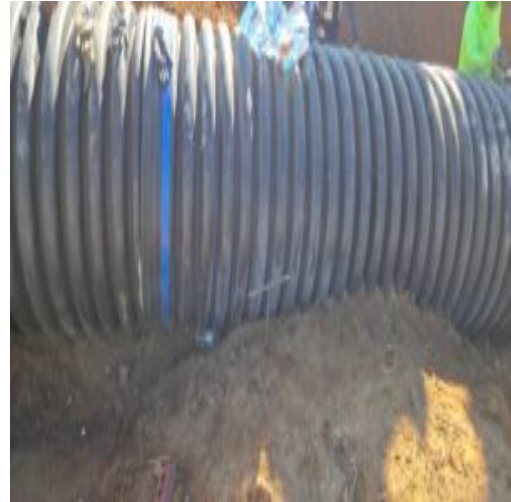
topsoil used as backfill around BA1 to BA2 failing
probe rod test

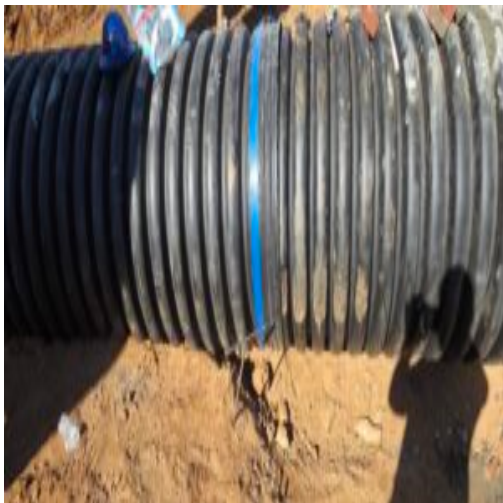
topsoil used as backfill around BA1 to BA2 failing
probe rod test

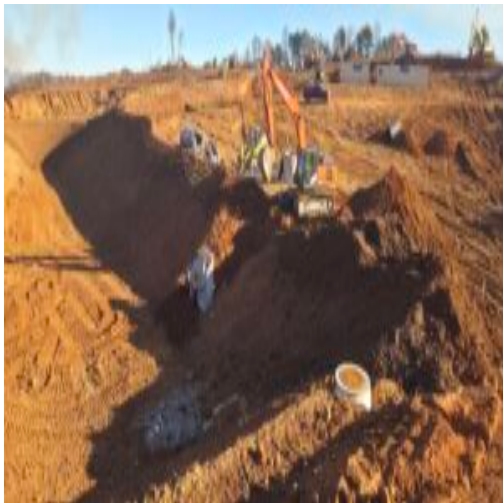
installation of BA1 to BA2
