Date : 11/17/2025
Project No : 2025C211
Client Company : Pulte
Arrival Time : 11/17/2025 07:30
Onsite Hours : 07:30

ASEC Report ID : 87939
Name of the Project : Haley's Bluff - Philadelphia Rd.
Project Location : Jasper
Weather : Sunny
Departure Time : 11/17/2025 15:00
ASEC Technician Name : Sean Willett

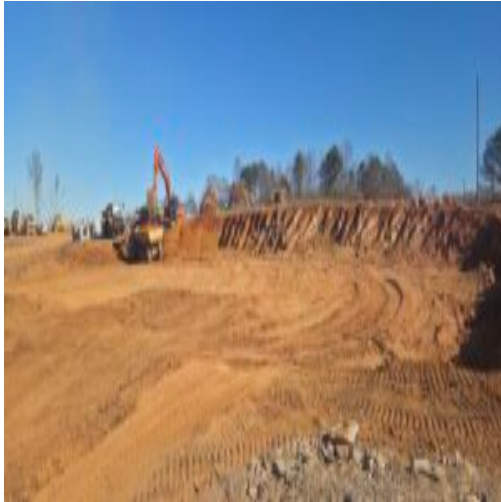
excavation of commercial lots above Connex

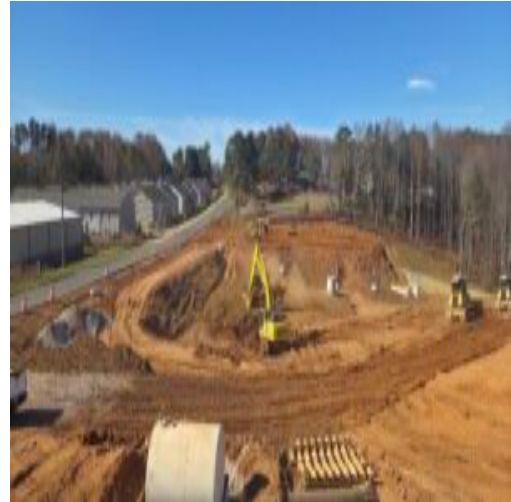
commercial lot below Connex and lots #1-#4

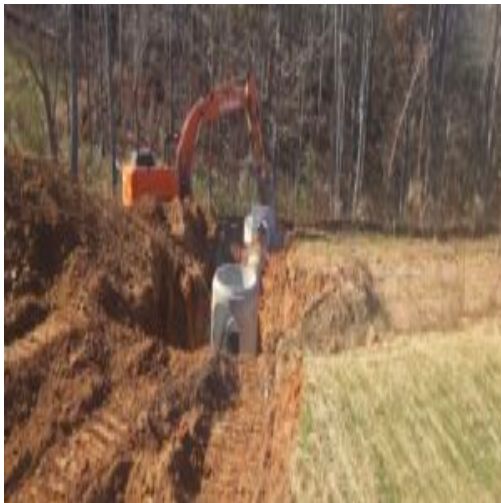
The contractor began excavation/installation of BZ1 to BZ2 headwall structures into front of the detention pond. The contractor began backfilling around these structures with structural fill. Density testing will be performed once the contractor is approximately 2 feet above the pipeline.

BZ1 to BZ2 headwall

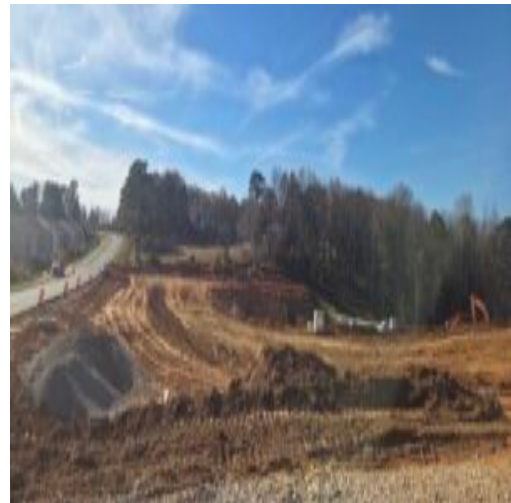
lots #1 - #4 and detention pond area

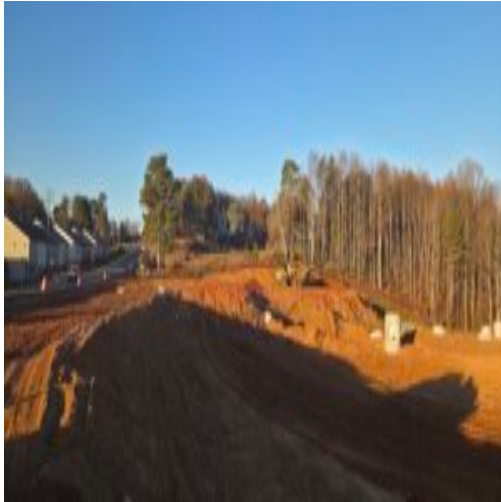
lots #1 - #4 and detention pond area

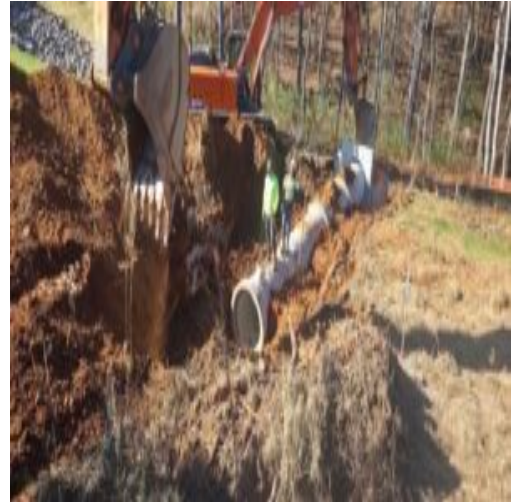
BZ1 to BZ2 headwall

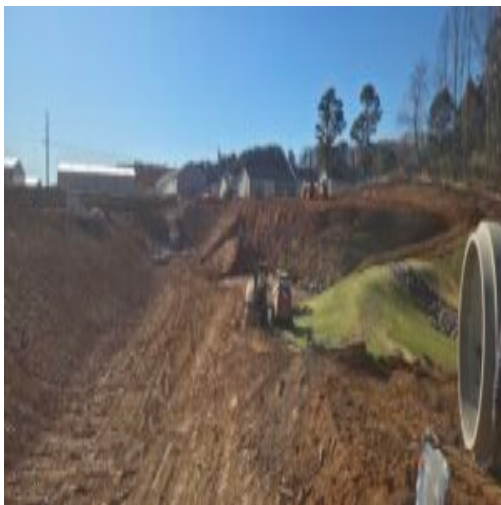
inside detention pond
