Date : 11/19/2025
Project No : 2025C211
Client Company : Pulte
Arrival Time : 11/19/2025 07:30
Onsite Hours : 07:30

ASEC Report ID : 88080
Name of the Project : Haley's Bluff - Philadelphia Rd.
Project Location : Jasper
Weather : Overcast
Departure Time : 11/19/2025 15:00
ASEC Technician Name : Sean Willett

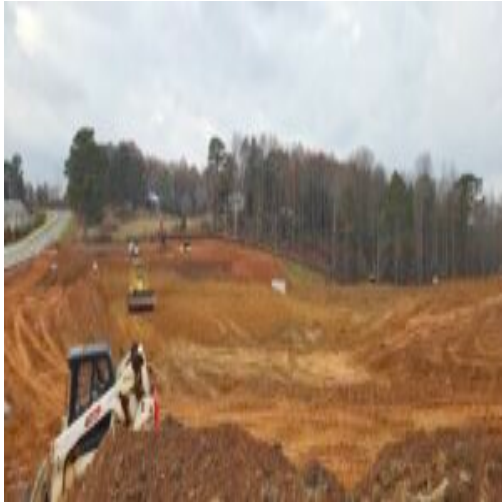
commercial lots

Our ASEC representative was on site for the observation/testing of the placement of fill/backfill. The contractor continued placing lifts of approximately 6 in to 8 in in thickness across the commercial lot area located around the front detention pond. The lifts were compacted using an 815 sheep's foot roller. Density testing was performed, and test results were provided to the contractor. It was recommended to recompact the first lift of the morning due to failing density tests. The contractor agreed, and after rolling the lift with a loaded off-road truck, density tests began passing. There was no severe pumping or rutting observed. The lot appears to be stable and well compacted.

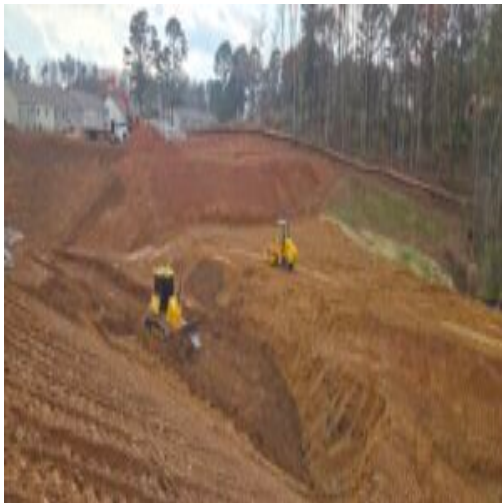
The contractor continued to build up the bank to the detention pond below Lot #4 and around Lot #5. The contractor is making an effort to have this bank built up over the drainage structure before the rainfall forecasted for the weekend. Part of this fill area includes the roadway in front of Lots #4 and #5. Density testing was performed along this bank/roadway and test results were provided to the contractor. ASEC watched as loaded dump trucks rolled across the lifts to check for stability. There were no signs of severe pumping/rutting observed. The contractor placed topsoil in the bottom of the detention pond. This topsoil was compacted with a sheep-foot roller.

topsoil in bottom of detention pond and filling bank around
lot #4 and #5

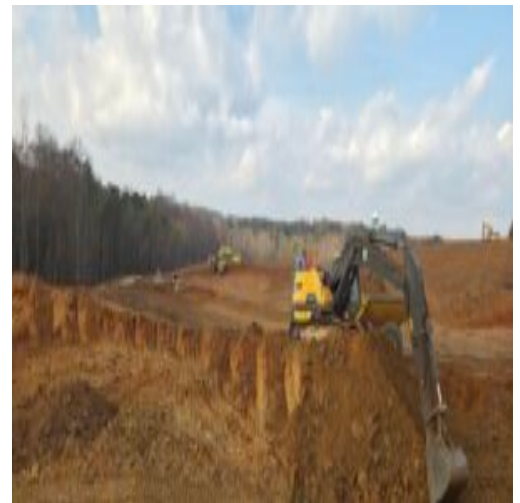
The contractor continued placing lifts on the approximate location of Lots #8 through #13 and #52 through #60. This area is a deep fill area consisting of +20 feet of fill. The contractor placed approximate 8- to 12-inch-thick lifts in this area and compacted with a sheep-foot roller. ASEC watched as loaded dump trucks rolled across the lifts to check for stability. There were no signs of severe pumping/rutting observed. It was recommended to remove any large organics from fill prior to compaction. Density testing was performed, and test results were provided to the contractor.

filling on lots #8 - #13 and #52 - #60 area

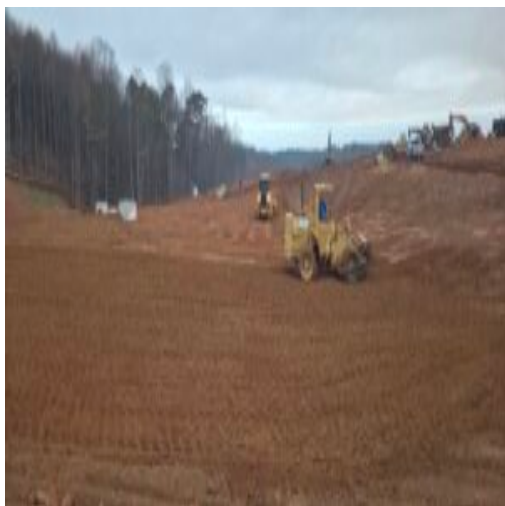
filling on commercial lot area

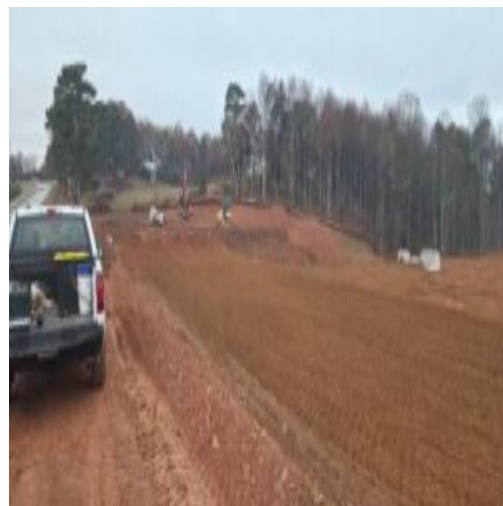
commercial lot area and detention pond

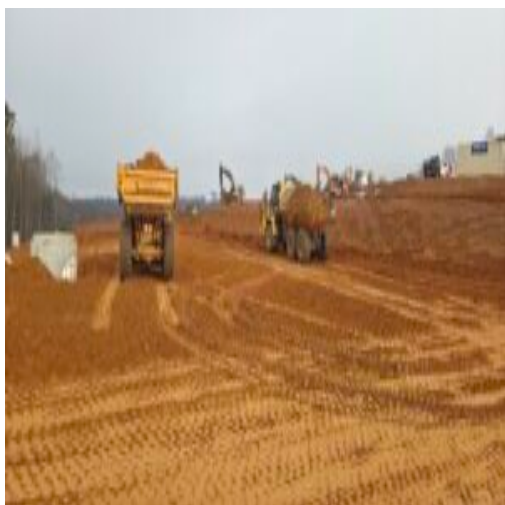
rolling in commercial lot area

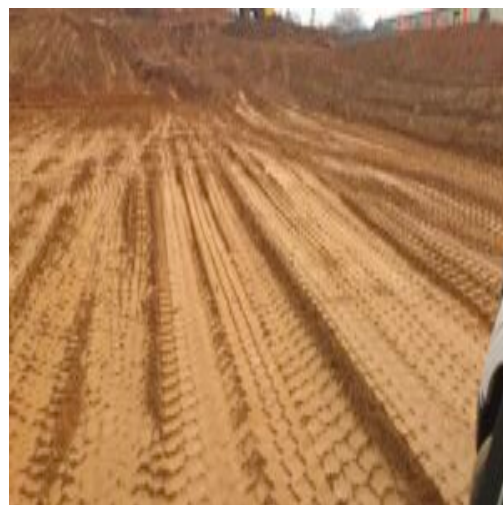
rolling in commercial lot area
