Daily Field Report

Date: 11/20/2025 Project No: 2025C211 Client Company: Pulte

ASEC Report ID : 88087 Name of the Project : Haley's Bluff - Philadelphia Rd. Project Location : Jasper

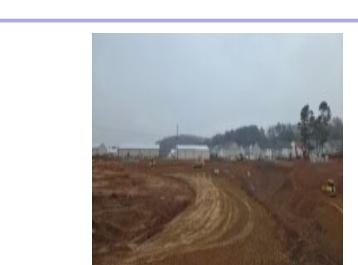
Our ASEC representative was on site for the observation/testing of the placement of fill/backfill. The contractor continued placing lifts approximately 6 to 8 inches in thickness across the commercial lot area located around the front detention pond. The lifts were compacted using an 815 sheep's foot roller. ASEC watched as loaded dump trucks rolled across the lifts to check for stability. There were no signs of severe pumping or rutting present. Density testing was performed, and test results were provided to the contractor.

commercial lots, front detention pond, and bank/roadway in front of lot #4 - #5
