Date : 12/03/2025
Project No : 2025C211
Client Company : Pulte
Arrival Time : 12/03/2025 07:30
Onsite Hours : 08:30

ASEC Report ID : 88301
Name of the Project : Haley's Bluff - Philadelphia Rd.
Project Location : Jasper
Weather : Sunny
Departure Time : 12/03/2025 16:00
ASEC Technician Name : Sean Willett

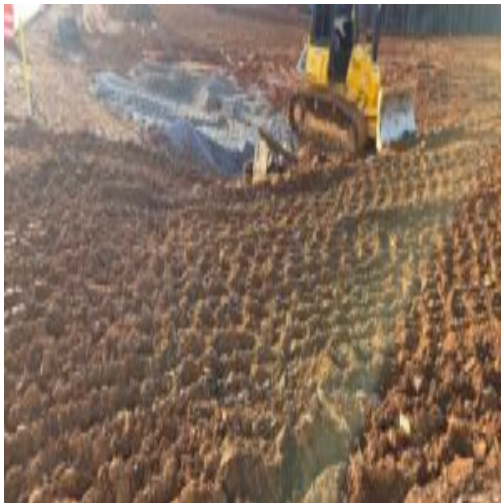
replacing the cut area

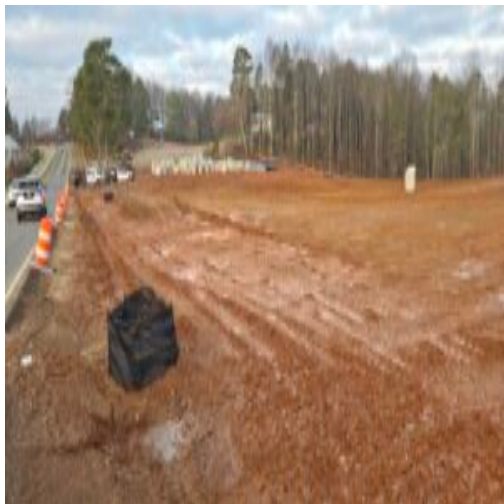
Our ASEC representative was on site as requested by the contractor (NG Grading) for the observation/testing of the placement of fill/backfill. Upon arrival to the site, it appears that the site has not dried out much from the previous days rainfall. There was a freeze and most of the water on the surface is now ice. ASEC spoke with the contractor to see how the contractor planned to handle this situation. The contractor insisted on working, so ASEC recommended that the frozen ground should be stripped away before any placement of fill material. The contractor agreed and spent most of the day stripping frozen ground away. As the sun came out in the afternoon, it turned the surface into mud. It was recommended to remove any over-saturated material before placement of fill.

site conditions at beginning of day

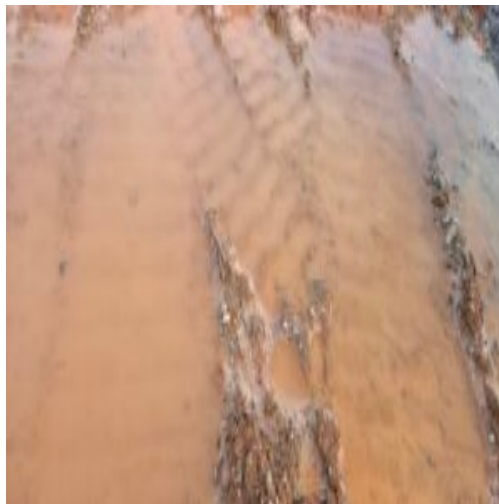
site conditions at beginning of day

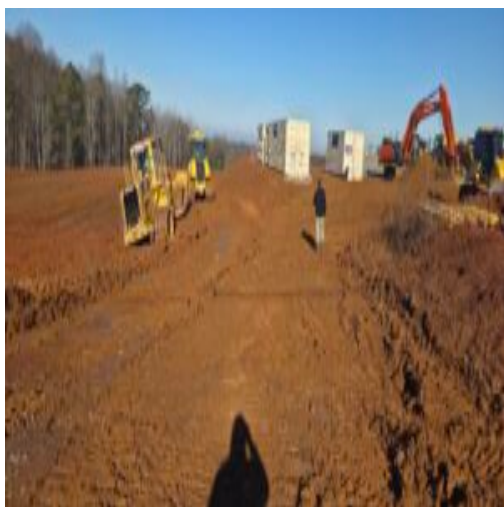
cutting mud/frost out before filling entrance way
