Date : 12/15/2025
Project No : 2025C211
Client Company : Pulte
Arrival Time : 12/15/2025 07:30
Onsite Hours : 07:30

ASEC Report ID : 88573
Name of the Project : Haley's Bluff - Philadelphia Rd.
Project Location : Jasper
Weather : Sunny
Departure Time : 12/15/2025 15:00
ASEC Technician Name : Sean Willett

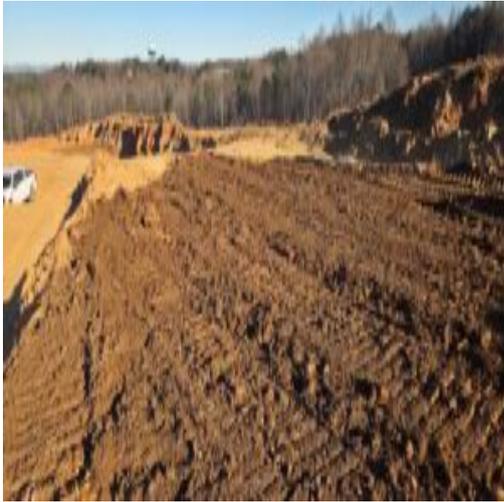
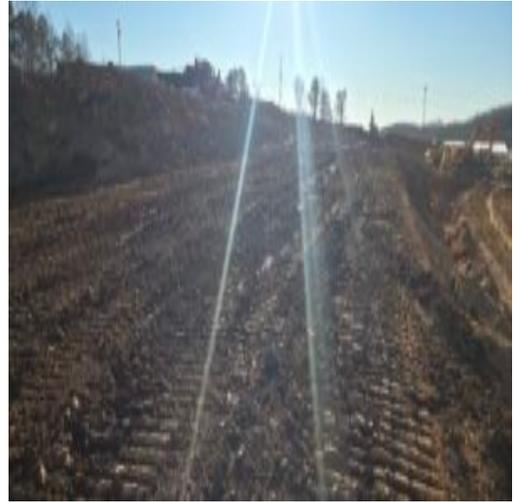
The contractor is spreading one lift of approximately 12 inches of topsoil across the excavation area to dry and then mix into the fill material as it is excavated. Our representative recommended to remove any large organics that were present. The organics were shown to the contractor, and they agreed to the removal. The contractor is attempting to mix the topsoil gradually into the fill material to help decrease the amount of stockpiled topsoil. This was a decision made by the contractor and not recommended by ASEC.

topsoil spread into cut

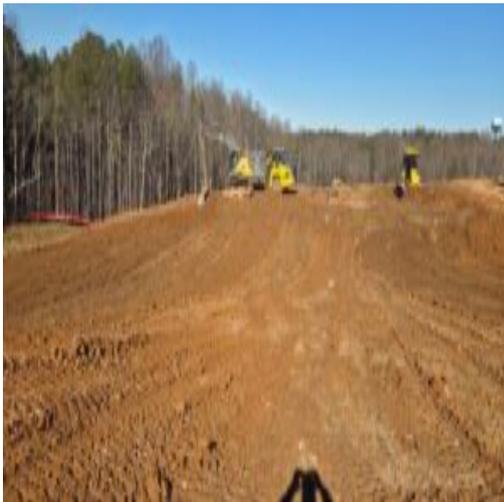
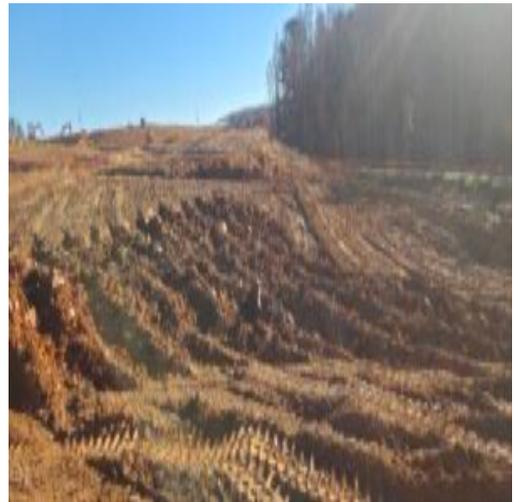
The contractor removed topsoil from in between the approximate area of Lots #13 through #20. A proof-roll was performed on the approximate area of Lot #14 - #15. Lots #16 through #19 will be proof-rolled on the following day once the topsoil has been removed. the proof-roll was performed with a loaded off-road truck. Any pumping was shown to the contractor and will be excavated until stable ground is achieved. Probe rod testing was used to check the stability of the residual soils as well. In areas with +10ft of fill, the contractor plans to place a lift of crushed concrete, and then a bridge lift.

topsoil removal 13 - 20

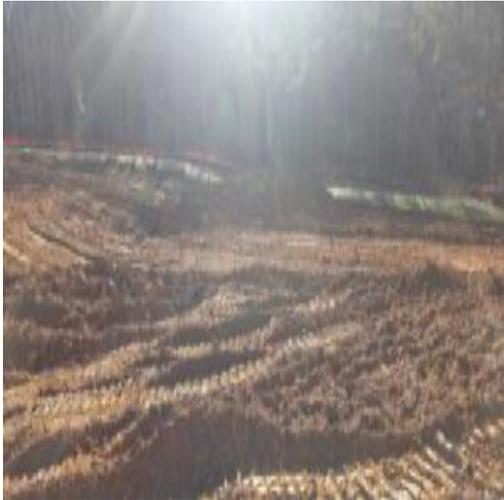
stockpiled topsoil 13 - 20

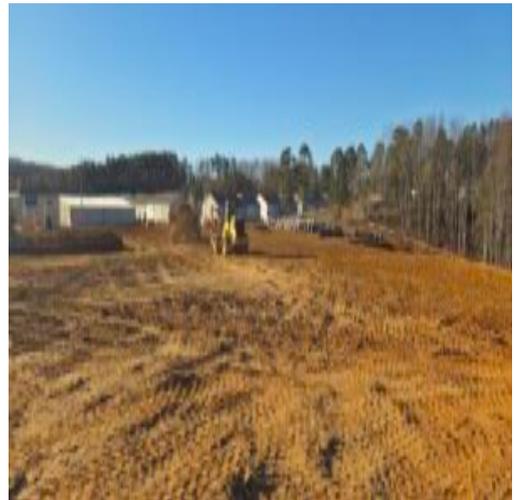
commercial lot by front pond

The contractor continued placing lifts in approximately 6 to 12 inches in size across the commercial lot by the front pond and Lots #8 through #13 and # 52 through #60. Lifts were compacted using a sheep-foot roller. ASEC watched as a loaded off-road truck rolled across the lifts to check for stability. There was no severe deflection or pumping present, and the lifts appeared to be stable.
