Date : 01/05/2026
Project No : 2025C211
Client Company : Pulte
Arrival Time : 01/05/2026 07:30
Onsite Hours : 06:30

ASEC Report ID : 88989
Name of the Project : Haley's Bluff - Philadelphia Rd.
Project Location : Jasper
Weather : Sunny
Departure Time : 01/05/2026 14:00
ASEC Technician Name : Sean Willett

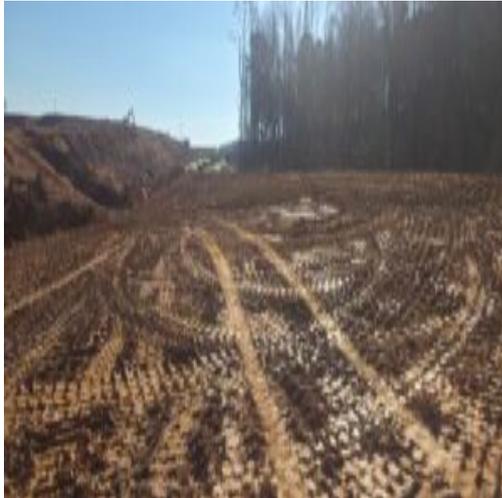
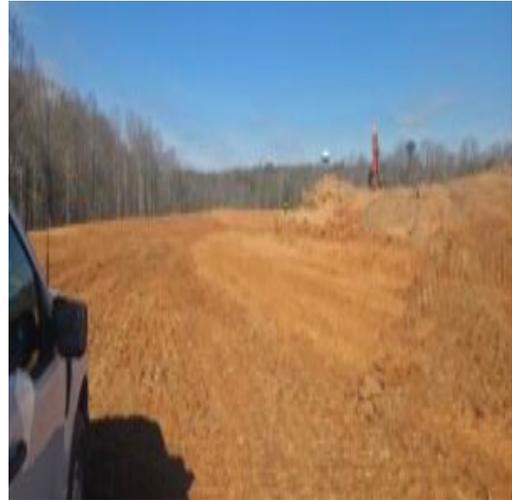
14 - 19

Our ASEC representative was on site to observe the contractor (NG Grading) and for the observation/testing of the placement of fill/backfill. The grading crew placed soil lifts of approximately 8 to 12 inches in size across Lots #14 through #19. Lifts were compacted using a sheep-foot roller. ASEC watched as loaded off road trucks rolled across the lifts to check for stability. There were no signs of severe pumping or deflection present at this time. Density testing was performed, and test results were provided to the contractor.

Note: It appears that the contractor has started mixing topsoil into the structural fill when loading trucks. This is against our recommendation. The contractor is benching in natural slopes and spreading the benched topsoil across the fill areas. The contractor also has been spreading an approximate 1 foot lift of wet topsoil across cut (excavation) areas to dry and be mixed in. Now the contractor has started adding 2 to 3 buckets of topsoil into the off-road trucks as they are being loaded. ASEC has consistently been in communication with the contractor about the amount of topsoil being mixed into the fill. The concern is the organics present in the topsoil. It appears to have a large quantity of tree limbs, tree trunks, and smaller organics present. If the topsoil is clean and free of organics, mixing a small amount should be acceptable.

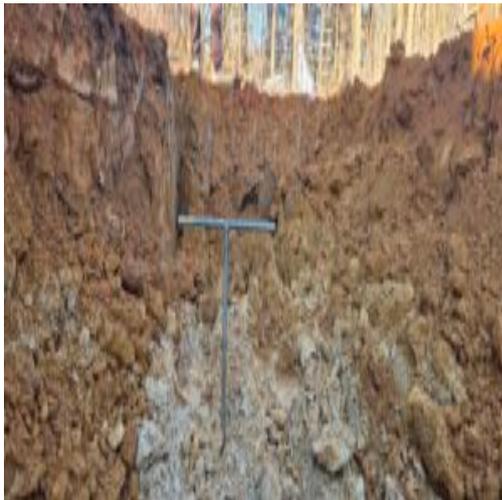
retaining wall 3 footing

The wall contractors began excavation of the wall footing. There was no rock present on site to begin backfilling of the footing. The wall crew left the site for the day and will begin tomorrow when the material is present on site.
