Date : 02/19/2026  
Project No : 2025C211  
Client Company : Pulte  
Arrival Time : 02/19/2026 07:00  
Onsite Hours : 08:15

ASEC Report ID : 90443  
Name of the Project : Haley's Bluff - Philadelphia Rd.  
Project Location : Jasper  
Weather : Overcast  
Departure Time : 02/19/2026 15:15  
ASEC Technician Name : Sean Willett

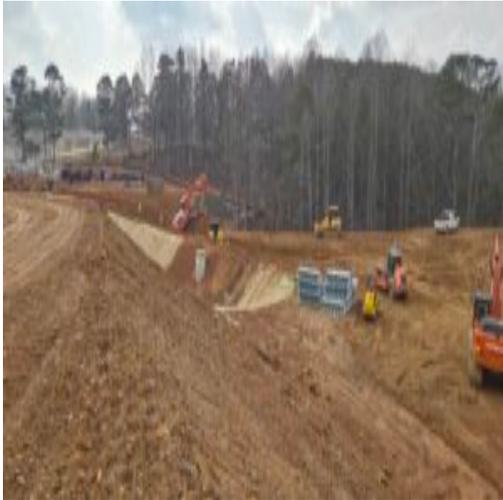
Upon arrival to the site, it was visually noticeable that the site was oversaturated from the previous night's rain. ASEC began checking moisture contents of soils located in different areas around the site. Moisture content showed 3% to 5% over optimum moisture content. The contractor stated they were still going to try to place structural fill today and removed approximately 8 inches of soil from the previously placed fill areas on Lots #30 through #32. ASEC watched as a loaded truck rolled across this area, and there were clear signs of severe pumping/deflection on the lots. ASEC pointed this out to the contractor and recommended not to continue placing soil, and to remove approximately 1.5 to 2 feet of the pumping soils, or until stable subgrade soils were reached. The contractor argued with the recommendations made by ASEC.

wet site

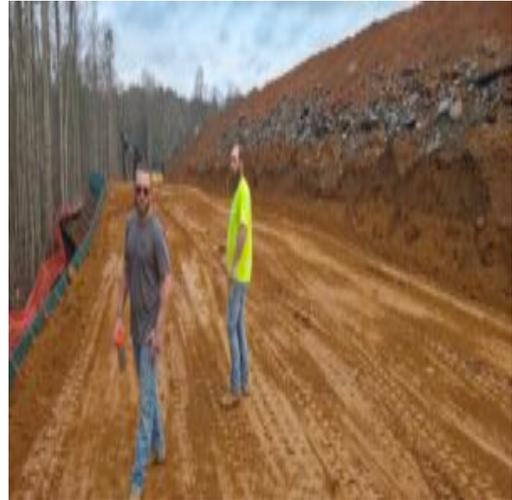
wall 2

The wall crew was present on site and requested testing to be performed on retaining wall #2 before continuing the installation of baskets. ASEC performed multiple density tests in this area, and all tests failed with low compaction and high moisture contents. The wall crew began to remove the over saturated soils in an attempt to replace with a drier material provided by the grading crew. The grading superintendent Daniel met with ASEC to discuss site conditions. ASEC recommended to Daniel and the wall crew not to remove any more soil from the lifts, as the crew runs a risk of damaging the geogrid and baskets. Daniel made the decision to have his crew and the wall crew continue to remove soil, against ASEC's recommendation. The contractors ripped and damaged an approximate 24 feet x 10 feet section of geogrid out from the lift. ASEC recommended to replace any damaged portions of the wall back to job specifications as stated in the plans.

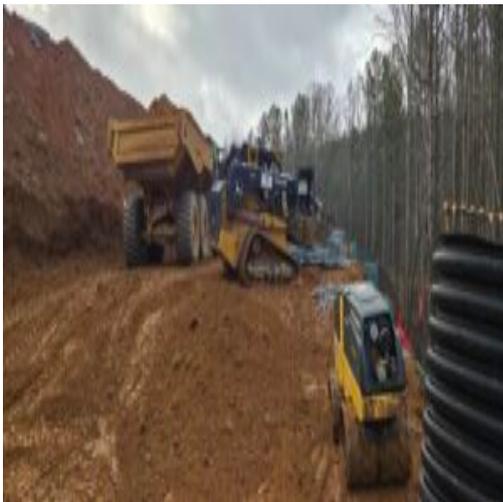
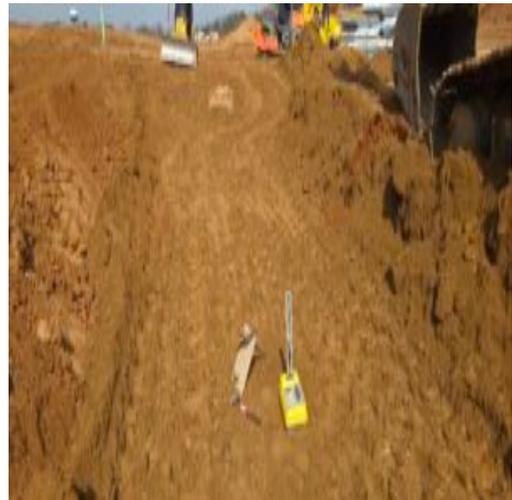
At this time, the grading crew and wall crew have shut down for the day. The pipe crew had begun a new excavation of SSMH 4.0 to SSMH 5.0, even though we have forecasted rainfall later in the day and the next day as well as clear signs that the soil on site was far too wet to backfill with. ASEC began density testing approximately 2 to 3 feet over the pipeline. All tests failed, and ASEC called the pipe crew foreman to discuss site conditions and failing tests. The contractor made it clear that they have no intention on stopping the installation of the pipeline because now they have an exposed trench that will fill with water.

testing pipeline

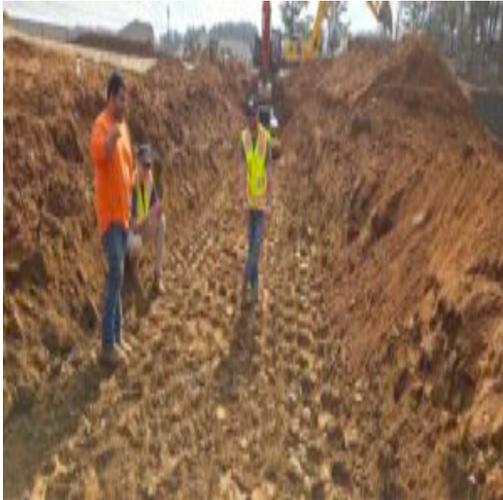
The contractor continued to backfill this pipeline over failing tests. This was against ASEC recommendation. The contractor has continued to work the site against ASEC recommendation and against the previous conversations with Mr. Wood. ASEC is not liable for any damages due to improper installation of this pipeline.

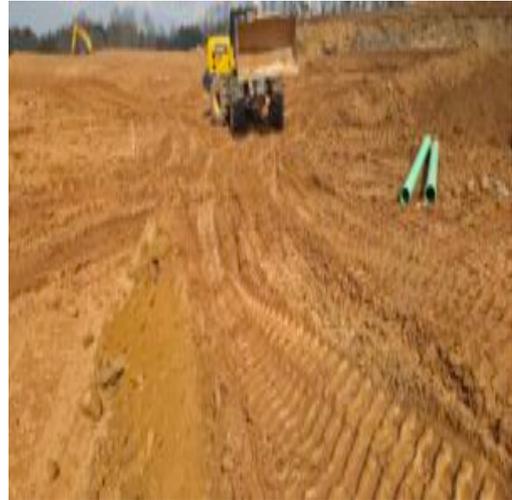
rutting from trucks due to wet site
