Date : 03/23/2026  
Project No : 2025C211  
Client Company : Pulte  
Arrival Time : 03/23/2026 10:00  
Onsite Hours : 05:30

ASEC Report ID : 91687  
Name of the Project : Haley's Bluff - Philadelphia Rd.  
Project Location : Jasper  
Weather : Sunny  
Departure Time : 03/23/2026 15:30  
ASEC Technician Name : Sean Willett

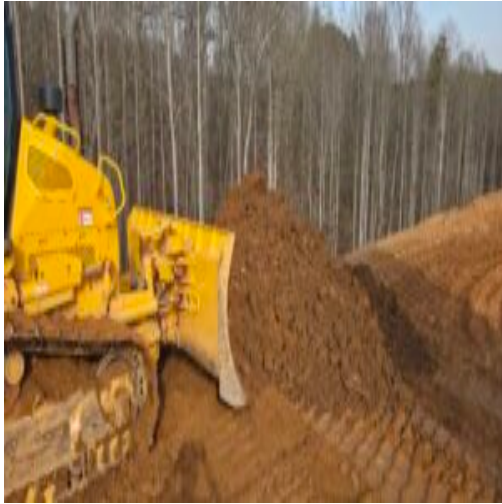
wall 1

The grading crew continued to assist the wall crew in installing retaining wall 1. The wall crew has expressed complaints of the footing not being over excavated past the face of the wall stakes. They are removing approximately 6 inches of soil along the face of the wall. The contractors started placing the topsoil in the middle of the footing. ASEC recommended to remove the topsoil before any installation of baskets, as the topsoil is not structural fill. The grading crew spread approximately 8-to-12-inch lifts across the baskets and compacted using their sheep-foot roller. Density testing was performed, and test results were provided to the contractor.

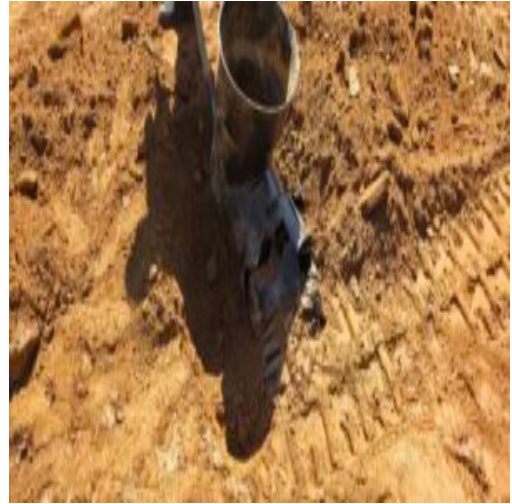
The wall crew has not been using their own equipment to compact this area. The wall crew damaged a drainage pipe with their skid steer, and it appeared that they tried to cover up the damage instead of replacing the pipe. ASEC documented this and informed the contractor that they need to replace the pipe. The wall crew watched as the grading crew hand shoveled the dirt around the pipe to fix the wall crew's damage.

damaged drain wall 1

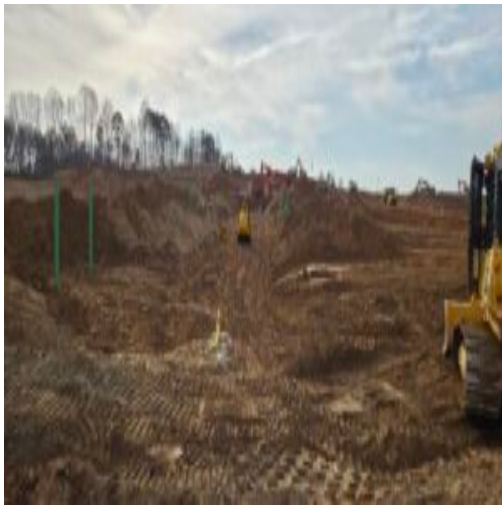
pipeline

The pipe crew continued installation of storm line 3.1 to 3.2. Backfill was placed in approximate 1-foot lifts and compacted using a sheep-foot roller and a trench roller. Density testing was performed and test results were provided to the contractor.

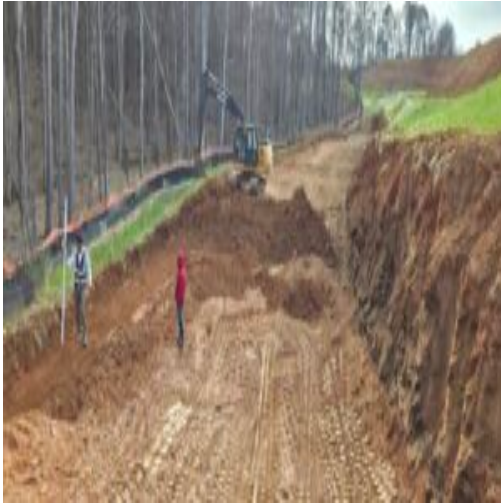
topsoil in footing wall 1
