Date : 03/26/2026
Project No : 2025C211
Client Company : Pulte
Arrival Time : 03/26/2026 10:00
Onsite Hours : 06:45

ASEC Report ID : 91734
Name of the Project : Haley's Bluff - Philadelphia Rd.
Project Location : Jasper
Weather : Sunny
Departure Time : 03/26/2026 16:45
ASEC Technician Name : Sean Willett

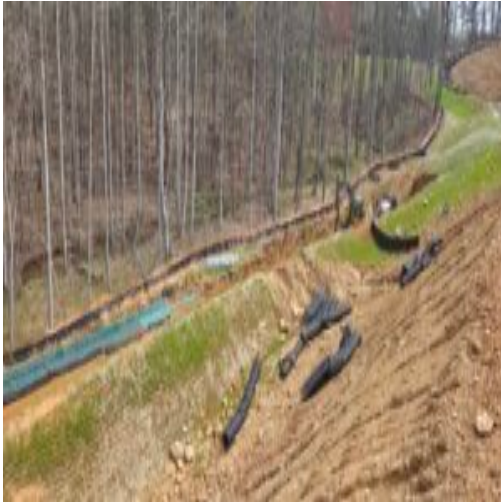
wall 1

On my way to the site, the grading crew sent me a picture of the wall crew removing the GAB and No. 57 stone from the footing of wall 1. It appeared that they stockpiled the stone together with soil mixed into the stockpile. This has now contaminated the rock that was recommended for the failed portion of this wall. When asked why they were digging out the rock, they claimed it was to be able to extend the face of the wall by approximately 6 inches (this made no sense to multiple individuals on site). ASEC explained they needed to remove their baskets and replace the contaminated rock with clean rock to achieve the recommended bearing capacity in this area. A test pit was dug (with Tyler grading crew foreman present) to expose the rock to verify if it was contaminated. It appeared to be contaminated and a mixture of No. 57 stone, GAB, and soil. When told to wait, as ASEC was discussing the situation with Phil (wall crew foreman, not present onsite) and Mr. Scott Wood of Pulte, the wall crew began ripping out their baskets. ASEC informed them to stop, as directed by Mr. Wood.

Mr. Wood, Phil, and ASEC plan to meet tomorrow morning to evaluate and discuss a plan of action. For now, the wall crew is going to continue placing baskets on another section of the wall. Density testing was performed, and test results were provided to the contractor.

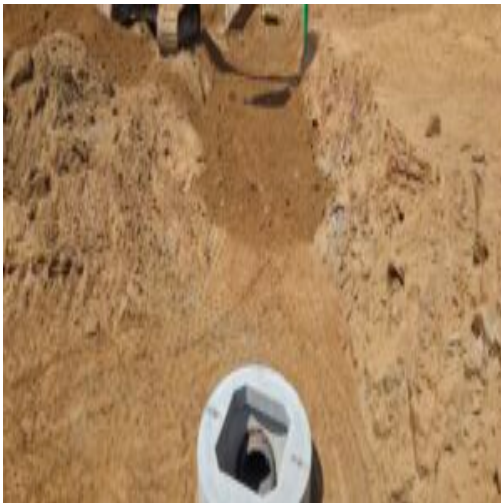
The pipe crew is continuing installation of storm line. The pipeline appears to be shallow (-2ft or less) to the final grade and is not ready to be tested at this time. Density testing will be performed once final grade is achieved.

storm line shallow

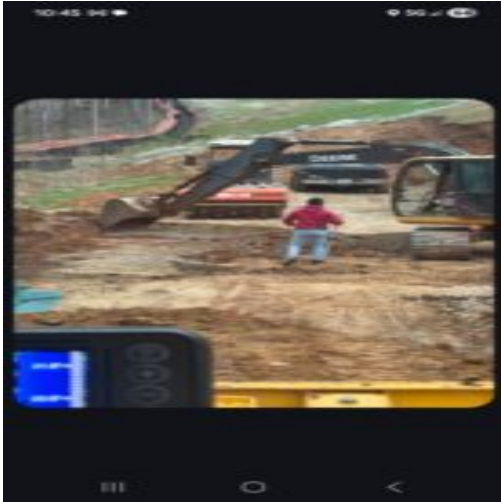
removing the rock in footing wall 1

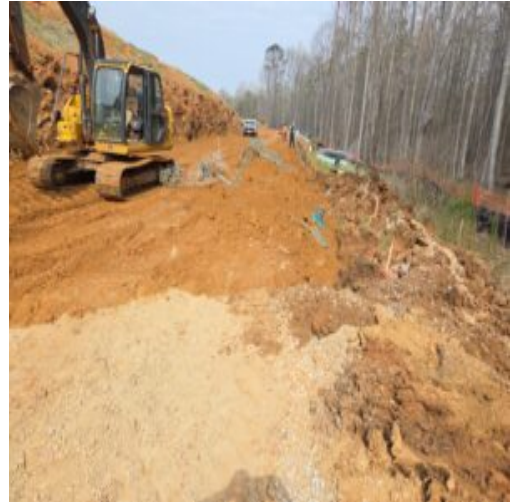
wall 1 contaminated area

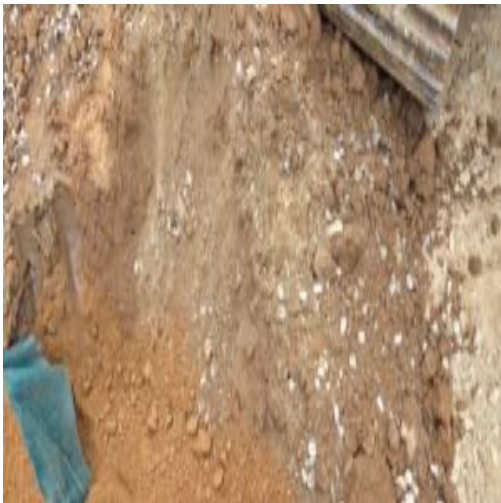
contaminated rock

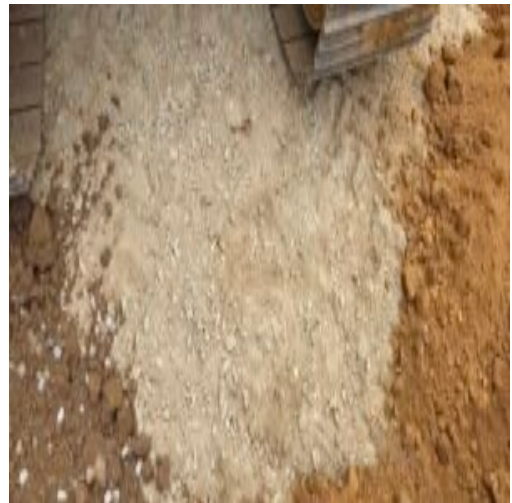
clean rock

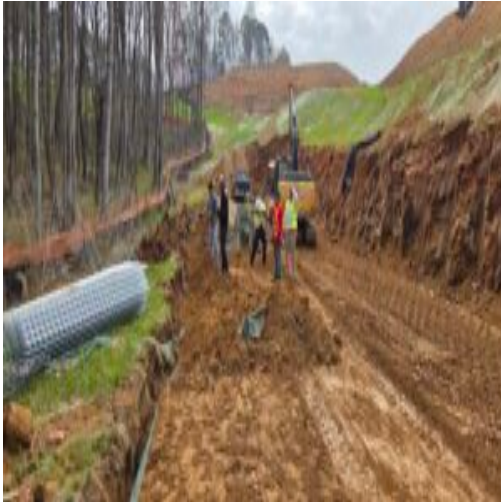
wall 1 contaminated area
