Date : 03/27/2026  
Project No : 2025C211  
Client Company : Pulte  
Arrival Time : 03/27/2026 07:00  
Onsite Hours : 08:00

ASEC Report ID : 91746  
Name of the Project : Haley's Bluff - Philadelphia Rd.  
Project Location : Jasper  
Weather : Sunny  
Departure Time : 03/27/2026 15:00  
ASEC Technician Name : Sean Willett

As requested, the site was visited by our AS Engineering and Consulting (ASEC) representative for the purpose of providing quality control inspection and testing services. Visual observation techniques were employed to verify compliance with project drawing/specifications, applicable codes, and materials submittals. The following observations were observed on site this day.

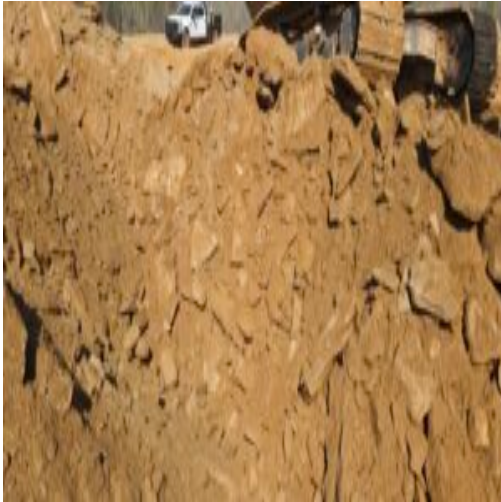
pipeline backfill

The pipe crew continued installation of sewer and storm line. This area consists of a large amount of blasted rock and PWR. Visual inspections were used to confirm that the contractor is attempting to properly compact this line. Density testing was unable to be performed in this area due to the large rock. The contractors are attempting to mix finer material into the rock before placing as backfill to help fill voids. A proof-roll will be performed once final grade is achieved to confirm that the backfilled material is stable.

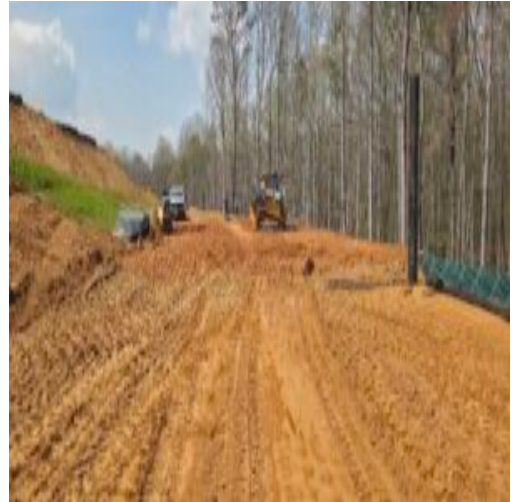
wall 1

ASEC met with Phil (wall crew foreman) and Mr. Wood to discuss a plan of action to fix the footing of retaining wall 1. The contractors are going to remove and replace their baskets and any contaminated rock. They will also fill in the additional 6 inches of the extended face of the footing. Phil questioned ASEC as to why we were not on site to "supervise" his crew. ASEC informed Phil that we are here on site to perform density testing and inspections for quality control and quality assurance purposes. ASEC is not responsible for supervising or running any crews on site. We only provide recommendations, but it is up to the contractor to do the job according to the job specifications of the site. This point was reinforced by Mr. Wood. Phil was requested to be on site for the remainder of the job.

The wall crew continued placing baskets on the other sections of the wall and has not yet begun to remove and replace the failed section. Density testing was performed and test results were provided to the contractor.
