Date : 03/30/2026
Project No : 2025C211
Client Company : Pulte
Arrival Time : 03/30/2026 10:00
Onsite Hours : 04:00

ASEC Report ID : 92069
Name of the Project : Haley's Bluff - Philadelphia Rd.
Project Location : Jasper
Weather : Sunny
Departure Time : 03/30/2026 14:00
ASEC Technician Name : Sean Willett

Our ASEC representative was on site to observe the contractor (NG Grading) and for the observation/testing of the placement of fill/backfill.

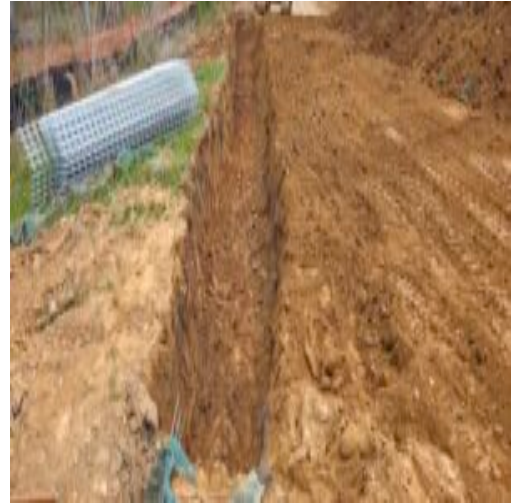
The grading crew continued to assist the wall crew in the installation of retaining wall 1. Soil lifts were spread approximately 8 to 12 inches in thickness and compacted using a vibrating sheep-foot roller. Density testing was performed and test results were provided to the contractor. The contractor undercut approximately 3 feet deep x 4 feet wide x 75 feet long to replace with No. 57 stone and a 6-inch GAB cap in the failed portion of the footing for retaining wall 1. It was recommended to excavate 2 feet deep, but the contractor over excavated the area. Additional No. 57 stone was needed to fill the trench to the final grade of the footing.

trench for rock in failed area of wall 1
