Date : 04/20/2026  
Project No : 2025C211  
Client Company : Pulte  
Arrival Time : 04/20/2026 07:00  
Onsite Hours : 05:00

ASEC Report ID : 93276  
Name of the Project : Haley's Bluff - Philadelphia Rd.  
Project Location : Jasper  
Weather : Sunny  
Departure Time : 04/20/2026 12:00  
ASEC Technician Name : Sean Willett

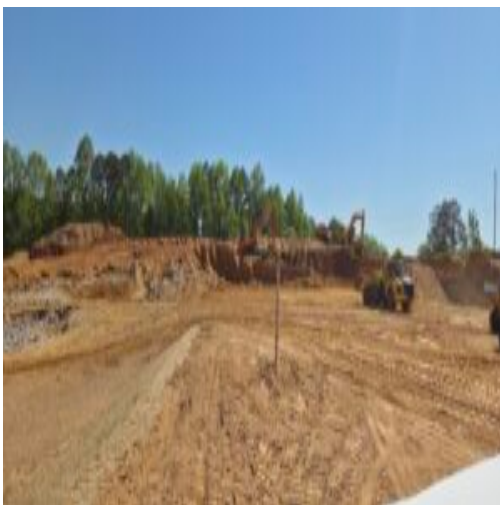
commercial lot

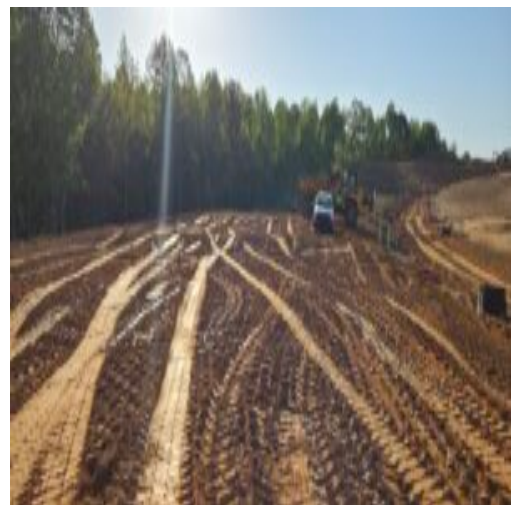
Our ASEC representative was on site to observe the contractor (NG Grading) and for the observation/testing of the placement of fill/backfill. The grading crew continued to fill on Lots #33 through #44 located above retaining wall 1. Fill was spread in 8-to-12-inch lifts and compacted using a sheep-foot roller. Density testing was performed and test results were provided to the contractor. The grading crew is starting to haul and place blasted rock into the deep fill areas along these lots. ASEC watched as loaded off road trucks rolled across the lifts to check for stability. There were no signs of severe pumping or deflection present.

lots above wall 1

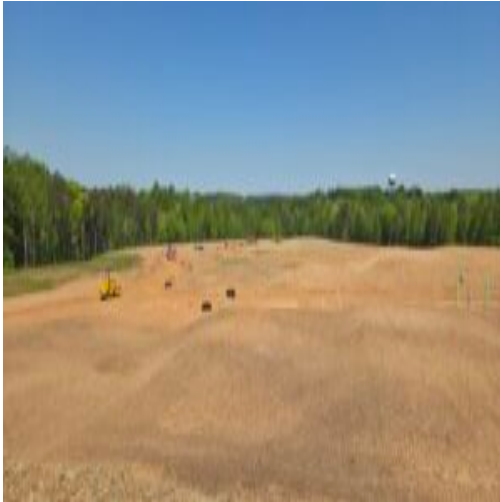
site picture
