ASEC Report ID : 92834  
Name of the Project : NW Unit 4 BRIDGE (Materials Testing)  
Project Location : Dallas  
Weather : sunny  
Departure Time : 03/20/2026 11:30  
ASEC Technician Name : Ramchandra Mogulla

**FIELD OBSERVATIONS**

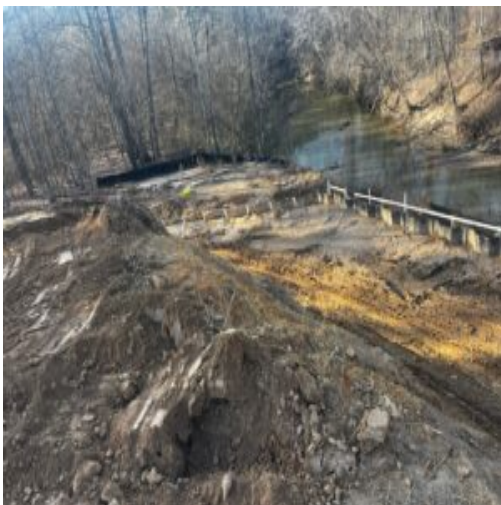
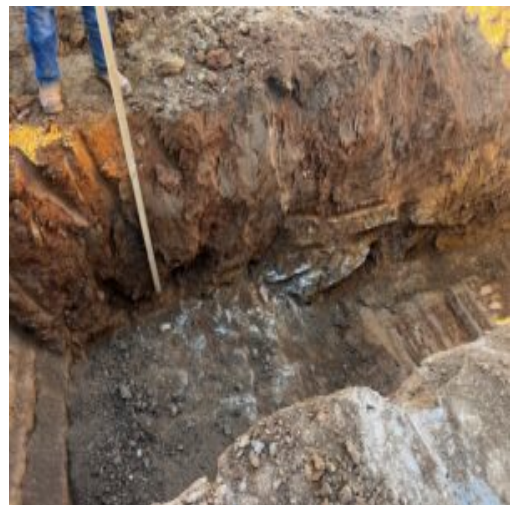
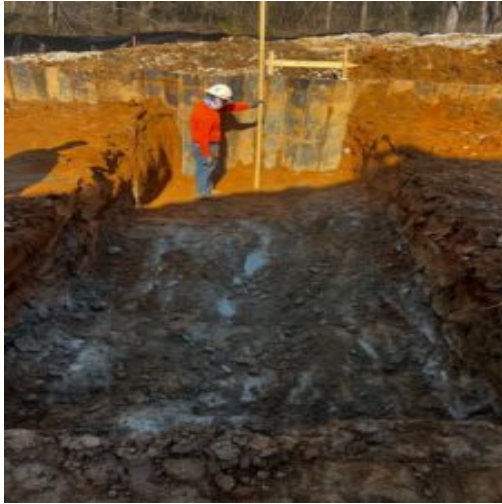
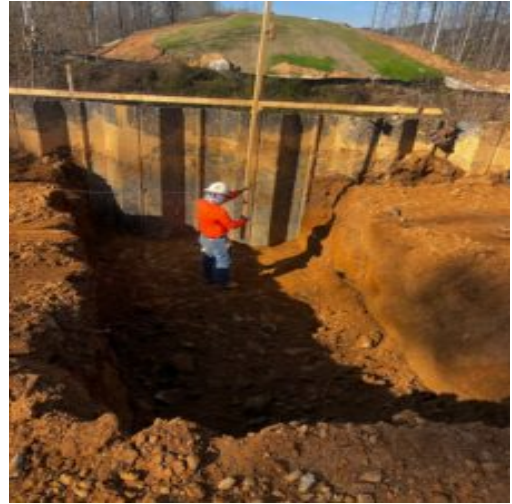
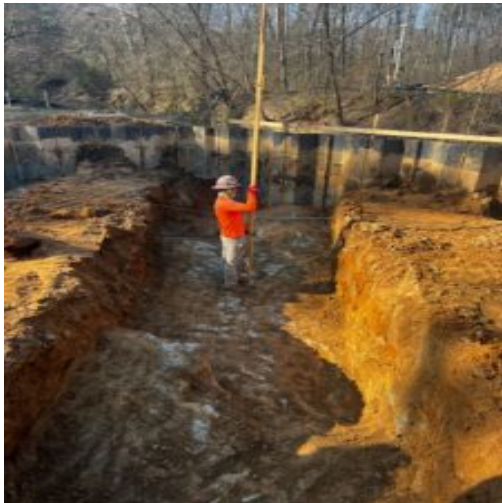
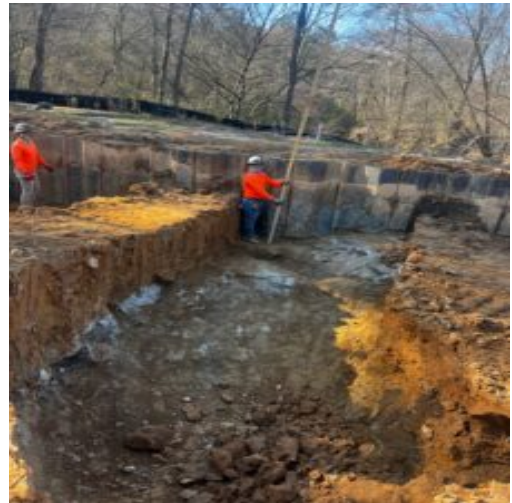
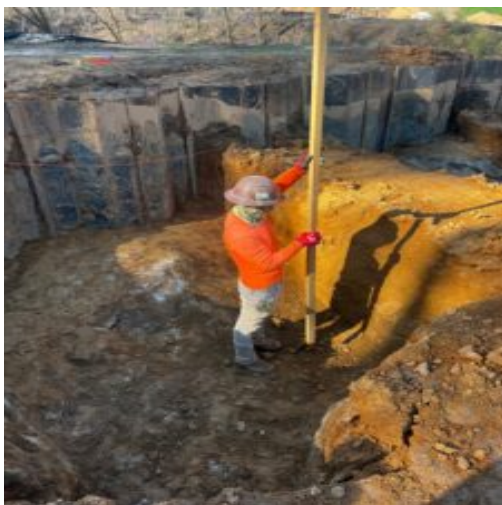
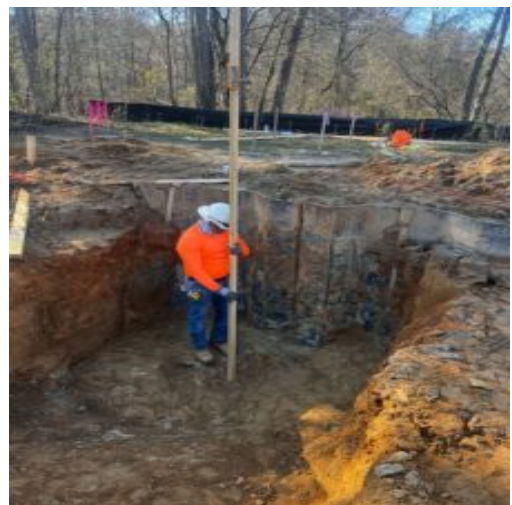
- The remaining **nine (9) locations** encountered bedrock at **shallower depths**, resulting in potential mud mat thicknesses of **less than 5 feet**.
- In several areas, bedrock was encountered at or above the **proposed bottom of footing or mud mat elevation**.

The exposed bedrock surface was **observed for cleanliness and preparation**. The contractor utilized **hand tools (shovels and brooms)** to remove loose soil and debris and provide direct contact between the mud mat and the rock surface. The cleaned rock surface appeared **adequately prepared** for concrete placement.

Photographs documenting the **rock profile and excavation conditions** are included with this report.

Based on these observations, **additional guidance from the project designer is required** to address areas where the **minimum 5-foot mud mat thickness cannot be achieved.** Construction in these areas should **not proceed until design direction is provided.**
