Date : 03/27/2026  
Project No : 2025C214  
Client Company : Artisan  
Arrival Time : 03/27/2026 08:30  
Onsite Hours : 03:00

ASEC Report ID : 92854  
Name of the Project : NW Unit 4 BRIDGE (Materials Testing)  
Project Location : Dallas  
Weather : sunny  
Departure Time : 03/27/2026 11:30  
ASEC Technician Name : Ramchandra Mogulla

## FIELD OBSERVATIONS

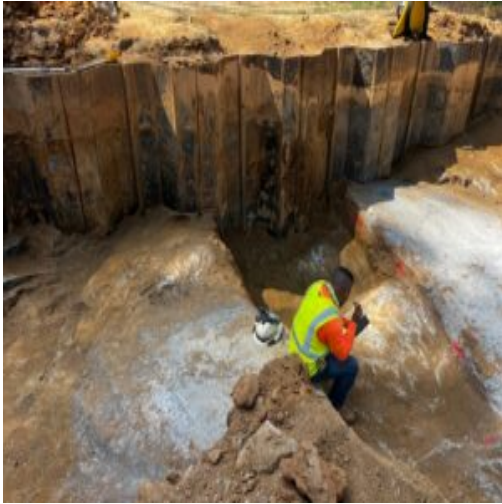
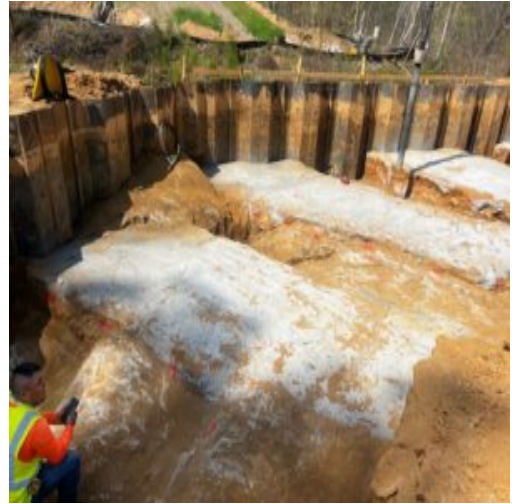
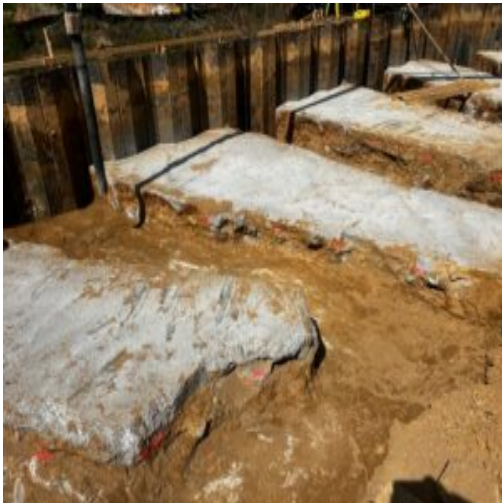
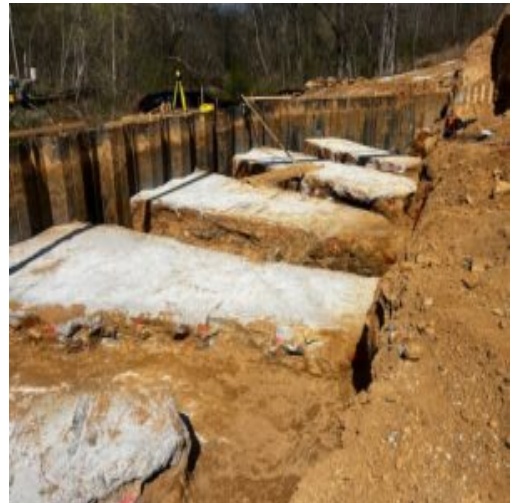
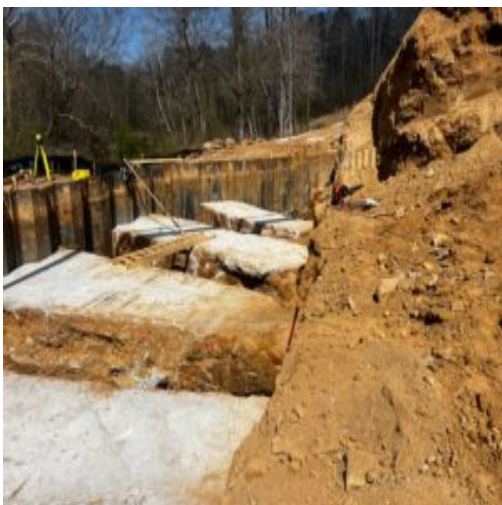
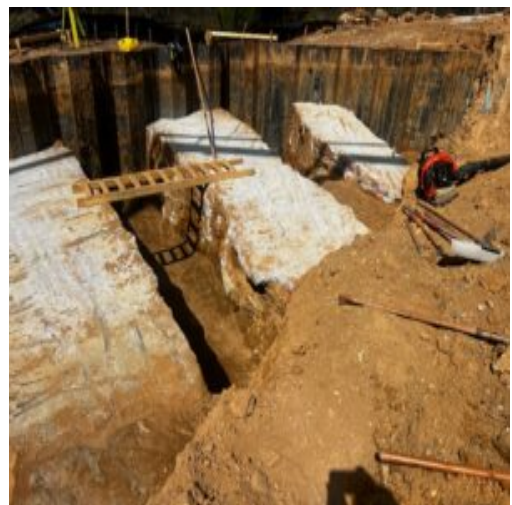
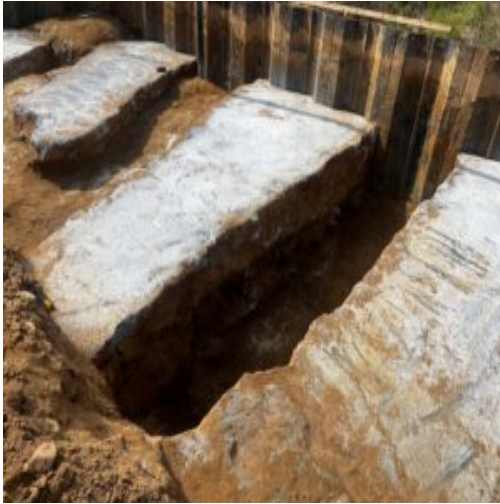
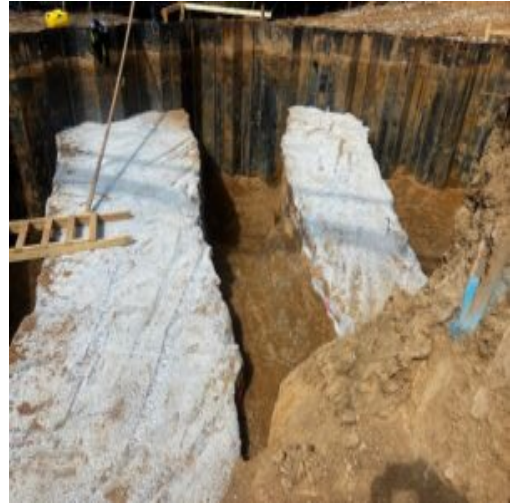
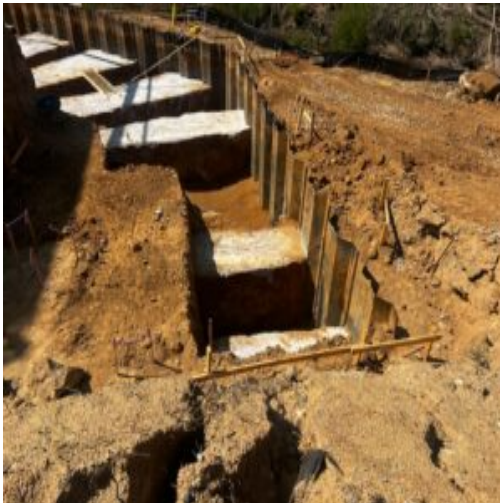
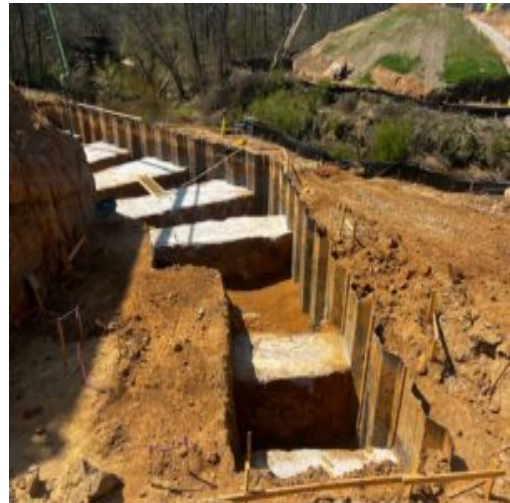
A total of **nine (9) excavation sections** were observed along the sheet pile alignment. Bedrock was encountered at **varying elevations** within each section.

In several locations, bedrock was encountered at or above the **proposed bottom of footing or mud mat elevation**, consistent with prior observations. These conditions indicate that the **required 5-foot mud mat thickness may not be achievable** in these areas without modification.

The exposed bedrock surface and previously placed mud mat were **observed for cleanliness and preparation**. The contractor utilized **hand tools (shovels and brooms)** to remove loose soil and debris and promote direct contact between the mud mat and the rock surface. The prepared surfaces appeared **acceptable for concrete placement** at the time of observation.

The bedrock was observed to be **generally competent** based on visual assessment. While vertical continuity of the rock surface could not be verified within the exposed sections, **prior subsurface exploration** in this area indicates the presence of **competent residual bedrock** at the observed elevations.

Photographs documenting the **excavation conditions and rock profile** are included with this report.
