Date : 02/05/2026
Project No : 2025C215
Client Company : Artisan
Arrival Time : 02/05/2026 08:00
Onsite Hours : 9:30

ASEC Report ID : 89999
Name of the Project : NW Unit 4 Parkway Ext. Phase 1
Project Location : Dallas
Weather : cloudy
Departure Time : 02/05/2026 17:30
ASEC Technician Name : Clyde Smith

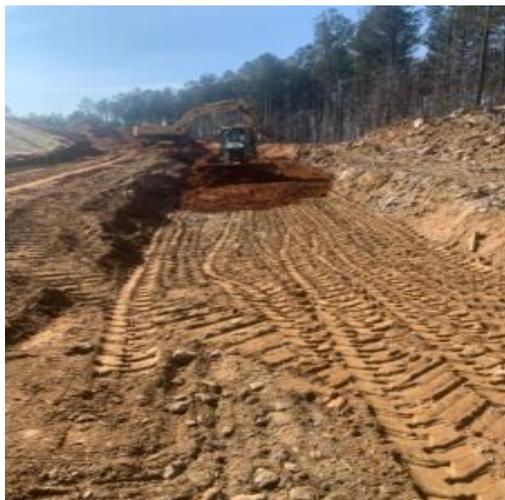
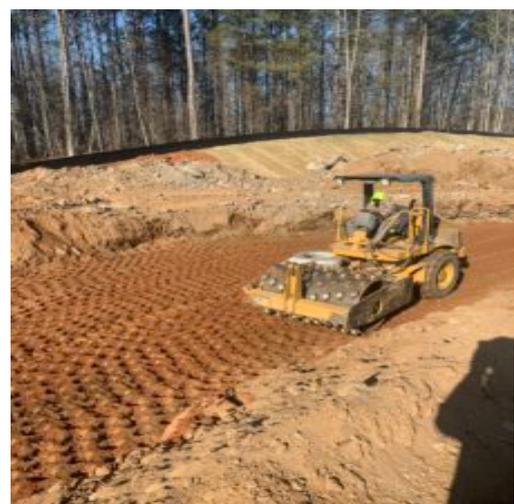
1 Backfill between manhole # 13 and 14 and compacting

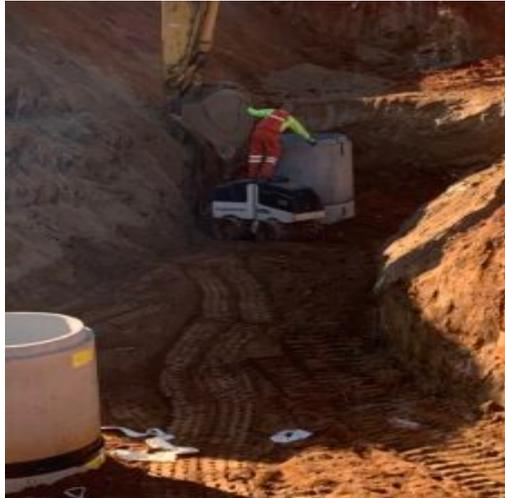
Backfill between Manhole #15 and 16

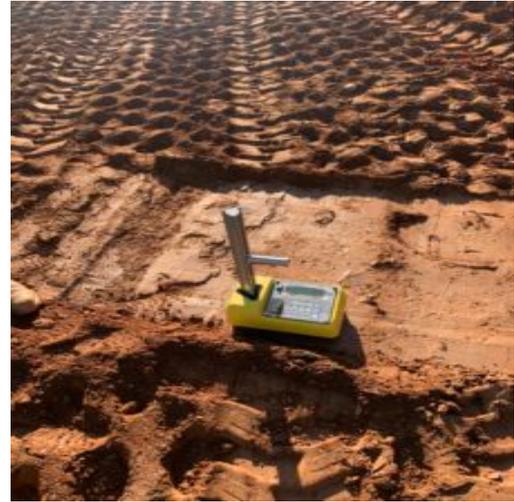
Density tests performed between manhole #13
thru 15

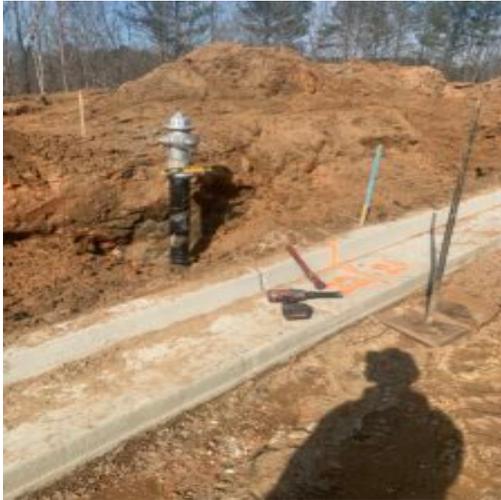
8" ductile iron water line installation between Lots #22 and 18

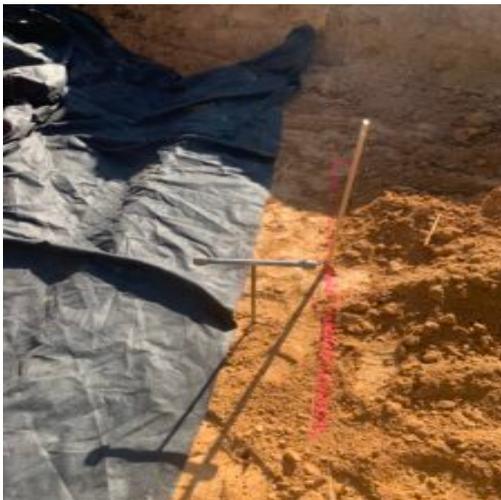
Sub grade observations at OCS headwall structure

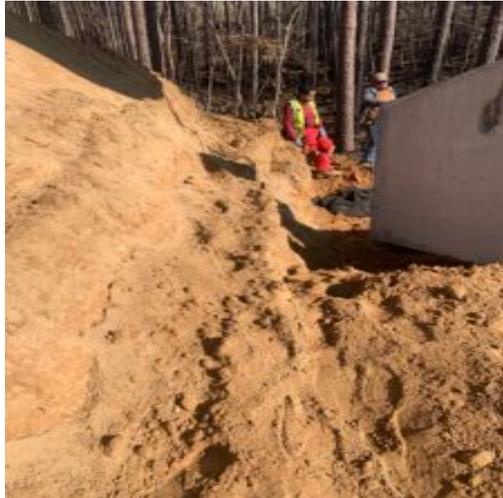
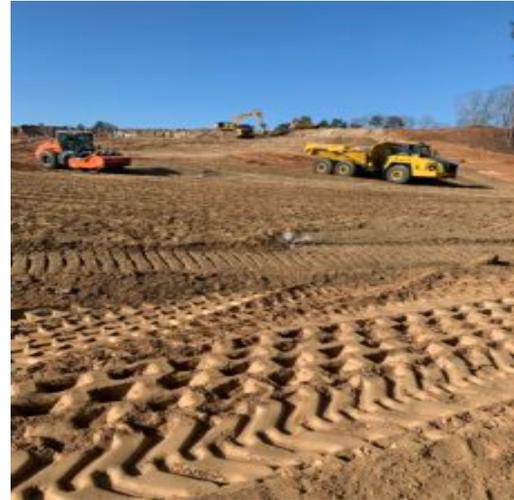
Fill placement at Lots # 56 thru 59
