Date : 09/22/2025
Project No : 2025C216
Client Company : Artisan
Arrival Time : 09/22/2025 11:00
Onsite Hours : 02:30

ASEC Report ID : 86218
Name of the Project : NW (Lots) Unit 4 PH 1A & 1B
Project Location : Dallas
Weather : Sunny
Departure Time : 09/22/2025 13:30
ASEC Technician Name : Clyde Smith

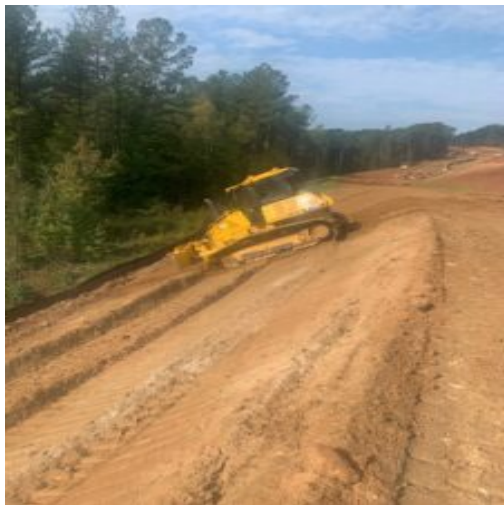
Embankment slope stabilization

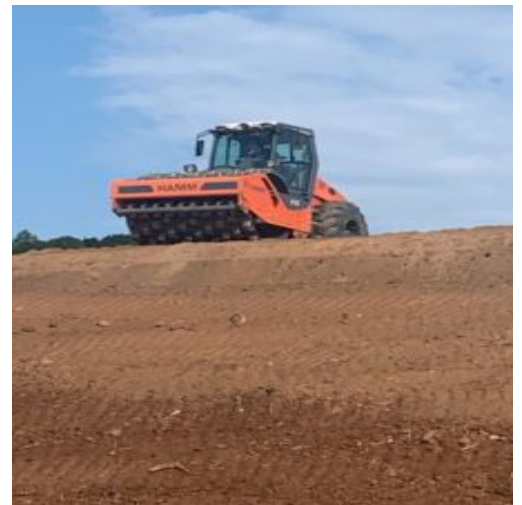
Building lots sub grade compaction

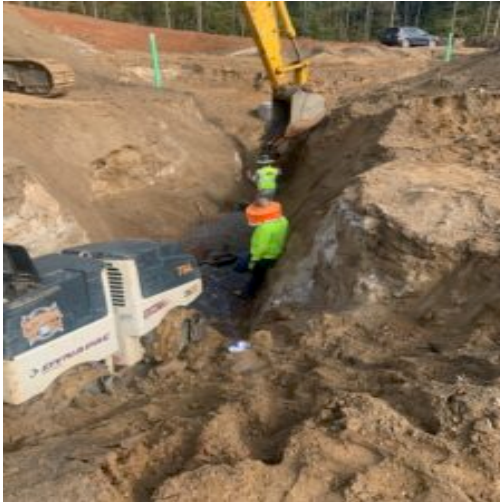
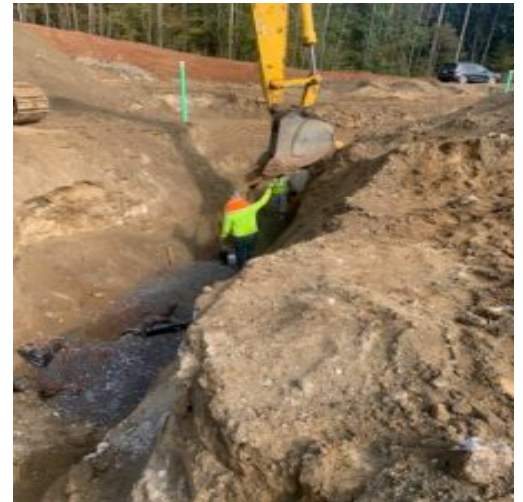
8" d.i.p.sanitary sewer installation between structure #9 and A-9

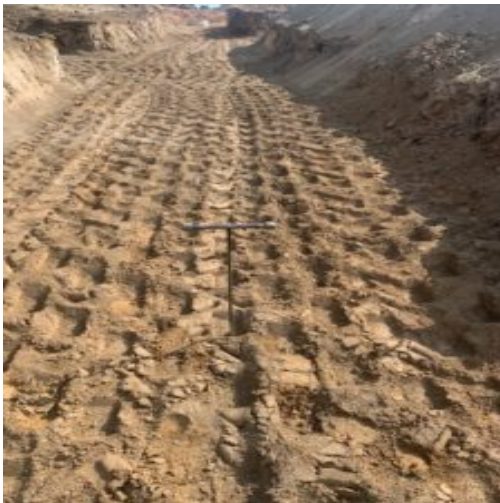
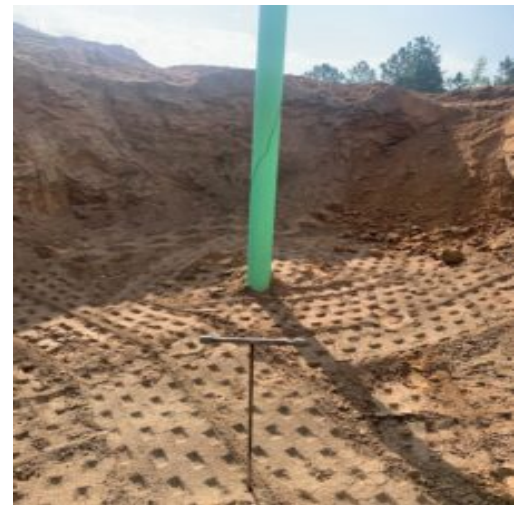
Backfill between structure A-9 and A-7
