Date : 09/30/2025  
Project No : 2025C216  
Client Company : Artisan  
Arrival Time : 09/30/2025 08:00  
Onsite Hours : 07:15

ASEC Report ID : 86482  
Name of the Project : NW (Lots) Unit 4 PH 1A & 1B  
Project Location : Dallas  
Weather : Sunny  
Departure Time : 09/30/2025 15:15  
ASEC Technician Name : Sean Willett

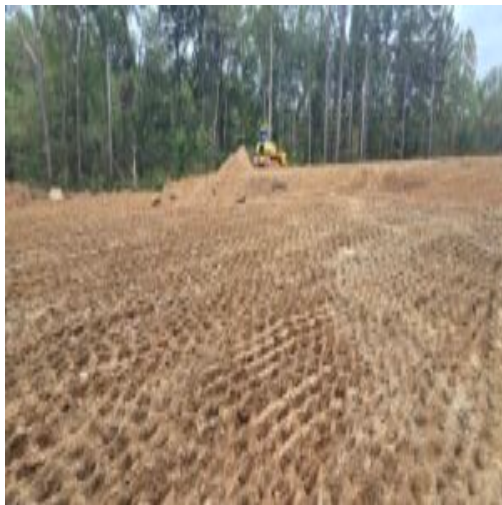
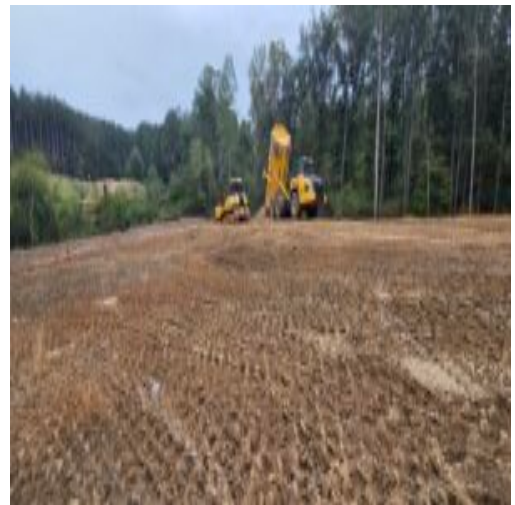
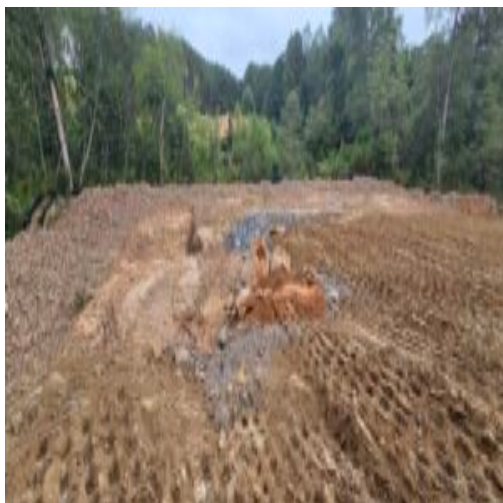
Our ASEC representative was on site for the observation/testing of the placement of fill/backfill. The contractor continued placing blast rock material in the roadway leading up to the bridge. The blast rock material fill consists of rocks approximately 1 ft to 2 ft in diameter. Due to this, lifts were being placed at approximately 2 ft in thickness. As the contractor rolled in the lifts with a sheep-foot roller, it appeared to be breaking down the larger rocks. The contractor was also spreading approximately 1 ft thick lifts of finer materials over top of the blast rock material to help fill voids. Our ASEC representative watched loaded off road trucks and they rolled over the lifts to watch for any signs of instability. No severe pumping/rutting were present.
