Date : 02/04/2026  
Project No : 2025C216  
Client Company : Artisan  
Arrival Time : 02/04/2026 08:00  
Onsite Hours : 9:30

ASEC Report ID : 89961  
Name of the Project : NW (Lots) Unit 4 PH 1A & 1B  
Project Location : Dallas  
Weather : cloudy  
Departure Time : 02/04/2026 17:30  
ASEC Technician Name : Clyde Smith

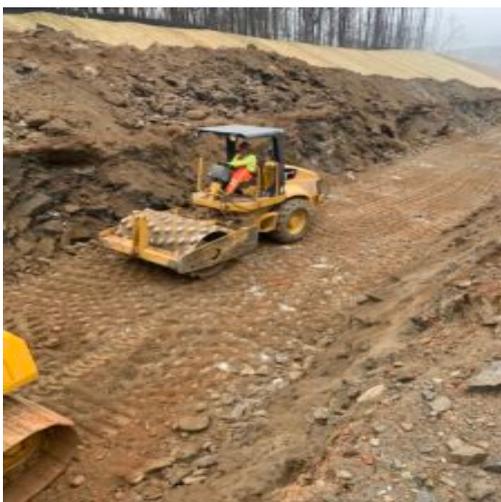
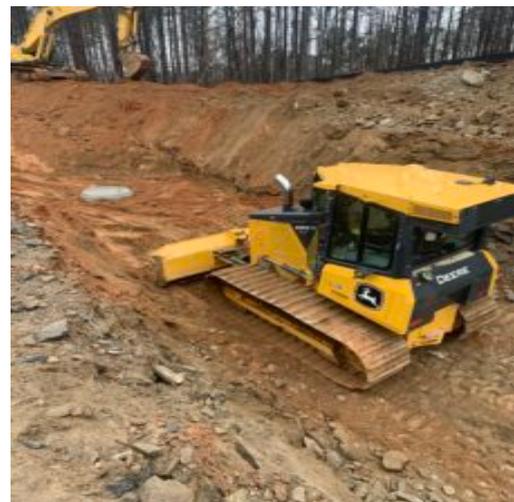
Compacting and spreading rock fill between manhole structure #13 and 14

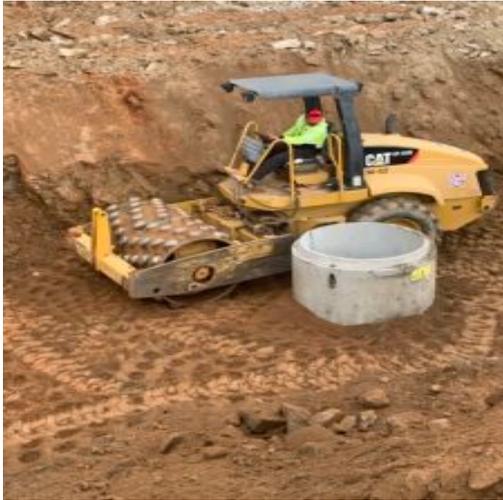
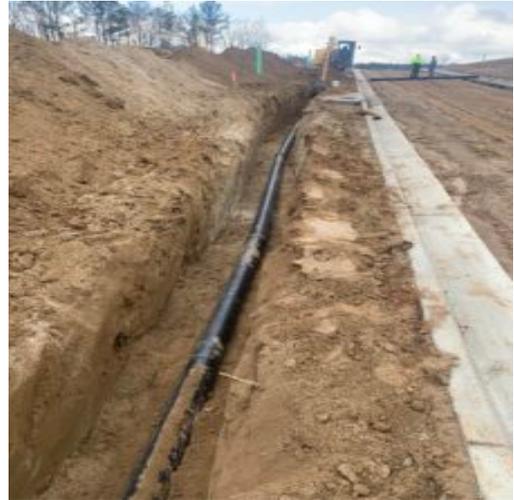
Installation of 8" ductile iron water line pipe at Unit 4 - phase 1A

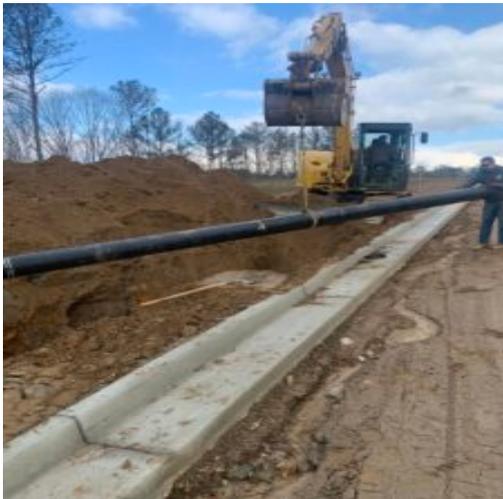
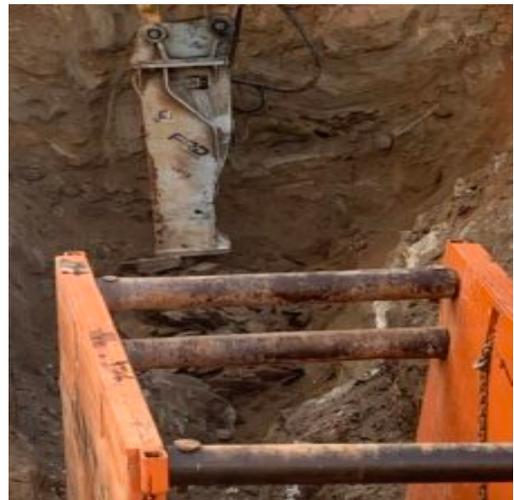
Hammering hard rock between manhole # 15 and 16 to install 8" ductile iron sewer line

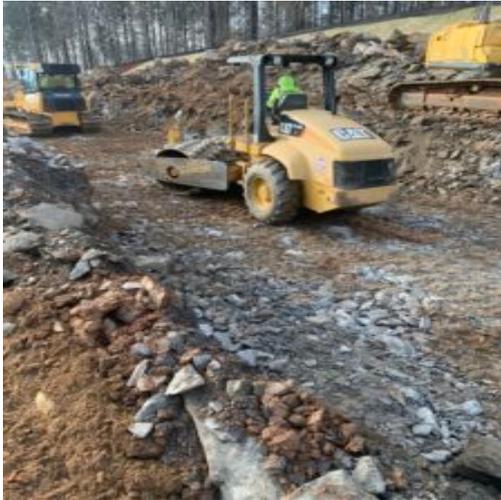
Compacting rock fill between manhole # 13 and 14
