Date : 04/08/2026
Project No : 2025C216
Client Company : Artisan
Arrival Time : 04/08/2026 07:00
Onsite Hours : 03:00

ASEC Report ID : 92675
Name of the Project : NW (Lots) Unit 4 PH 1A & 1B
Project Location : Dallas
Weather : Sunny
Departure Time : 04/08/2026 10:0
ASEC Technician Name : Clyde Smith

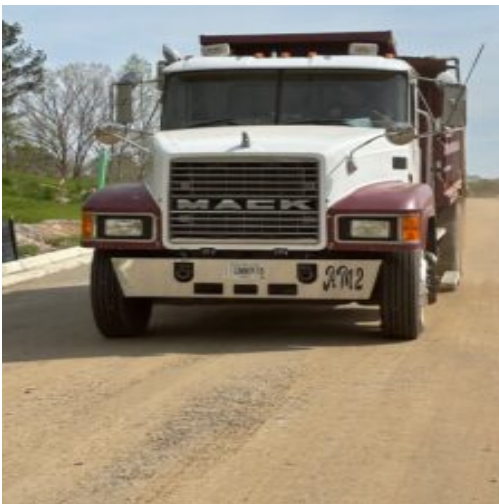
Observing test proof roll of subbase

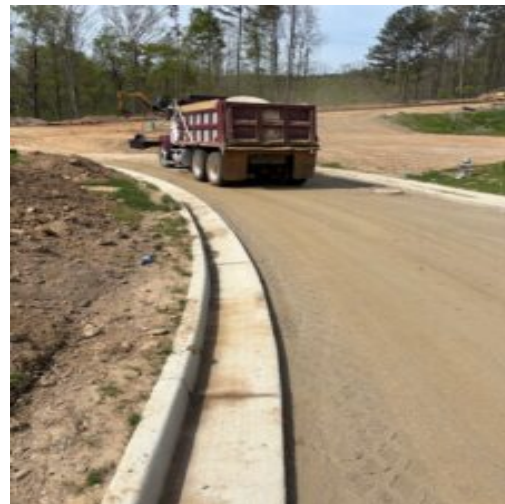
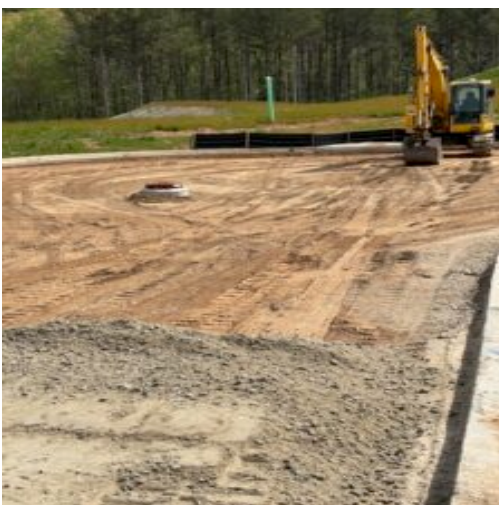
Subgrade prep. at cul de sac

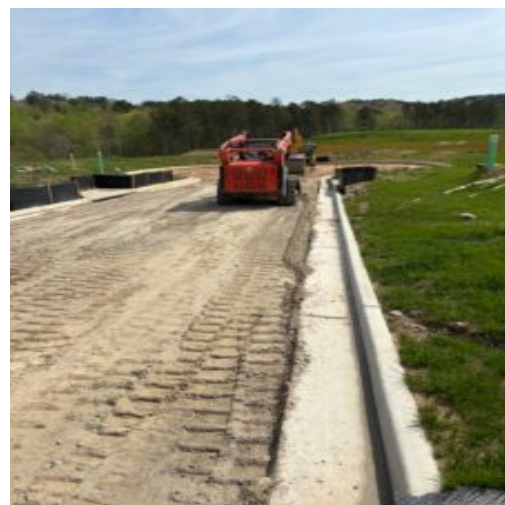
Subbase prep. compacting in place base stone
