Date : 04/27/2026
Project No : 2025C216
Client Company : Artisan
Arrival Time : 04/27/2026 08:00
Onsite Hours : 03:00

ASEC Report ID : 93585
Name of the Project : NW (Lots) Unit 4 PH 1A & 1B
Project Location : Dallas
Weather : Sunny
Departure Time : 04/27/2026 11:00
ASEC Technician Name : Clyde Smith

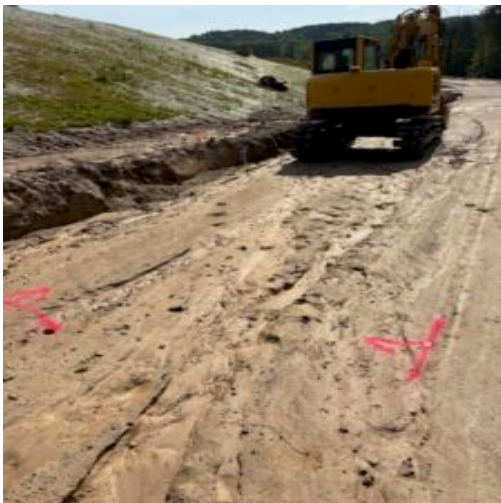
Sub grade requiring -4" clip

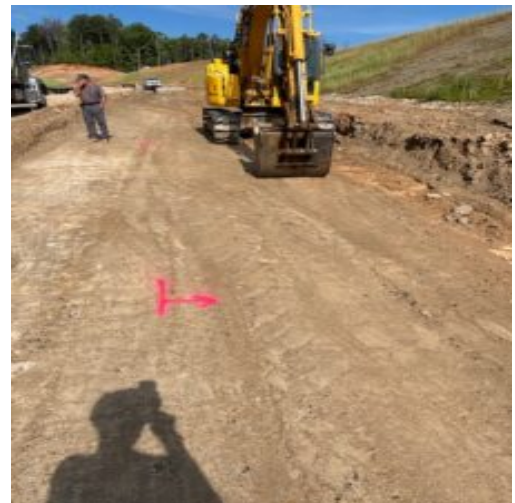
Repair area for clip

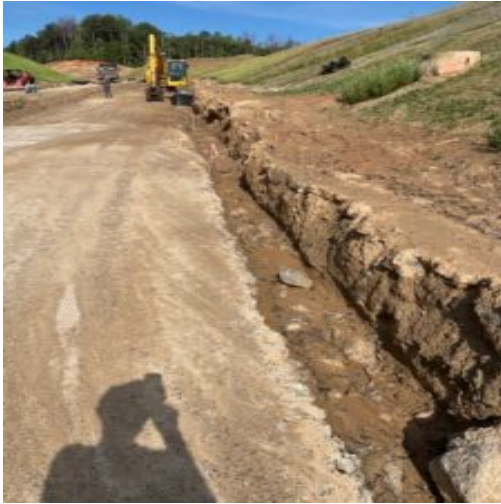
Washed gullies at curb line

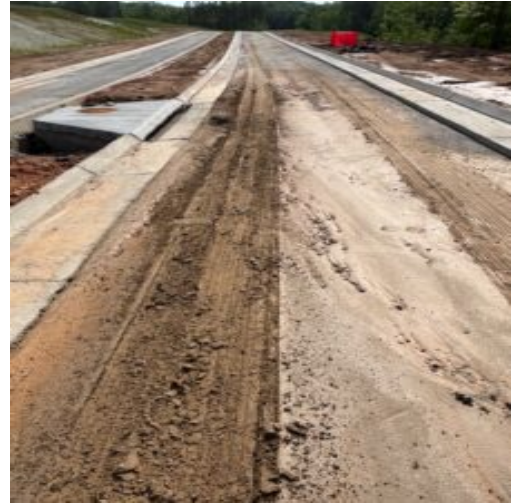
Washed silt over sub base stone

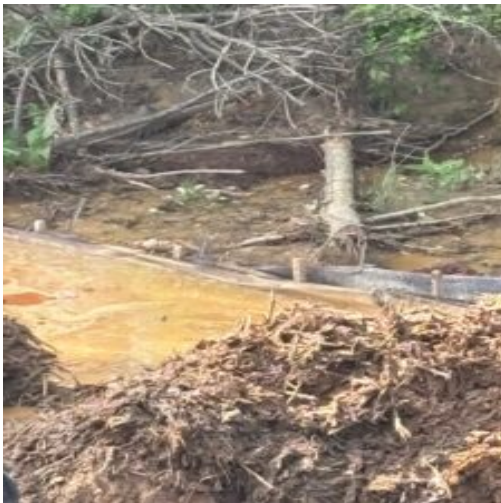
The writer also observed the Erosion contractor (Valor) onsite repairing erosion deficiencies at toe of slope on Nature Walk Pkwy. near sanitary sewer manhole #6.

Deficient area due to rain event at toe of slope

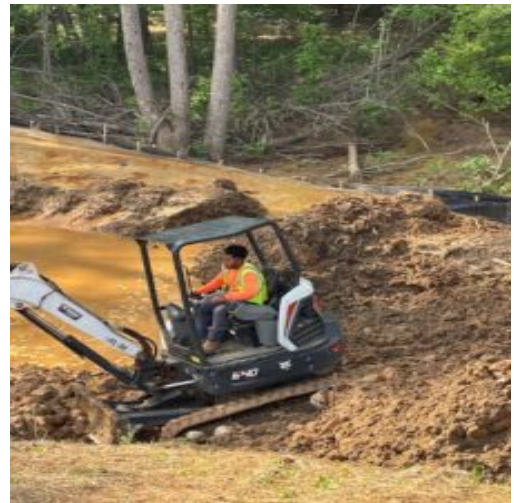
Repairing deficient area at toe of slope

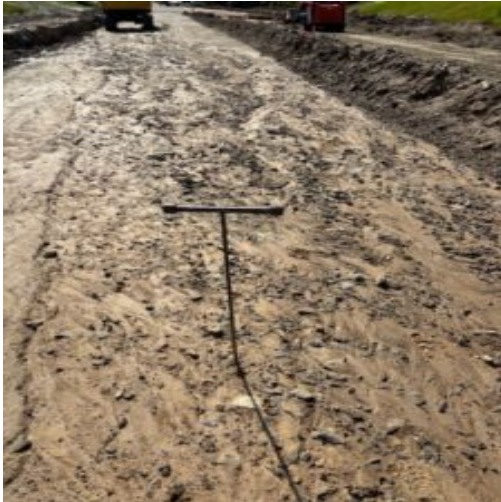
Washed sub grade area approved for stone placement

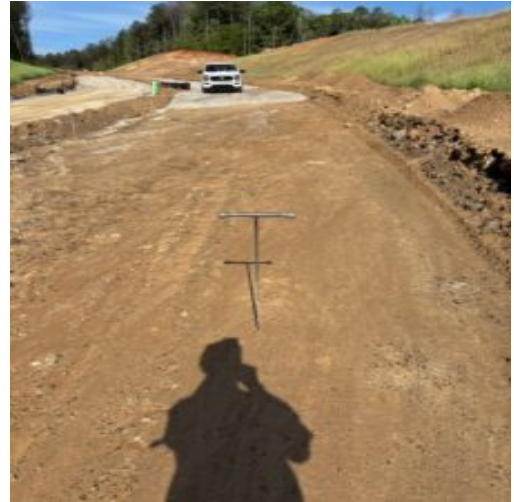
Sub grade approved for base stone placement

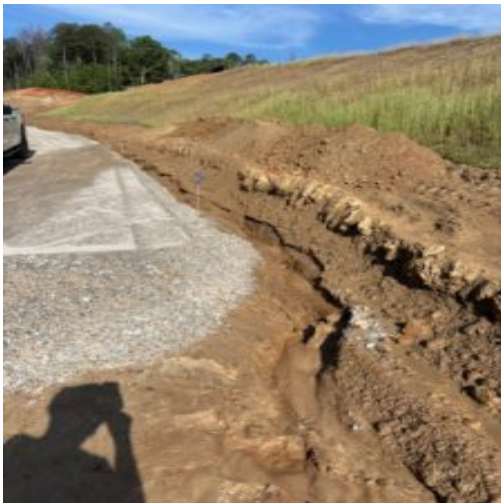
Gullies at curb line after rain event

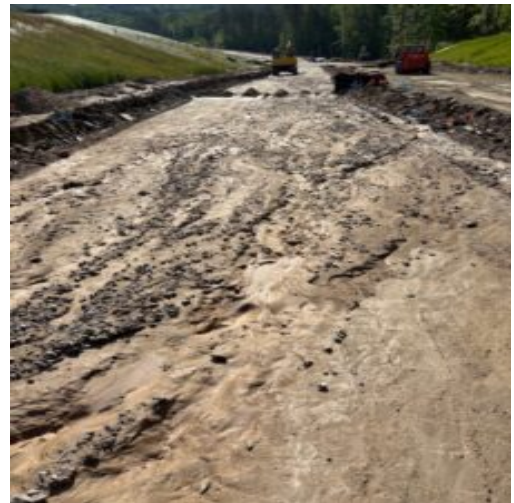
Approved area with rock in place
