Date : 10/03/2025  
Project No : 2025C245  
Client Company : Bearing Engineering  
Arrival Time : 10/03/2025 08:00  
Onsite Hours : 06:00

ASEC Report ID : 86506  
Name of the Project : Dunkin Donuts 2025  
Project Location : US 29, Palmetto, GA  
Weather : Sunny  
Departure Time : 10/03/2025 14:00  
ASEC Technician Name : Sean Willett

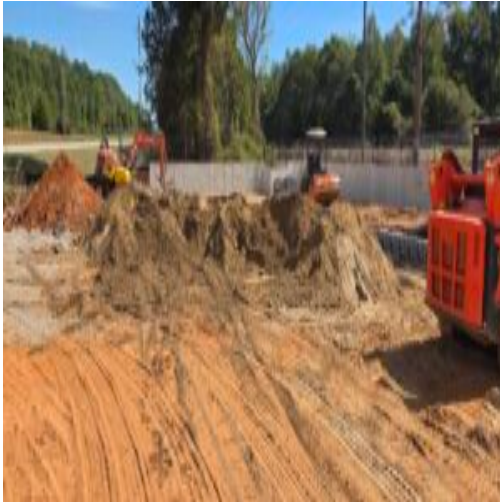
Our ASEC representative was on site for the observation/testing of the placement of fill/backfill. The contractors started hauling in new fill material from offsite due to the in-situ moisture content issues with the borrow area that is located on site. They stated that the material is all the same, but as density testing was performed, it appeared to be a different material. Our representative performed a field proctor for the new material. This material appeared to be darker in color than what was onsite and was different in texture. The field proctor displayed a maximum dry density of 101 pcf and an optimum moisture content of 19%. The fill being brought in was moisture checked and displayed a moisture content of 14%.

new fill

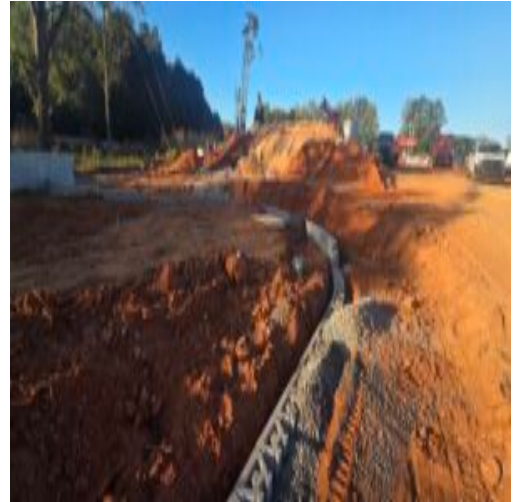
The fill that was already onsite was tested by our ASEC lab for a proctor that displayed a max dry density of 115.6 pcf and an optimum moisture content of 12.7% (after rock correction). The fill in place was moisture checked and displayed an in-place moisture content of approximately 18-19%.

These results were provided to the contractor, and the contractor was informed that both materials were not within the optimum moisture content range for proper compaction (+3 to -3 above/below optimum moisture content). There is no water truck available on site. The contractor began hauling buckets of water with a skid steer and trying to actively mix water into the new fill material to bring it up to proper moisture range. A decision was made to wait for the soil that was already on site to dry and try to bring it down to a proper moisture level. Our representative left the site.

retaining wall and fill already on site
