Date : 10/10/2025
Project No : 2025C245
Client Company : Bearing Engineering
Arrival Time : 10/10/2025 09:00
Onsite Hours : 07:30

ASEC Report ID : 86745
Name of the Project : Dunkin Donuts 2025
Project Location : US 29, Palmetto, GA
Weather : Sunny
Departure Time : 10/10/2025 16:30
ASEC Technician Name : Sean Willett

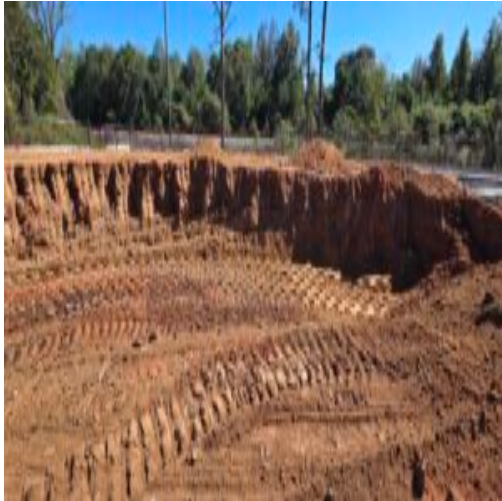
roadway bench cut out of slope on retaining wall

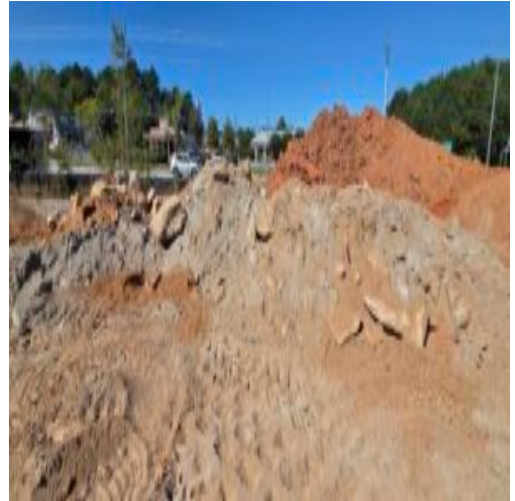
The road crew (Bowlin) was present on site. Our representative observed the road crew filling in the roadway in front of retaining wall with the unsuitable material that was stockpiled on site. This material consisted of large boulders, topsoil, and trash. It was also observed that the lifts being placed in the roadway were approximately 2+ feet in thickness. Our representative recommended not to use this unsuitable material, and to place smaller lifts, consisting of 8 in to 12 in in size, for proper compaction. The contractors argued with our representative about the size of the lifts and the material being used. Our ASEC representative called the road crew boss (Thomas with Bowlin) to inform him of the work his crew was conducting. Thomas made it very clear to our representative that it "was not your job to tell me (Thomas) how to do the work" and that he "had been to the site and looked at the material himself". He said our representative had no right to stop his work and to not interfere with his crew. He also stated, "you're only here for density testing, and to provide him with test results". Our ASEC representative told Thomas that this area of the roadway had not been proof-rolled and cleared prior to his crew placing the fill. Thomas said, "the whole site has been proof-rolled, and he has heard all about how the testing has been going onsite". A large amount of water was present, from the previous night's rain, in the lower part of the roadway where fill is being placed. It is up to the contractor to relocate this water before placing fill, or to mix it in with drier fill materials to try to achieve optimum moisture content.

unsuitable fill

Our representative called Mr. Patel to inform him of the improper work, and Mr. Patel came to the site. Mr. Patel agreed that the work was out of code, and that the fill material was unsuitable for structural fill areas. Mr. Patel also agreed that the red stockpiled fill material was outside of optimum range for proper compaction. Mr. Patel also said that this area of the roadway (in front of retaining wall) was not proof-rolled. Mr. Patel conducted a proof-roll and informed the contractor of which areas to undercut and replace with proper fill material.

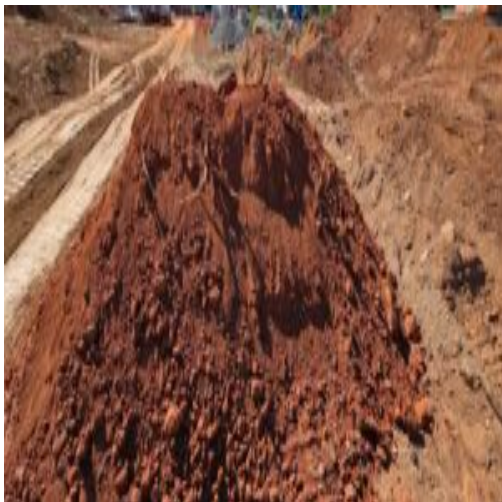
large quantity of organics in fill

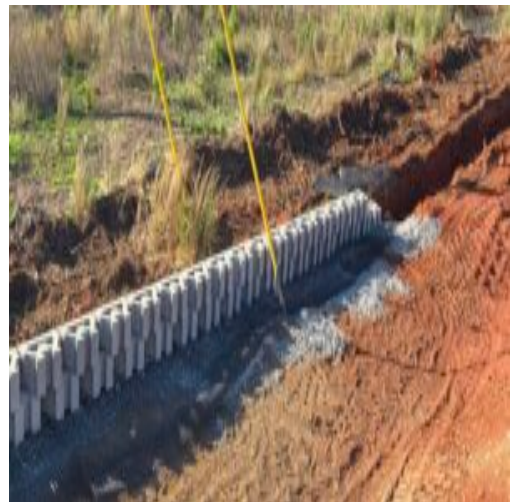
wall splits power line supports

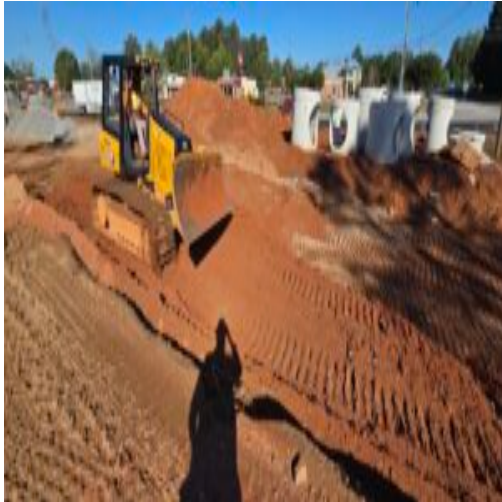
road fill

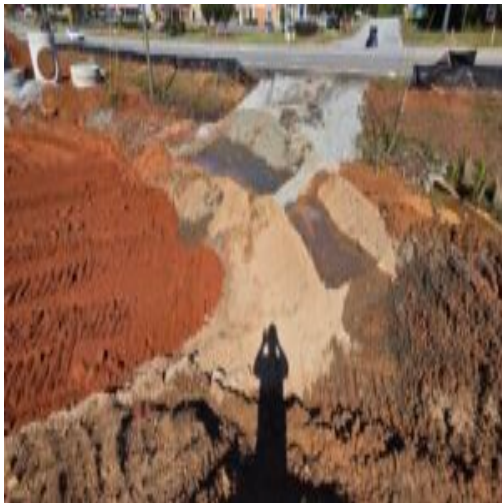
water present in roadway during filling
