Date : 10/14/2025
Project No : 2025C260
Client Company : Artisan
Arrival Time : 10/14/2025 12:00
Onsite Hours : 03:00

ASEC Report ID : 86898
Name of the Project : NW (PHASE 2) Parkway Extension
Project Location : Dallas
Weather : Sunny
Departure Time : 10/14/2025 15:00
ASEC Technician Name : Clyde Smith

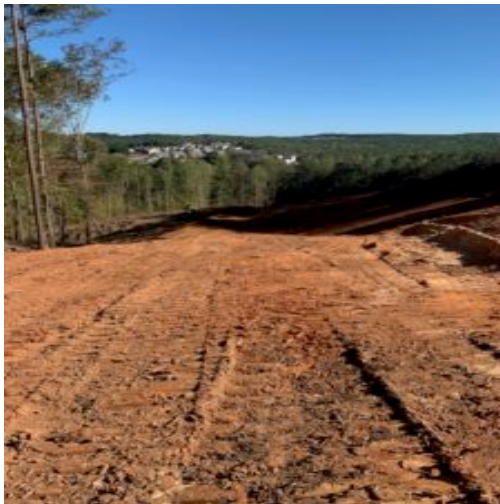
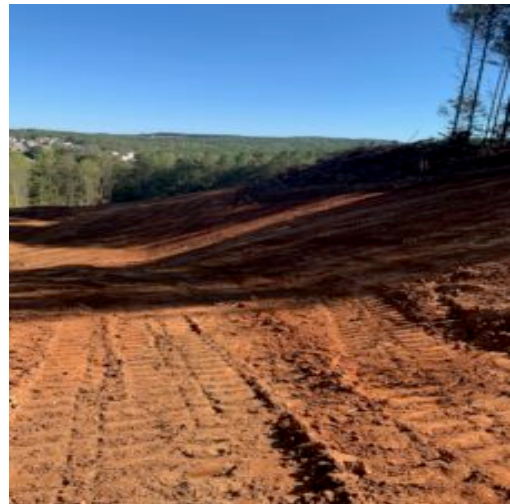
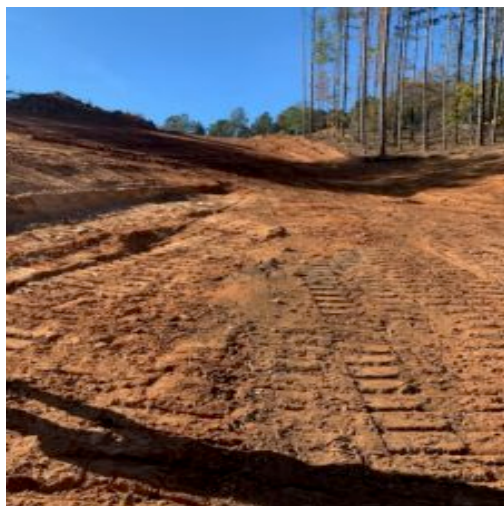
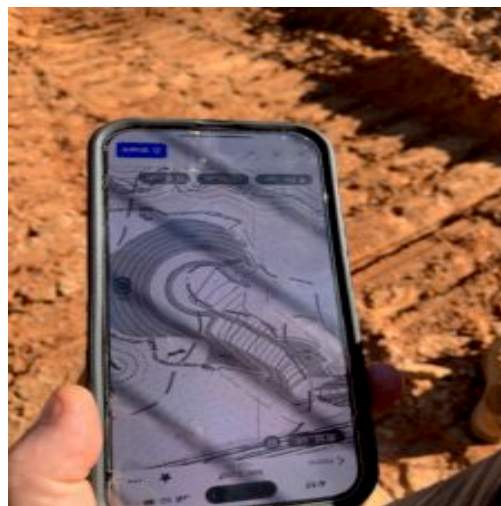
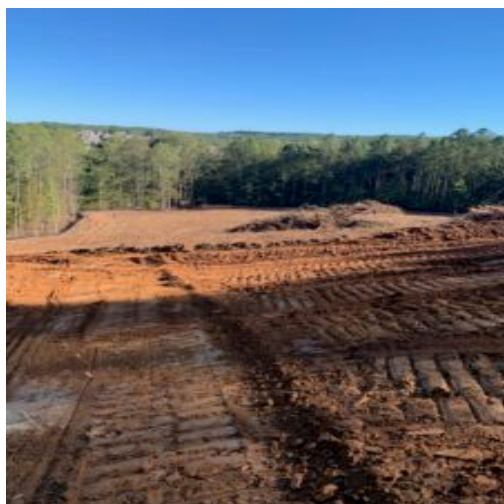
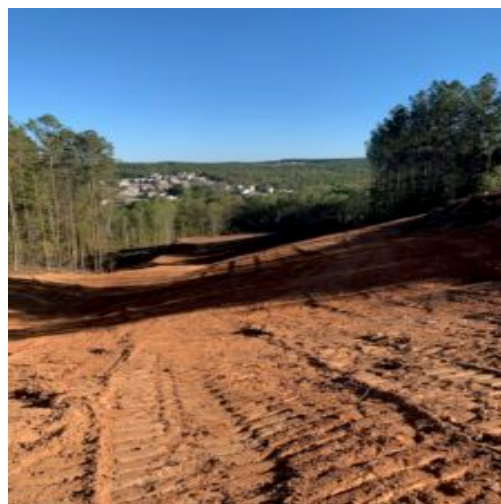
On the above date our representative was on site to observe the grading contractor continue clearing and perform subgrade preparation for the phase 2 of the parkway extension. The writer observed the subgrade soils by probing areas using a rounded end steel rod. Subgrade soils were cleared of organic debris and the residual soils appeared suitable for fill placement.
