Date : 12/01/2025
Project No : 2025C260
Client Company : Artisan
Arrival Time : 12/01/2025 09:30
Onsite Hours : 05:30

ASEC Report ID : 88376
Name of the Project : NW (PHASE 2) Parkway Extension
Project Location : Dallas
Weather : cloudy
Departure Time : 12/01/2025 15:00
ASEC Technician Name : Clyde Smith

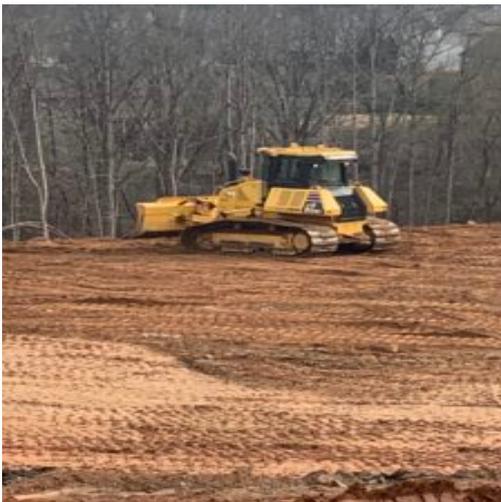
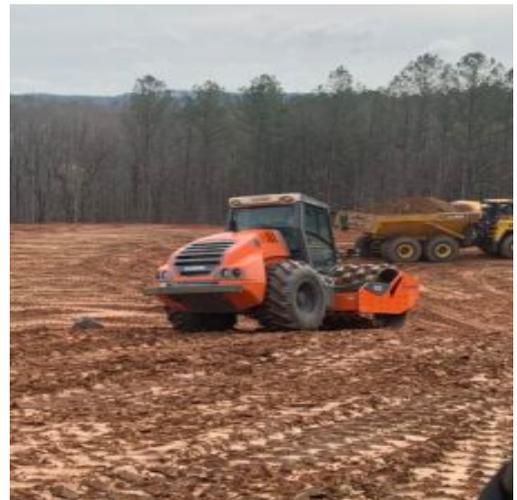
Our representative was on site to observe site conditions at Parkway Ext Phase 2 for base stone placement following a rain event. There was no standing water on the subgrade, however, subgrade soils were saturated where base stone was to be placed today. The grading contractor however continued rockfill placement at the slope embankment. The fill was placed in recommended compacted lift thickness as is suitable for site requirements.

Rockfill placement and compacting efforts
