Date : 12/17/2025
Project No : 2025C260
Client Company : Artisan
Arrival Time : 12/17/2025 15:00
Onsite Hours : 02:00

ASEC Report ID : 88594
Name of the Project : NW (PHASE 2) Parkway Extension
Project Location : Dallas
Weather : cloudy
Departure Time : 12/17/2025 17:00
ASEC Technician Name : Clyde Smith

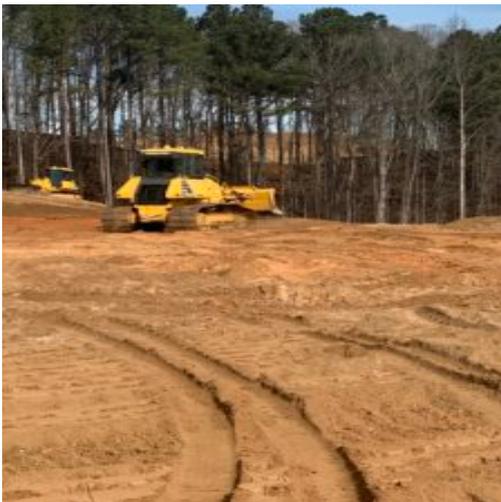
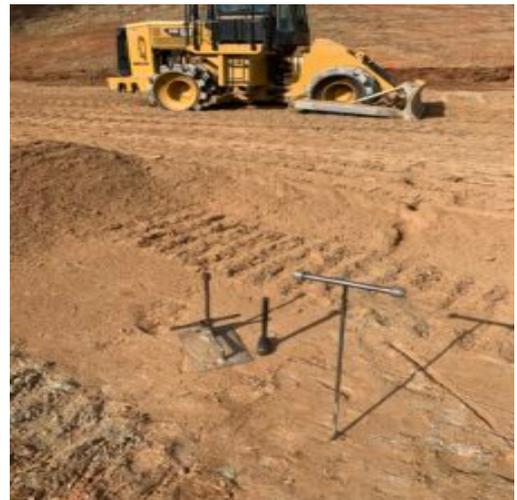
On the above date our representative was on site to observe the grading contractor continue to place fill for the cul de sac building lots including spreading and compacting in recommended lifts. The fill was observed by proof-rolling and probing using a 3/8" diameter steel rod. Compaction efforts were suitable as per job specifications. Fill placement today was observed at elevation 861 and 859 having approximately 18' of remaining fill to be placed.

Fill placements and observation at cul de sac lots
