Date : 12/16/2025  
Project No : 2025C269  
Client Company : Lewis Contracting  
Arrival Time : 12/16/2025 08:00  
Onsite Hours : 9:00

ASEC Report ID : 88694  
Name of the Project : Main St. & First Ave. - Mixed-use  
Project Location : Lilburn  
Weather : sunny  
Departure Time : 12/16/2025 17:00  
ASEC Technician Name : Samara Simha Reddy Kandi

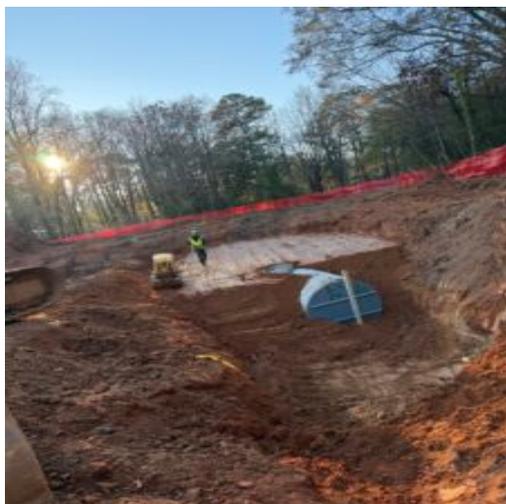
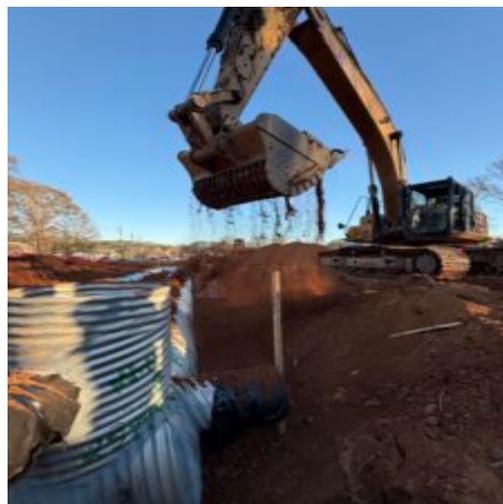
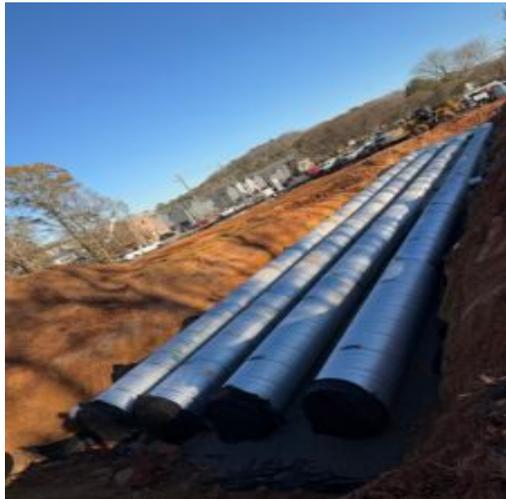
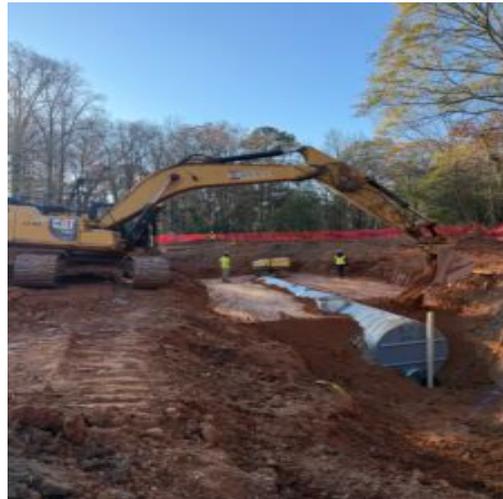
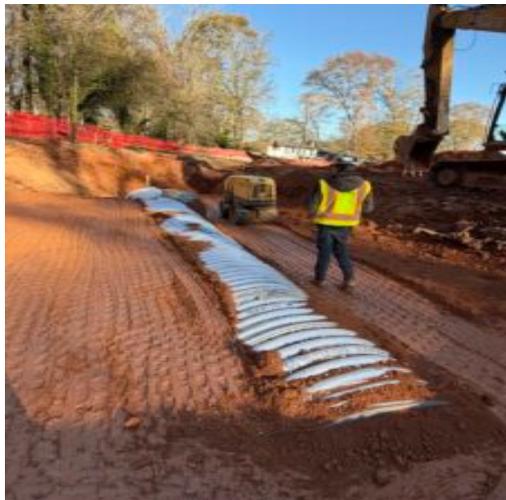
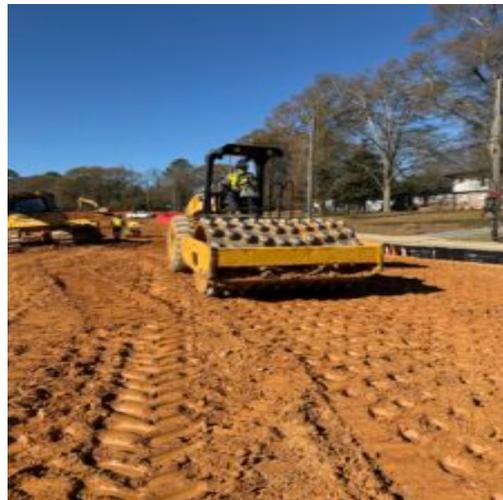
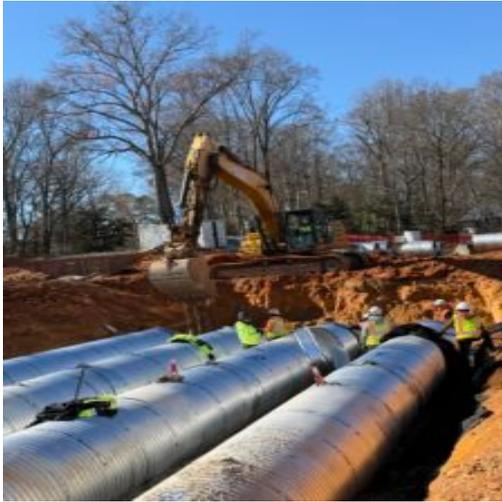
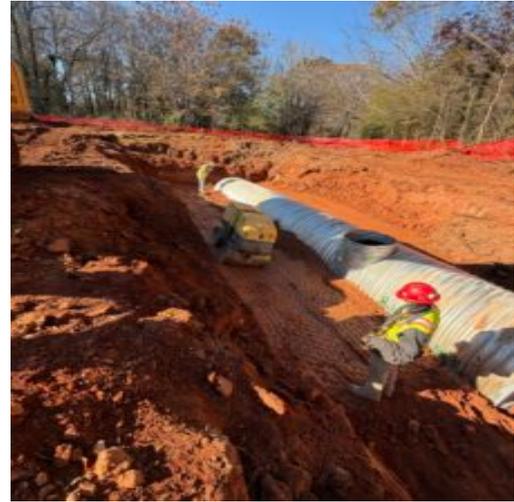
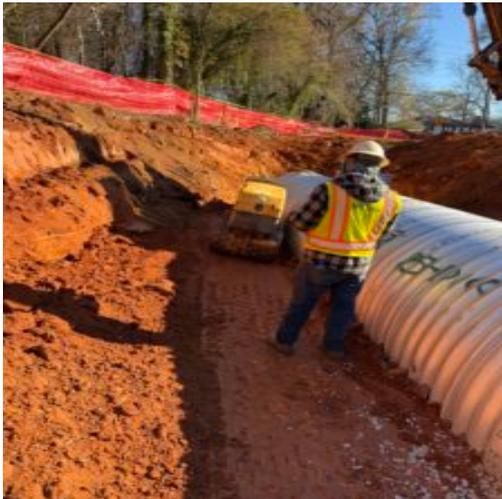
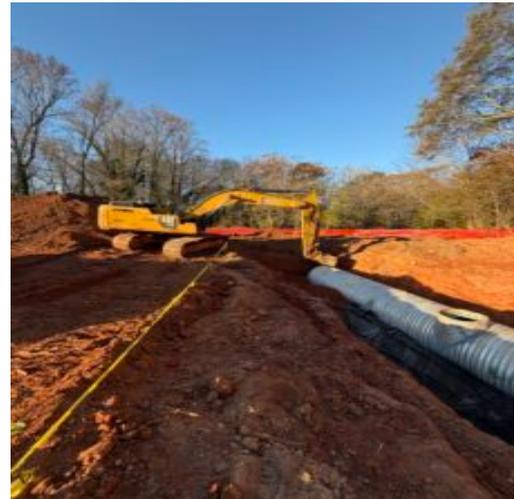
On the next working day, construction activities continued at Pond 1, non-woven geotextile fabric was placed along the bottom and sides of the excavation, following fabric placement, a gravel bedding layer was installed and leveled.

The crew then installed corrugated metal pipes (CMP) in alignment with the existing detention system. Pipe installation at Pond 1 progressed to an approximate total length of 140 lineal feet. After installation, gravel was placed around and between the pipes. The open ends of the detention pipes were closed and wrapped with geotextile fabric to prevent soil intrusion and to protect the system prior to final backfilling.

At Pond 3, work focused on backfilling operations following completion of the detention system. Suitable fill material was placed around the pipes in controlled lifts of approximately 6 to 8 inches. Each lift was compacted using a sheep-foot roller, and backfilling continued to an approximate height of 3 feet on sides of the pipe system. Compaction was observed to be uniform, and the fill was compacted thoroughly to achieve the required density.

At Pond 2, backfilling activities were initiated. Fill material was placed to an approximate height of 1 foot in a single lift and compacted. However, compaction did not meet the required density, and the area failed compaction requirements. As a result, backfilling operations at Pond 2 were temporarily stopped pending corrective measures.

Following pond-related activities, the crew shifted operations at foundation wall to sd2-p 912. Fill material was placed to restore grades and compacted in two controlled lifts, each approximately 6 to 8 inches thick. Compaction was performed using compaction equipment, and the area was graded.
