Date : 01/30/2026
Project No : 2026C103
Client Company : Artisan
Arrival Time : 01/30/2026 08:30
Onsite Hours : 08:30

ASEC Report ID : 89797
Name of the Project : NW PH 2, UNIT 4
Project Location : Dallas
Weather : cloudy
Departure Time : 01/30/2026 17:00
ASEC Technician Name : Clyde Smith

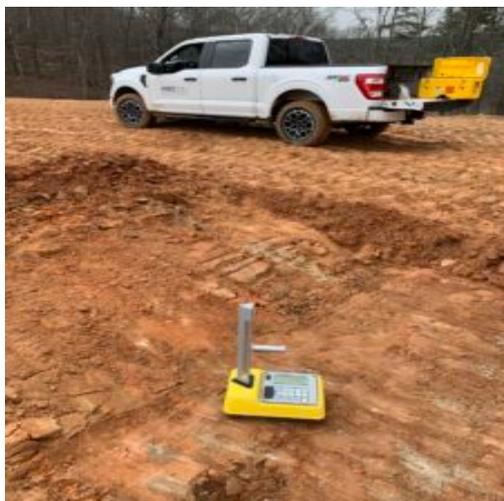
On the above date our representative was on site to observe the grading contractor continue to place fill for building Lots #37 thru 34. The fill placement was compacted using a vibratory sheep-foot roller (placed in lifts). The writer performed density testing using a Troxler Nuclear gauge model 3430, serial no. 91643. The density tests were performed at the basement slab elevations and the front of the lot elevations. The writer also performed a field proctor today with results being (98.0 pcf @17.2% moisture content) with the soil description of a multi-colored fine to medium sandy silt. After recompacting efforts all compaction results met job requirements.

Performing density tests lots # 37 thru 35

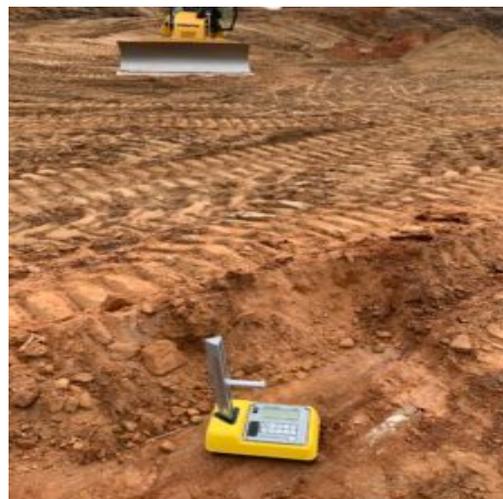
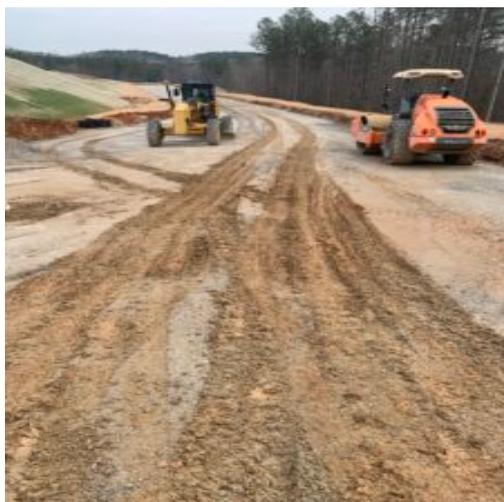
The writer also observed installation of an 8" ductile iron pipe (DIP) water line pushed through a sleeve across the Parkway south of the sanitary sewer manhole #5. In order to install the water line today (very muddy conditions on site) mud was tracked onto previous placed base stone for the Parkway between manholes #6 and 9. The existing subgrade between manhole #5 and 6 was also found to be disturbed. Standing water was present on the base rock between manholes #7 and 8 near the storm curb inlet. It was recommended to cut a ditch to drain this water into a swale ditch removing the water from the base rock and to limit all traffic off the subbase stone and subgrade soils to prevent further soil contamination of the rock and to prevent additional subgrade soils undercutting.

Observation of contamination mud on sub base stone between sanitary sewer manholes #9 and 6

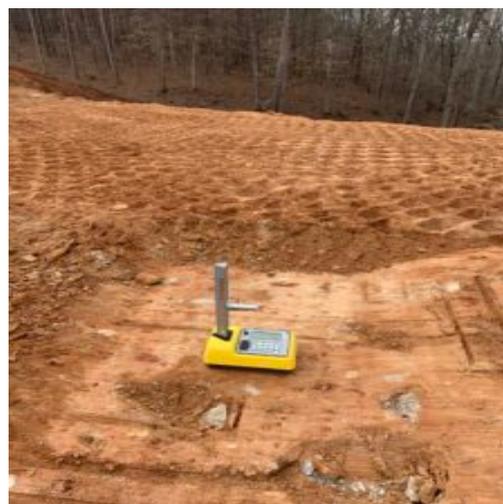
Performing density tests

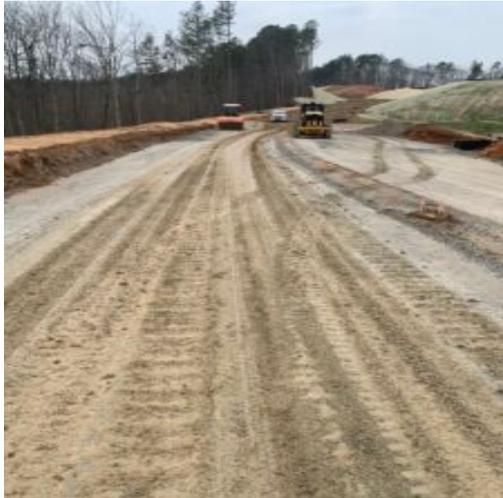
Contamination and saturation on base stone

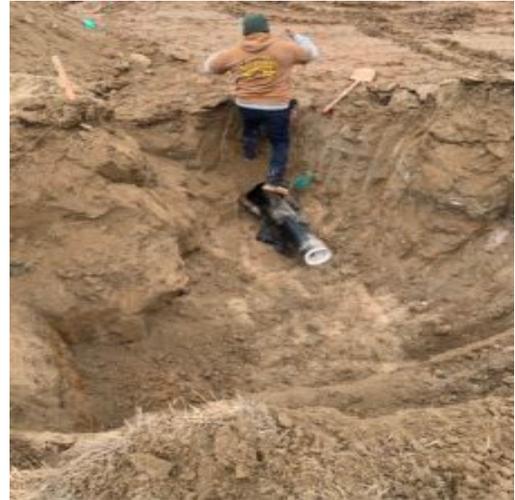
8" ductile iron water line pushed through sleeve east side of roadway south of manhole #5

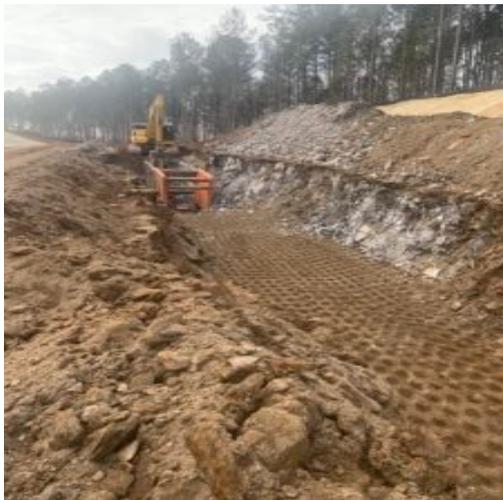
Observed the pipe contractor backfill an 8" PVC sanitary line between manhole structures #12 and 13 using excavated rock fill which was placed in suitable compacted lifts using a vibratory sheep-foot roller. Density tests couldn't be performed on the rock and soil mixture (rock fill). Compaction efforts were found to be visually satisfactory. The contractor is bedding all pipe on No. #57 stone and placing clean fill over top of the pipe. The contractor also continued installing 8" ductile iron pipe (DIP) between manholes #13 and 14 where heavy continuous hard rock was encountered without any fine soil materials present. The contractor was reminded that using predominately all rock fill requires monitoring to see if placement is acceptable. The contractor was reminded that at least four feet of clean fill should be placed over all rockfill (and predominately hard rock fill). All excavated rock until 4:00 pm was removed using the 490 excavator without requiring hammering. The contractor did spend one hour hammering hard rock between 4:00 and 5:00 pm. which was three feet too high in bottom of trench.

Excavation of sanitary sewer trench showing rock fill between manhole #12 and 13

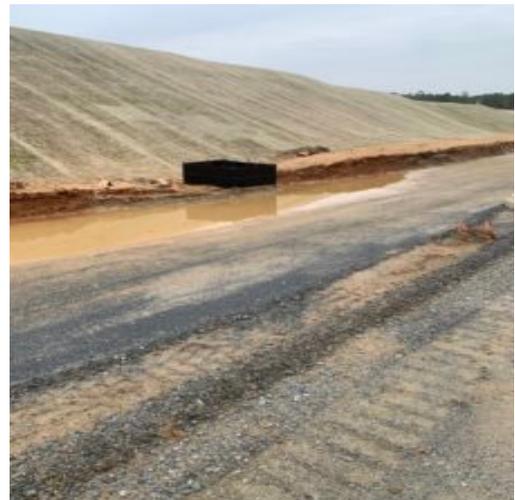
Standing water on base rock at Parkway between manhole #7 and 8, recommended to trench off and limit additional traffic.

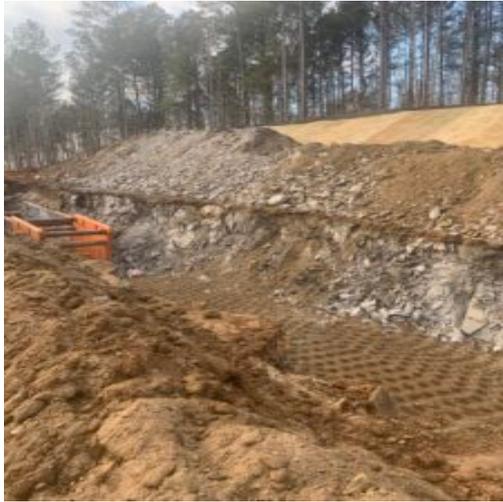
Excavated sanitary sewer trench

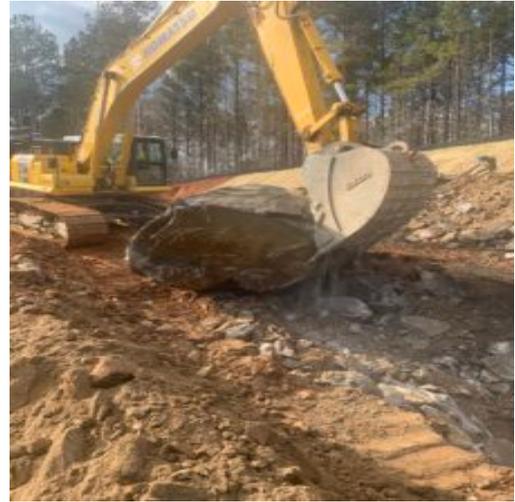
Excavated sewer trench removing large boulder

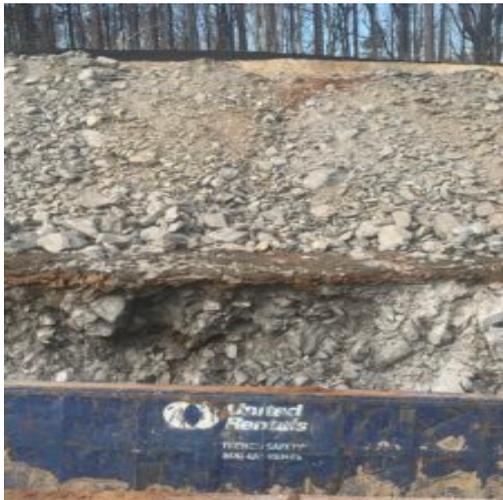
Excavated sewer trench showing hard rock full depth of trench excavation.

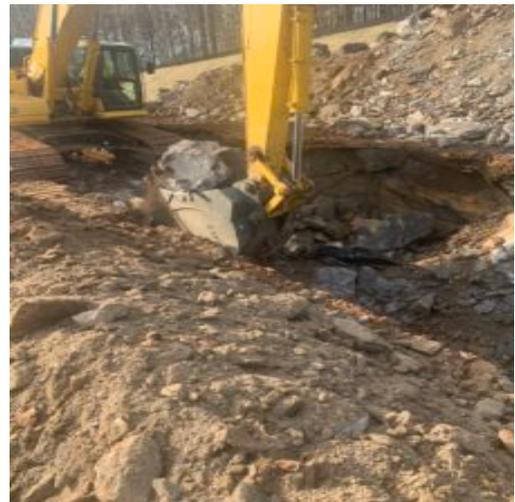
490 backhoe excavating hard rock

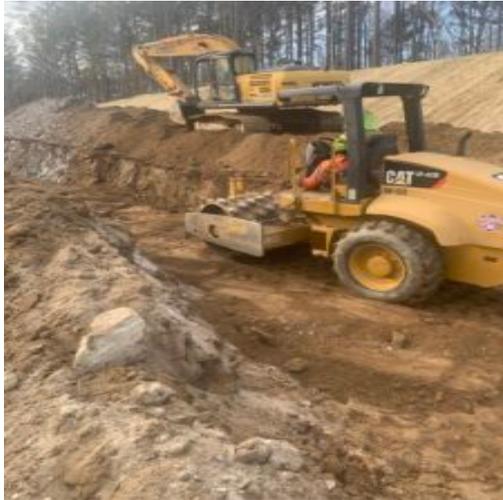
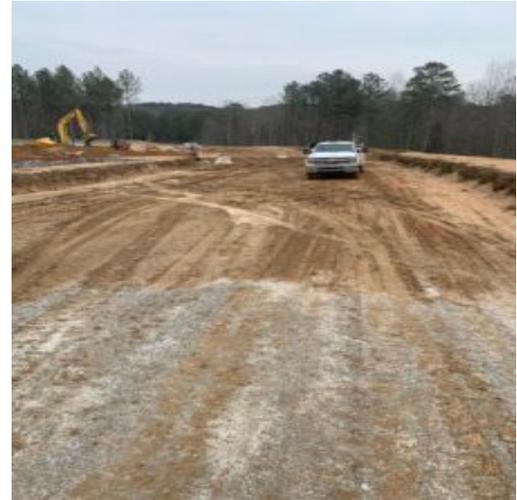
Compacting rockfill using vibratory sheet foot roller Sub grade observation being disturbed at Parkway

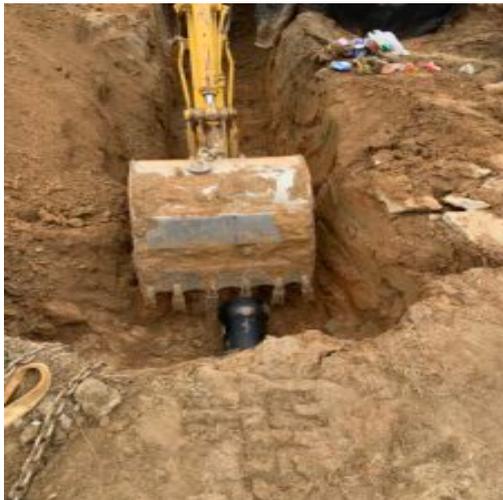
Excavation pushing 8" ductile iron pipe through sleeve
