Date : 02/06/2026
Project No : 2026C103
Client Company : Artisan
Arrival Time : 02/06/2026 08:00
Onsite Hours : 9:30

ASEC Report ID : 90116
Name of the Project : NW PH 2, UNIT 4
Project Location : Dallas
Weather : sunny
Departure Time : 02/06/2026 17:30
ASEC Technician Name : Clyde Smith

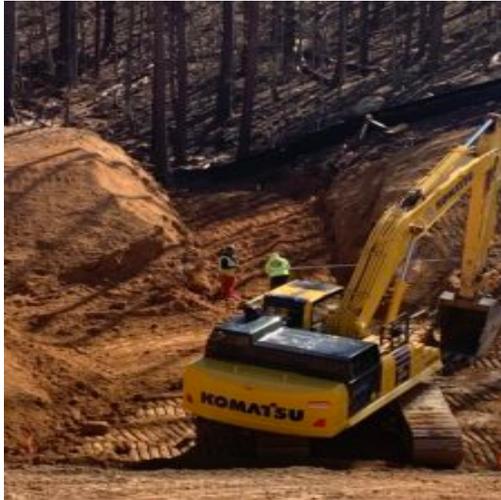
On the above date our representative was on site to observe the pipe contractor (Savanna) begin excavating to install a 48" RCP outlet pipe between the OCS structure and headwall #3. As recommended, the contractor undercut existing sandy silt soils to replace with clay-based soils. The undercut was extended -2' beneath bottom of design elevation for the pipe into residual materials. The undercut soils were replaced with suitable compacted clay base soils. The contractor set headwall structure #3 placed on filter fabric and begin laying a 48" RCP outlet line from the headwall toward the OCS structure in which the pipe was bedded on suitable compacted clay base soils.

Excavating removing sandy silt

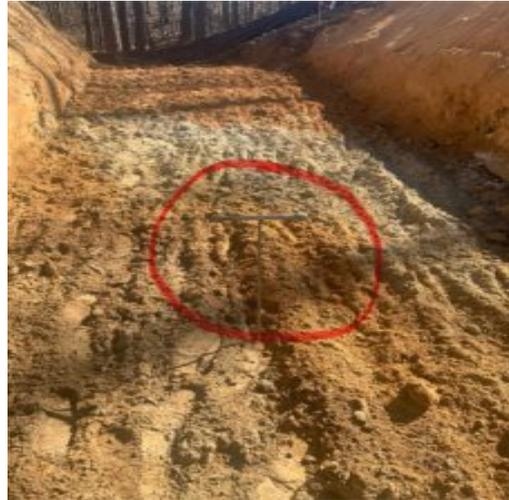
Excavated to suitable residual soils

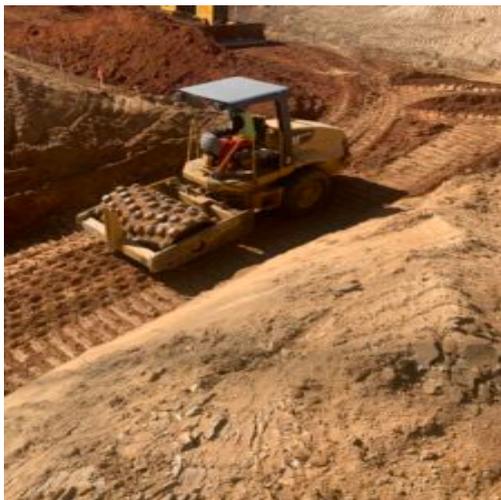
Replacing and compacting suitable clay base soils

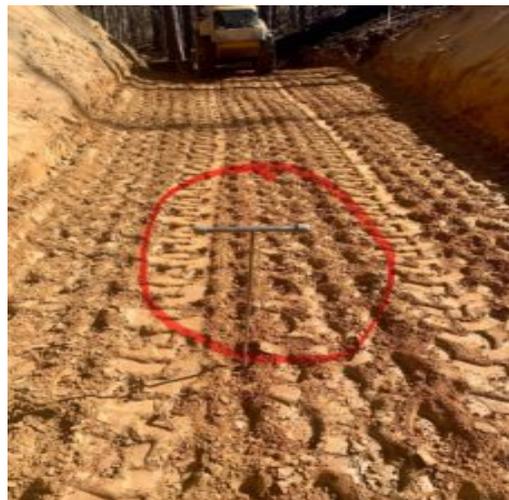
Probing compacted suitable fill soils for 48" rcp pipe

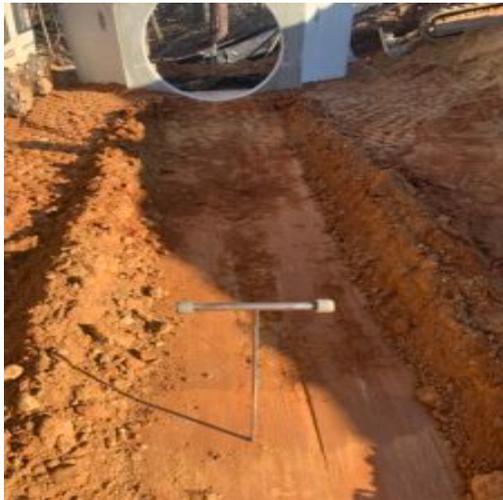
Probing bedding for for 48 " rcp pipe

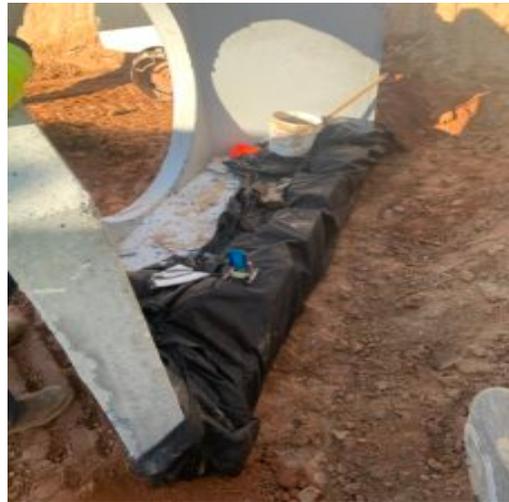
Observation of filter fabric placed under headwall #
3

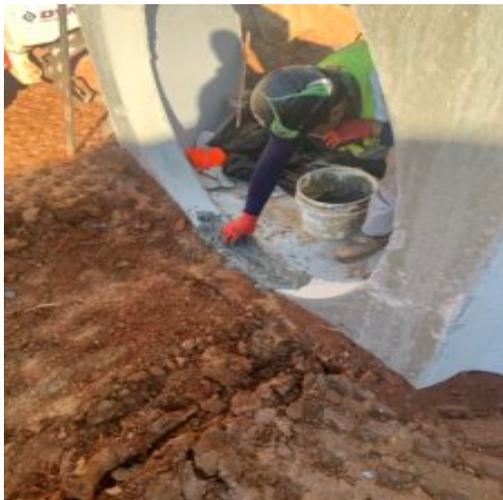
Grouting for 48" rcp seating into headwall
structure #3

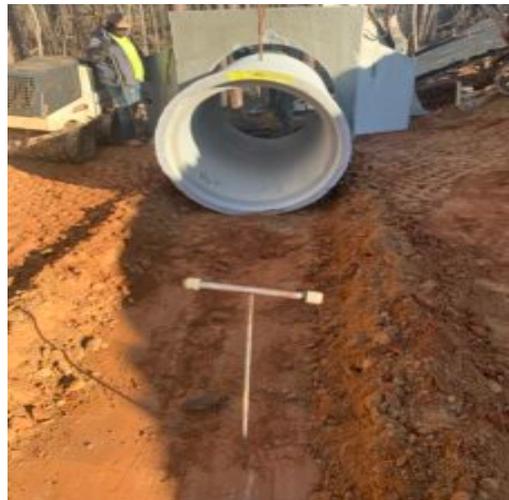
Observation of bedding for 48" rcp and installation.
