Date : 02/09/2026  
Project No : 2026C103  
Client Company : Artisan  
Arrival Time : 02/09/2026 08:00  
Onsite Hours : 9:30

ASEC Report ID : 90138  
Name of the Project : NW PH 2, UNIT 4  
Project Location : Dallas  
Weather : sunny  
Departure Time : 02/09/2026 17:30  
ASEC Technician Name : Clyde Smith

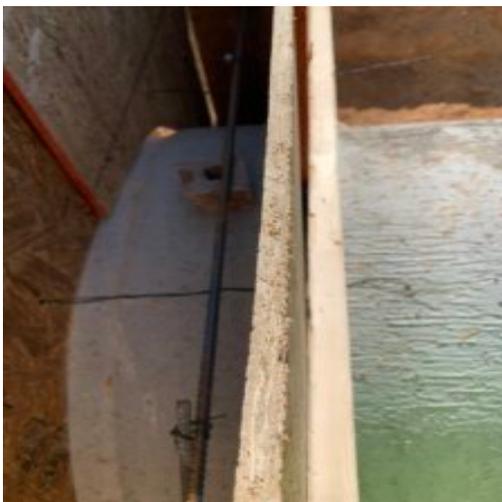
On the above date our representative was on site to observe the pipe contractor (Savanna) complete forming of the anti-seep collars at the Unit 4 phase 2 detention pond OCS. The contractor poured two anti-seep collars at the 48" RCP between headwall #3 and manhole #1. The contractor also poured the invert in the bottom of manhole #1. A total of five cubic yards of 3500 psi concrete was poured for the OCS. The writer observed the anti-seep collars having reinforcing steel in place meeting job specifications for size, spacing and quantity.

Showing reinforcing inside of forms

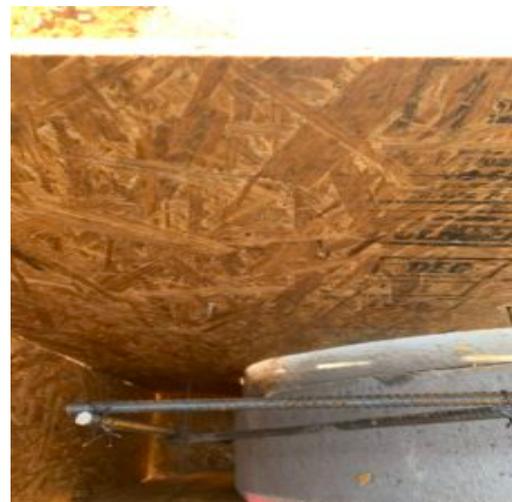
Showing 12" clearance under pipe

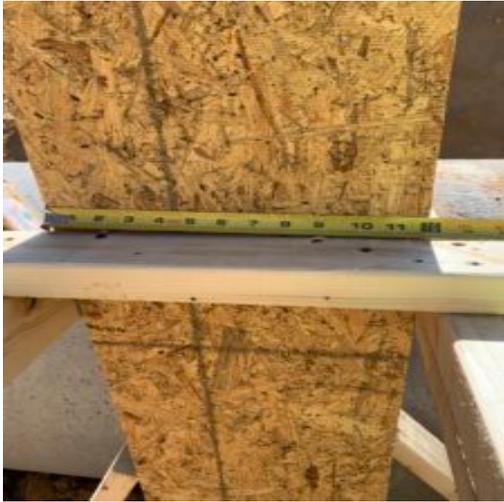
Form work for anti seep collars

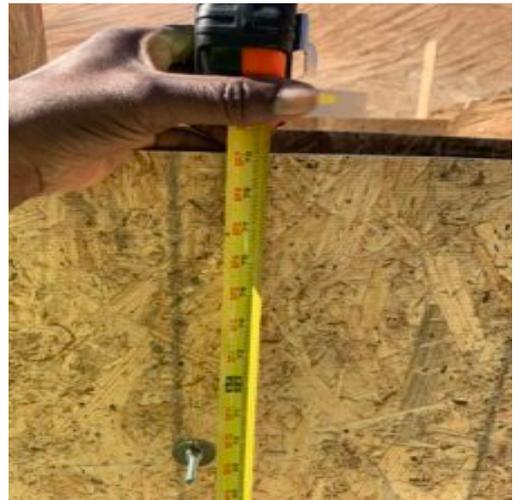
Height of form work
