Date : 02/10/2026  
Project No : 2026C103  
Client Company : Artisan  
Arrival Time : 02/10/2026 14:30  
Onsite Hours : 03:00

ASEC Report ID : 90210  
Name of the Project : NW PH 2, UNIT 4  
Project Location : Dallas  
Weather : sunny  
Departure Time : 02/10/2026 17:30  
ASEC Technician Name : Clyde Smith

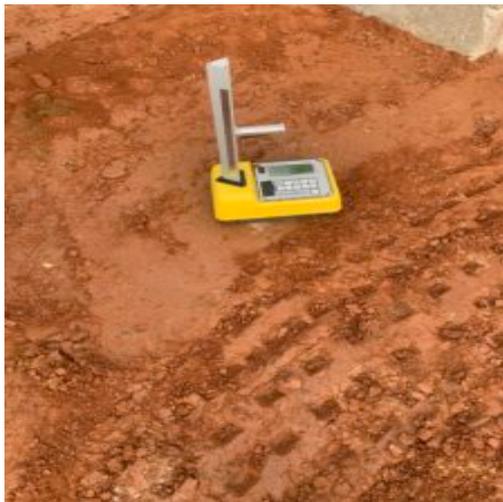
Performing density tests at 48 " rcp storm line between OCS and headwall #3
