Date : 02/18/2026
Project No : 2026C103
Client Company : Artisan
Arrival Time : 02/18/2026 09:00
Onsite Hours : 9:00

ASEC Report ID : 90358
Name of the Project : NW PH 2, UNIT 4
Project Location : Dallas
Weather : cloudy
Departure Time : 02/18/2026 18:00
ASEC Technician Name : Clyde Smith

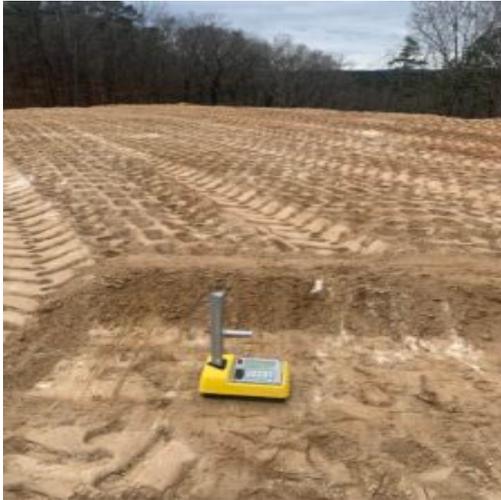
Density test at lot# 38

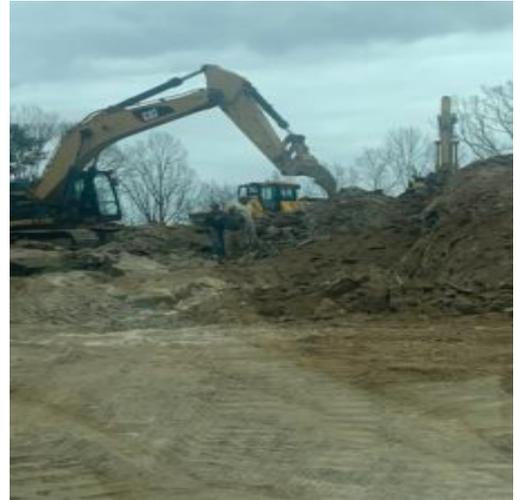
On the above date our representative was on site to observe the grading contractor continue to rip moderate to hard weathered rock at Lots #47 and 48. The contractor spent a total of six (6) hours today (8 am to 12 pm and 4 pm to 6 pm) using a ripper to break up rock. The contractor placed smaller broken pieces as rock fill at building Lots #65 and 66 at elevations 890 to 892.5 in compacted lifts. It was recommended to use off road dump trucks for additional compacting efforts during rock fill placement. The contractor also placed fill for building Lots #56 thru 58 in compacted lifts using a vibratory sheep-foot roller. The writer performed density tests for building Lots #38 and 39 using a Troxler Nuclear gauge model 3430, serial no. 91643. Compaction results were below required job specifications, and it was recommended to the contractor to perform additional compaction efforts to achieve 98% requirements in the top two feet. The contractor stated he would recompact after an upcoming rain event to add additional moisture to the dry soils.

Ripping rock at lo# 47

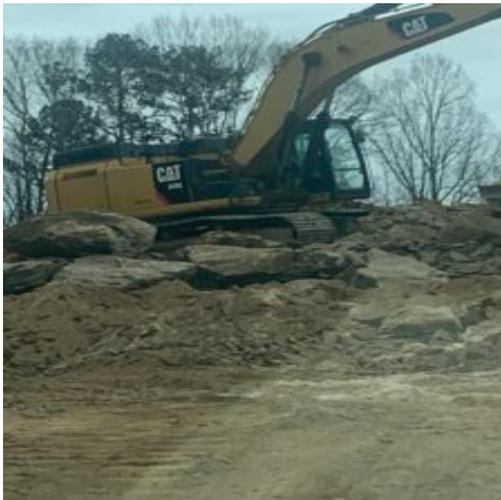
Ripping rock at lot# 48

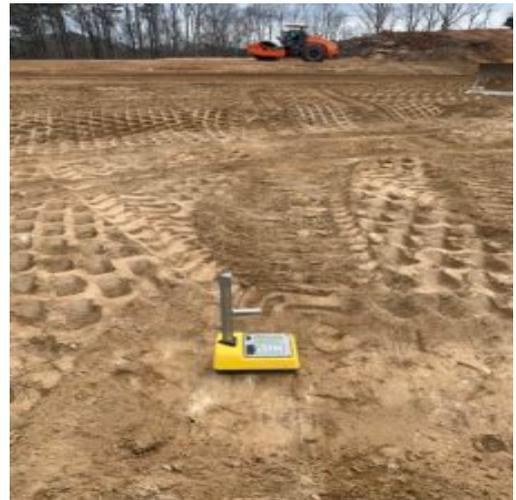
Density test at lot# 39

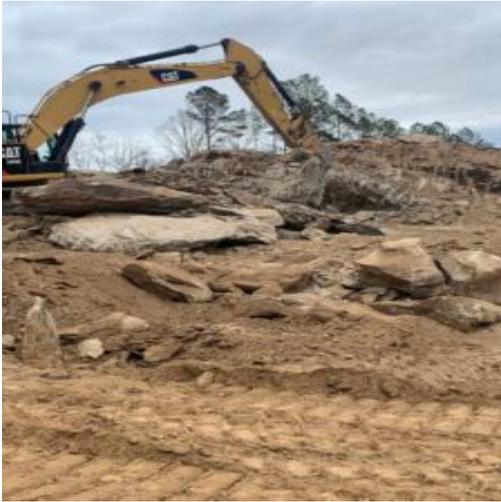
Ripping rock

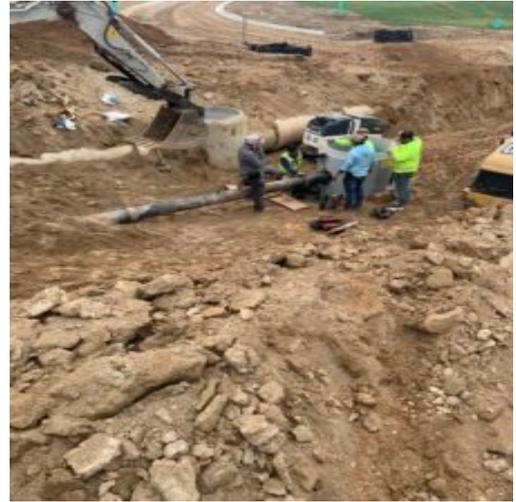
The pipe contractor continued backfilling and connecting 8" ductile iron sewer line to remaining existing line from structure 9-1.

Installation of revised 8" sanitary sewer line

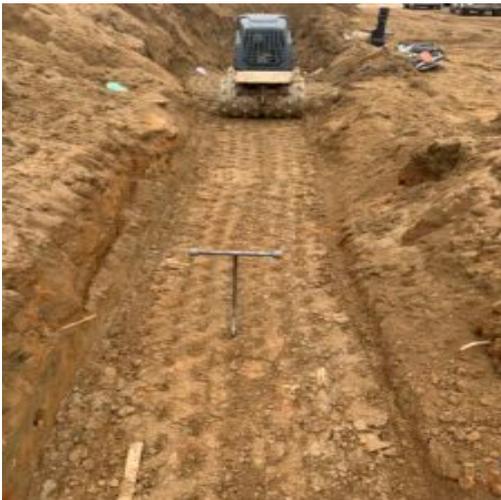
The water line contractor continued installing 12" ductile iron water line north of vale at road A crossing. The contractor also mixed concrete on site and poured the kicker at vale 90-degree bend. The contractor installed approximately forty (40) lineal feet of DIP water line south of vale and begin backfilling north of vale. The in-place backfill was probed using a rounded end steel rod and appeared to be below compaction of 93% and recommendations were made to perform additional compacting efforts.

Backfill and compacting efforts at 12" water line

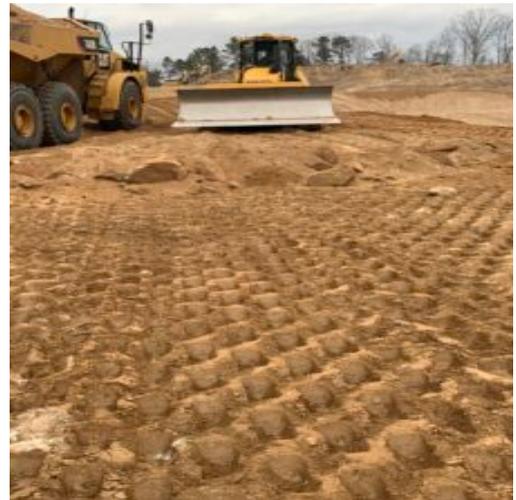
Rock fill at lots# 65 and 66

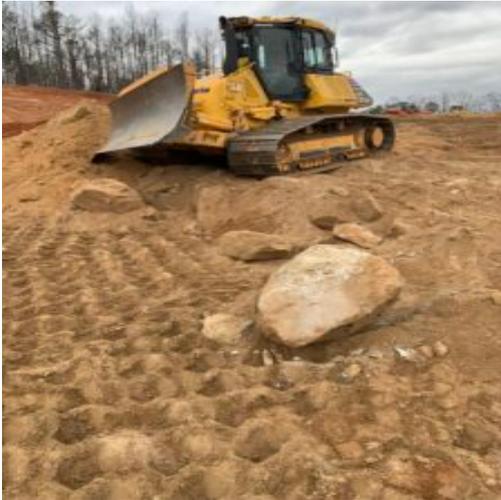
Rockfill

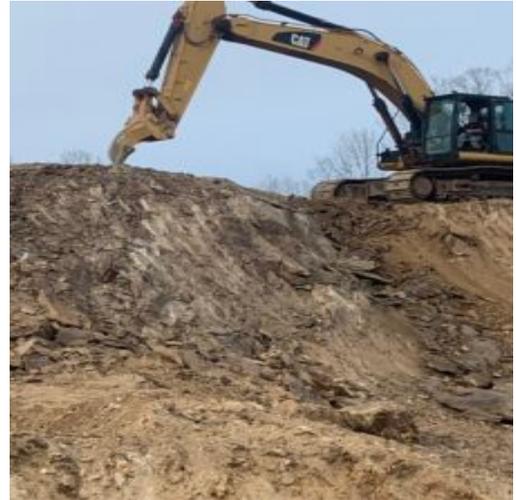
Ripping rock at lot # 48

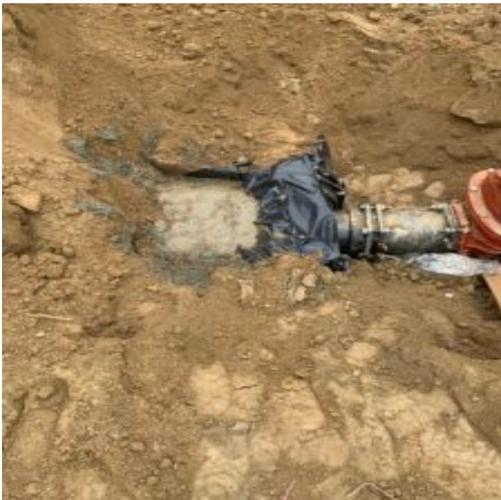
Concrete poured kicker at vale road crossing A
