Date : 02/20/2026  
Project No : 2026C103  
Client Company : Artisan  
Arrival Time : 02/20/2026 08:00  
Onsite Hours : 08:30

ASEC Report ID : 90472  
Name of the Project : NW PH 2, UNIT 4  
Project Location : Dallas  
Weather : cloudy  
Departure Time : 02/20/2026 16:30  
ASEC Technician Name : Clyde Smith

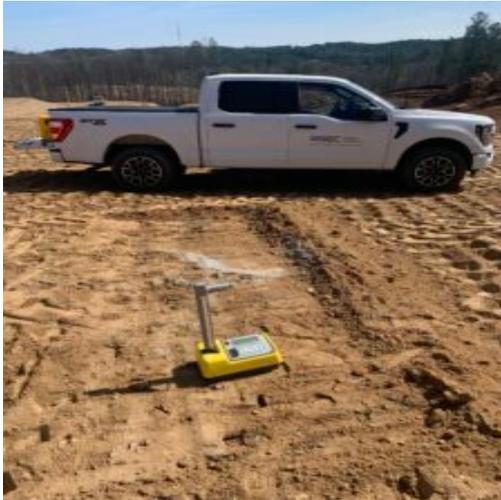
Attempting density tests at rock fill placement ,not enough fines to test.Placement was observed by compacting efforts at lots #64 thru 66, at elevations -4' to -6.5'

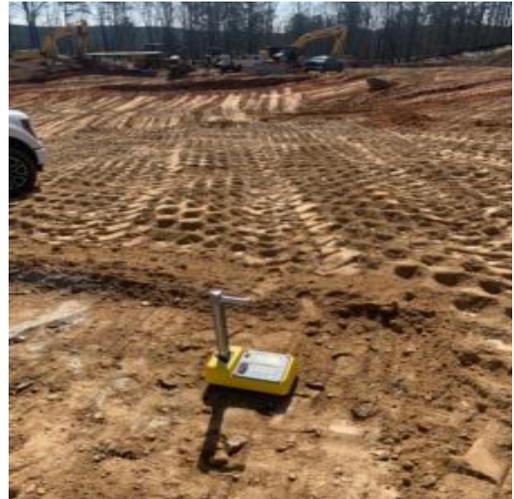
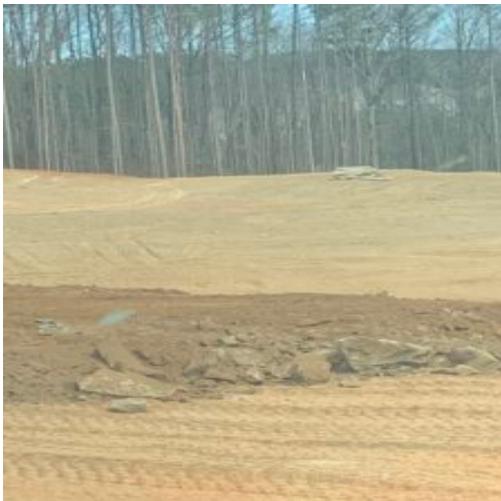
Rock fill placement

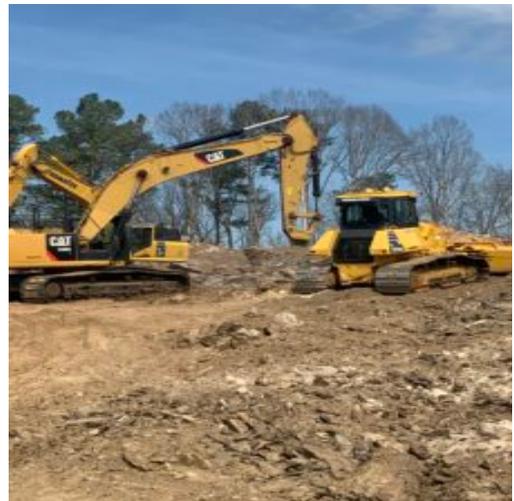
On the above date our representative was on site to observe the grading contractor continue to break up rock using a single tooth ripper attached to a Cat 349 excavator. The contractor spent five (5) hours using the ripper to break up rock today. The contractor loaded broken rock using two excavators and placed rock at building Lots #63 through 66 in compacted lifts using two vibratory sheep-foot rollers and a loaded off-road dump truck. Compacting efforts appeared suitable for rock fill placement. The contractor was reminded of recommendations made to keep all rock fill 4 feet below subgrade/bottom of footing elevation and the top two feet of fill compacted to 98% or higher. The area will be proof-rolled when finished grade is achieved.

Using ripper to break rock

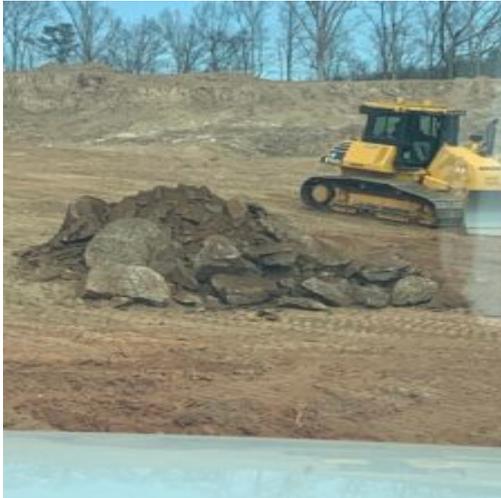
Rock fill placement

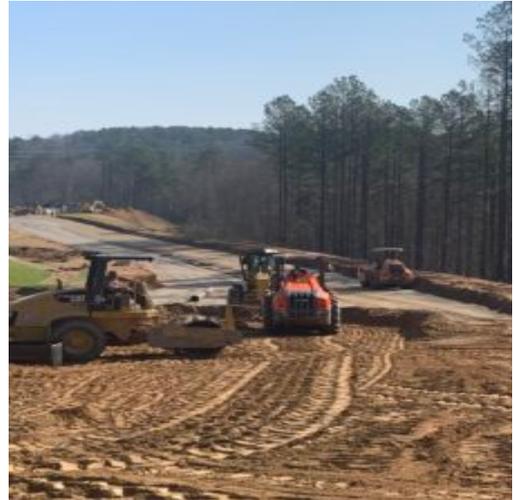
The pipe contractor continued to backfill an 8" sanitary sewer line between manholes #9 and 9.1. Compacting efforts appeared to be suitable for job specifications and will be tested and proof-rolled during final sub grade prep.

Compacting efforts at 8" sanitary sewer line  
between manhole # 9 and 9.1

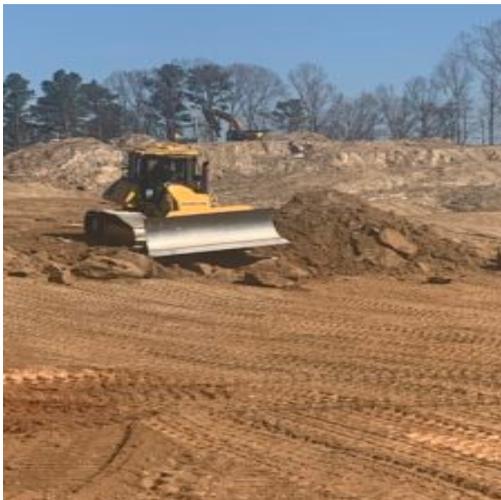
Rockfill placement at building lots

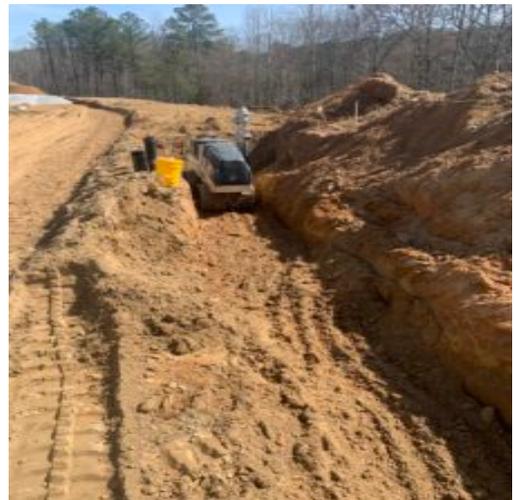
The water line contractor continued installing and backfilling 12" ductile iron water line at Nature Walk parkway between manholes # 5 and 6.

12" ductile iron water line installation at Natire  
Walk blvd. between manhole # 5 and 6

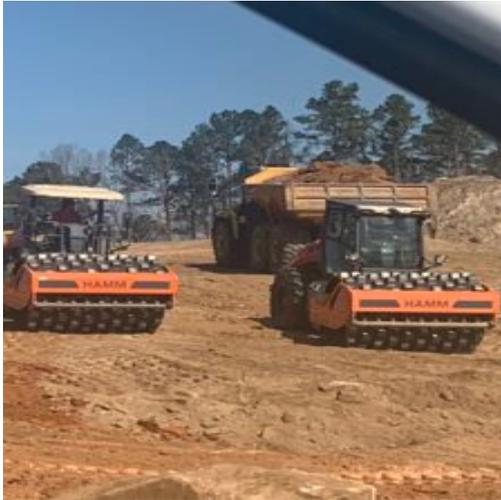
Compacting efforts at building lots # 64 thru 66  
rockfill placement.
