Date : 02/23/2026
Project No : 2026C103
Client Company : Artisan
Arrival Time : 02/23/2026 11:30
Onsite Hours : 06:00

ASEC Report ID : 90565
Name of the Project : NW PH 2, UNIT 4
Project Location : Dallas
Weather : sunny cold
Departure Time : 02/23/2026 17:30
ASEC Technician Name : Clyde Smith

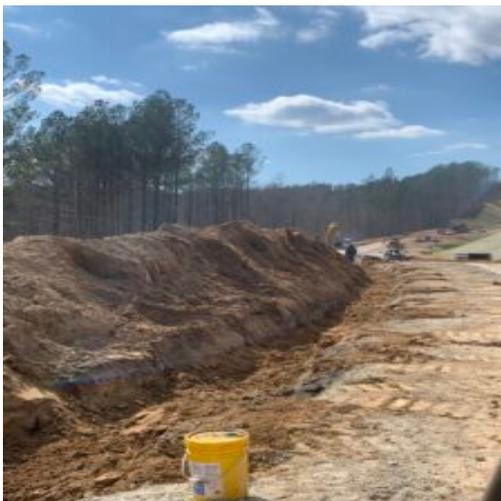
The water line contractor continued installation of 8" DIP at Nature Walk Boulevard between manholes #6 and 7. The water line was changed from a 12" to 8" DIP.

8" ductile iron water line installation

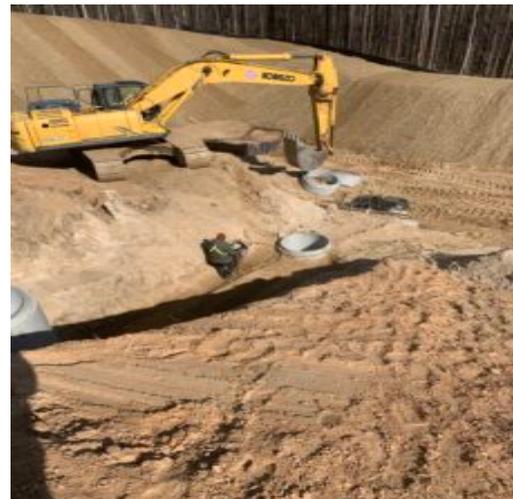
The writer also observed the pipe contractor continue installation of a storm line between headwall H1 and manhole #B2. The contractor installed 30" RCP storm line between headwall #1 and manhole #B1 and the 30" CMP storm line between manholes #B1 and B2.

Storm line installation between headwall #1 and manhole # B2

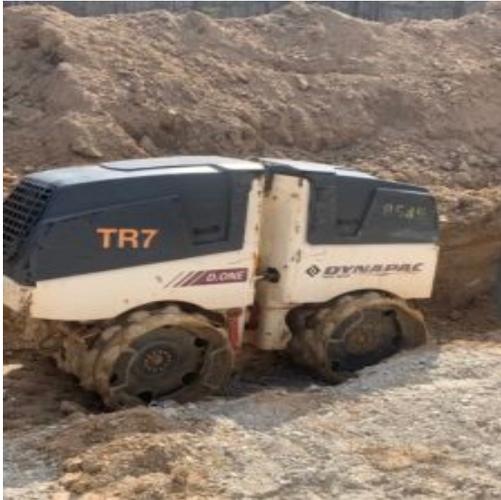
Compacting efforts at 8" water line

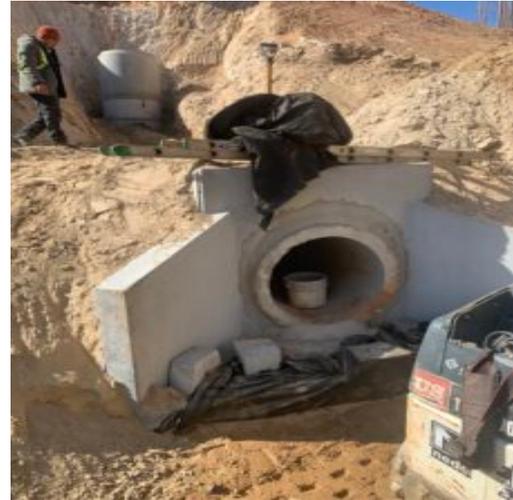
Headwall # 1 installed

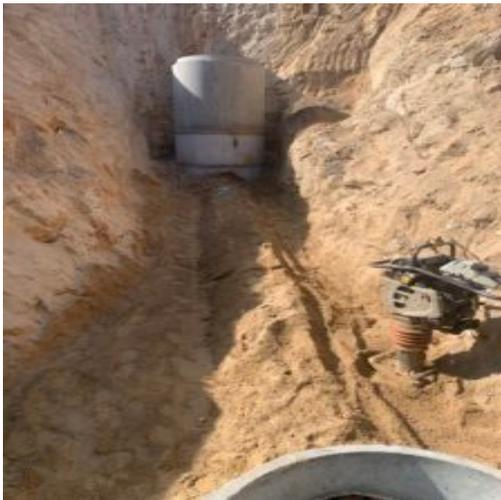
Compacting efforts at storm line between
headwall# 1 and manhole B2

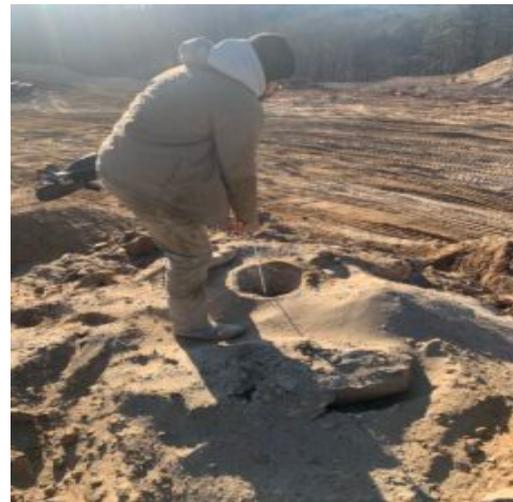
Checking drilled hole depths

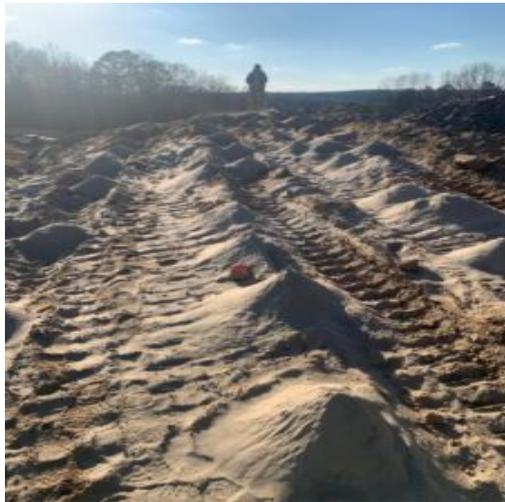
On the above date our representative was on site to observe the blasting contractor drilling hard rock at building Lots #47 and 48. The drilling log is attached.

Drilled holes at lots# 47 and 48

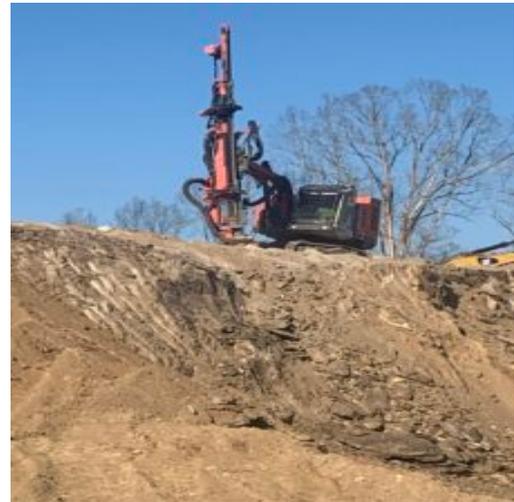
Drilling at lots# 47 and 48

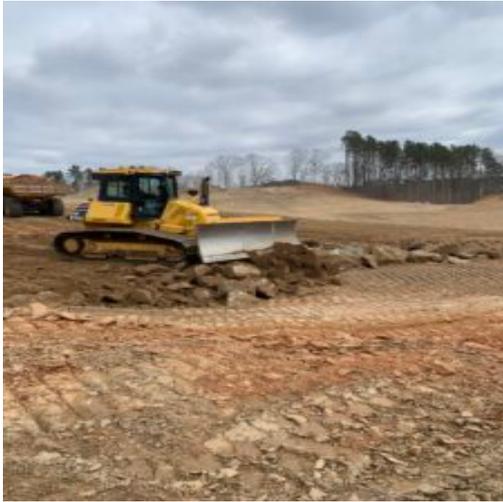
Spreading rock fill

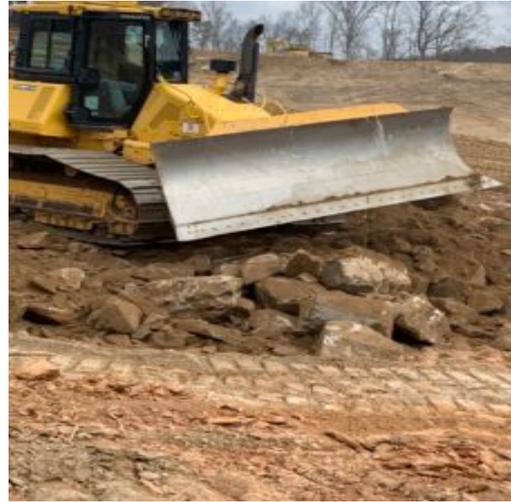
The grading contractor continued fill placement for building Lots #63 thru 66 placing rock fill for Lots #65 and 66 at elevations -7' and -5' which was observed to be placed as per suitable rockfill specifications. The grading contractor used the single tooth ripper attached to the 349 Cat excavator. The time spent today ripping was approximately 2.5 hours.

Spreading rockfill at building lots# 65 and 66
