Date : 02/24/2026
Project No : 2026C103
Client Company : Artisan
Arrival Time : 02/24/2026 08:00
Onsite Hours : 07:00

ASEC Report ID : 90640
Name of the Project : NW PH 2, UNIT 4
Project Location : Dallas
Weather : sunny
Departure Time : 02/24/2026 15:00
ASEC Technician Name : Clyde Smith

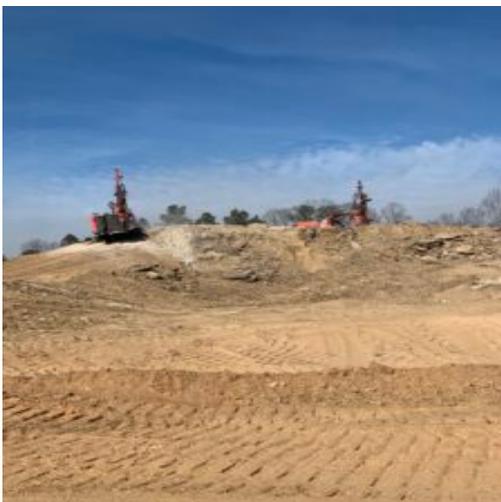
Drilling rock at lots# 47 and 48

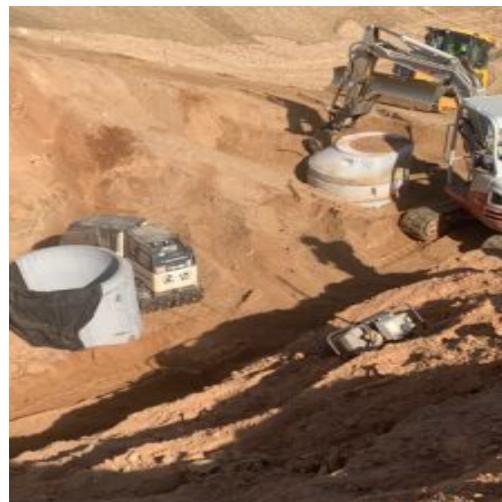
On the above date our representative was on site to observe the pipe contractor continue installing 30" CMP storm line and backfilling between manhole structures B1 and B3. The writer observed some CMP joints being connected with metal bands and lag bolts.

Backfilling and 30" cmp storm line between B2 and B4

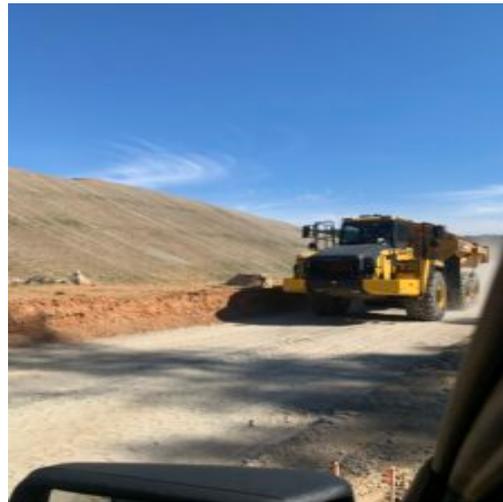
The grading contractor continued placing fill for building Lot #66 and placing fill at the pool area. The contractor also began hauling excavated soils from the bridge installation area placing this material in extended slope green space area designated for rockfill. The writer observed off road dump truck traffic on subbase stone in place at Nature Walk Boulevard between sanitary sewer manholes #4 and 9. The contractor was advised that the continuing traffic is breaking down the subbase stone and will require repair measures to complete subbase prep. The writer performed depth checks on the in-place base stone and areas observed averaged 4" to 5" of base stone in place which is starting to break up and having slight to moderate movement under the off-road dump truck traffic. The contractor was reminded with these depth checks that the 4" to 5" thickness will not hold up under this construction traffic. The client was also notified, and it was agreed to continue hauling and that repairs will be made at a later date. The drilling contractor (Advance) was on site also and continued drilling at Lots #47 and 48 using two drill rigs. Drill logs are attached.

Traffic on sub base stone

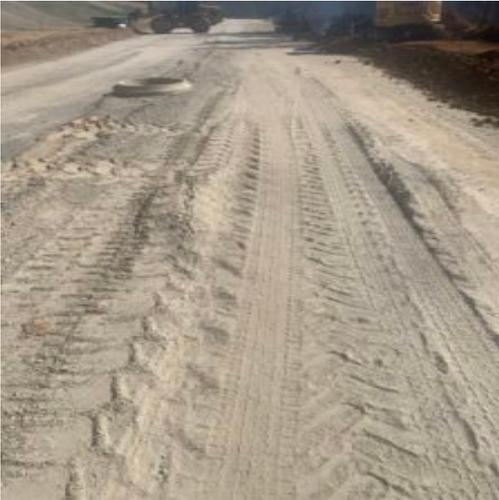
Base stone rutting and pumping

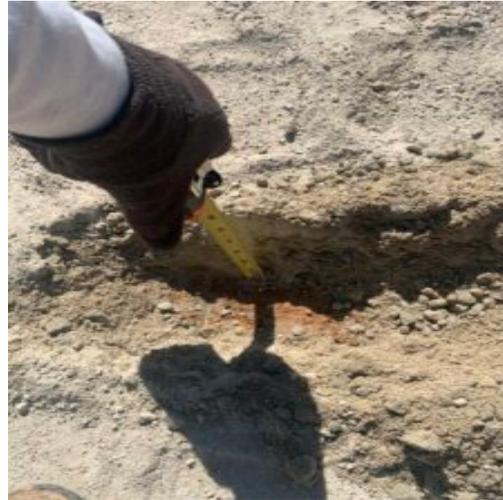
Showing 4" depth of base stone

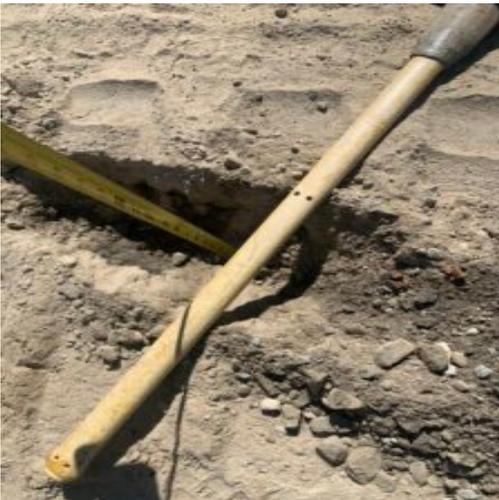
Showing 5" depth of base stone
