Date : 02/25/2026  
Project No : 2026C103  
Client Company : Artisan  
Arrival Time : 02/25/2026 08:00  
Onsite Hours : 08:00

ASEC Report ID : 90741  
Name of the Project : NW PH 2, UNIT 4  
Project Location : Dallas  
Weather : cloudy  
Departure Time : 02/25/2026 16:00  
ASEC Technician Name : Clyde Smith

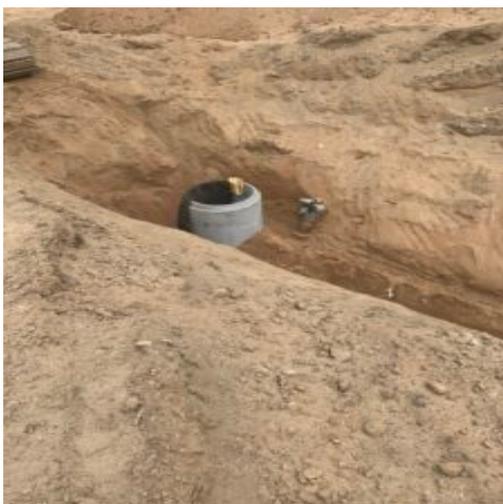
On the above date our representative was on site to observe the pipe contractor continue installing 30" CMP storm line between manholes #B2 and B4. Backfilling for the deep excavations was observed, and compacting efforts appeared to be suitable for job requirements.

30" cmp storm installation and backfill

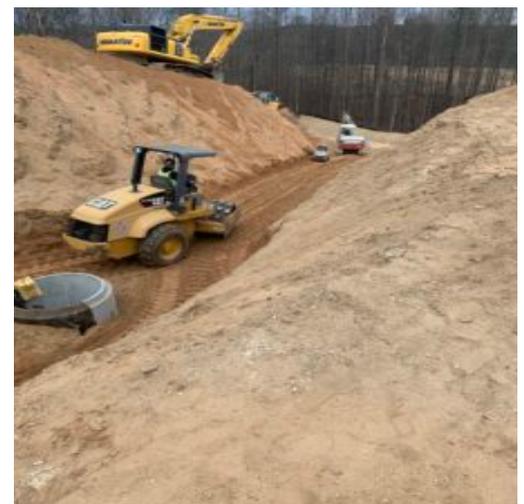
Backfill and compacting efforts

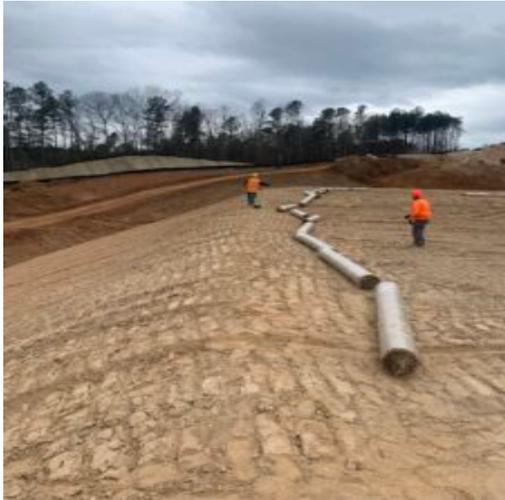
The erosion contractor (Valor) was on site and continued grass seeding and placing mat blankets at pond embankment slopes.

Matting and grass seeding at pond slope embankment

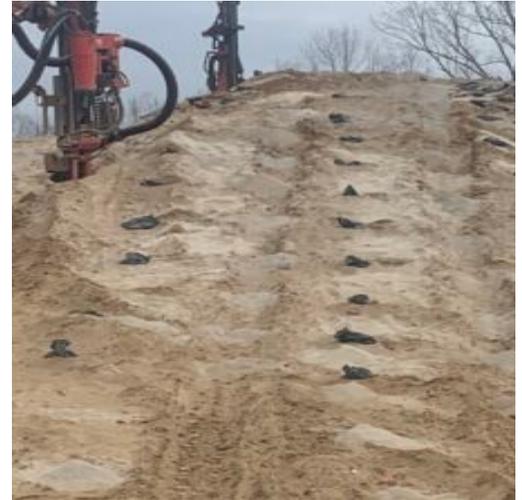
The drilling contractor (Advance) continued drilling hard rock at building Lots #47 and 48 using two drill rigs.

Drilling holes at lot# 47

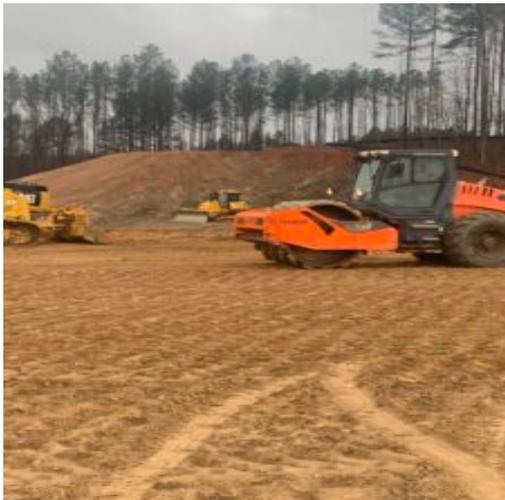
Fill placement and compacting at lot# 66
