Date : 03/04/2026
Project No : 2026C103
Client Company : Artisan
Arrival Time : 03/04/2026 07:30
Onsite Hours : 10:00

ASEC Report ID : 91073
Name of the Project : NW PH 2, UNIT 4
Project Location : Dallas
Weather : sunny
Departure Time : 03/04/2026 17:30
ASEC Technician Name : Clyde Smith

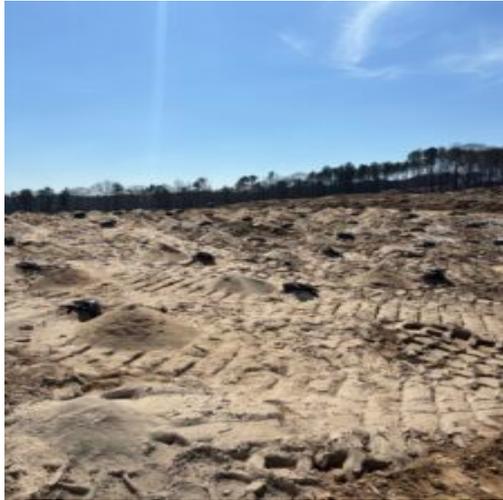
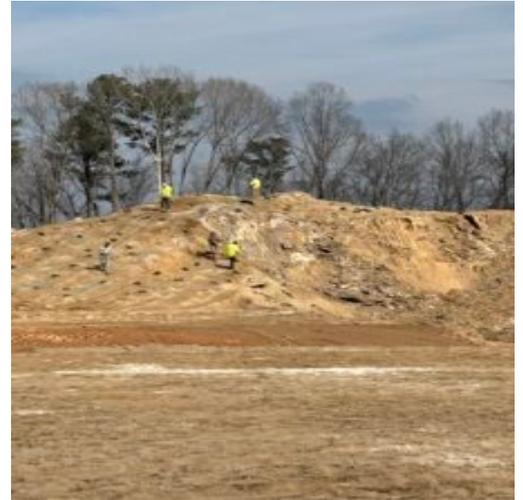
The blasting contractor performed a blast today for Lots #47 and 48 and also continued drilling at Lots #42 and 43.

Blast for Lots #47 and 48.

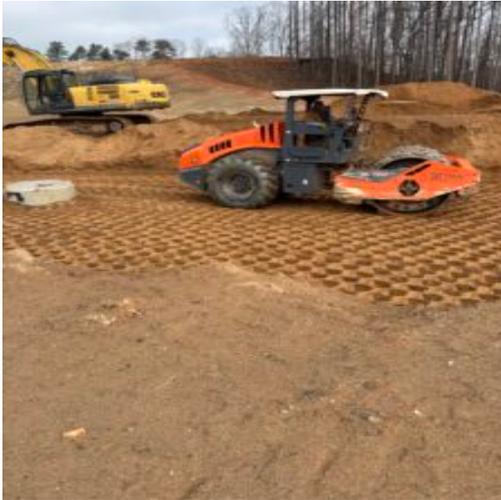
The pipe contractor continued installing 8" ductile iron sanitary sewer line between manholes # B-2 and B-4 (and backfilling). Density tests were performed using a Troxler Nuclear gauge model 3430, serial no. 91643. Compaction results were suitable for job specifications.

Backfill at storm line between B2 and B4.

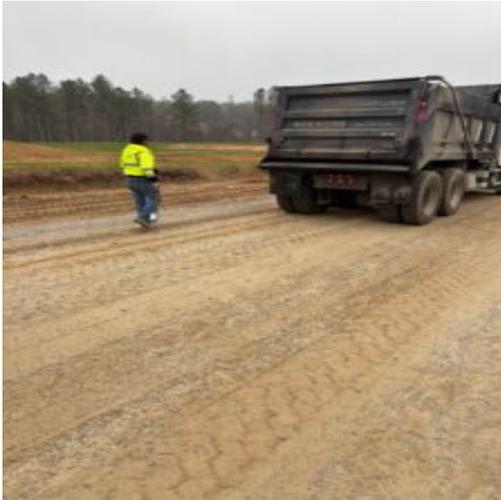
The paving contractor continued the undercutting of recommended subgrade repair areas between manholes #6 and 9 on Naturewalk Boulevard that was estimated to be 252 tons of extra base rock to stabilize the subgrade. A moderate amount of movement was observed under proof-roll traffic. The undercut areas averaged -8" with some isolated areas at -12". The base stone placement observed today appears to be coming from two different sources with one source having more finer materials. The contractor stated that the finer materials were coming from there office and have had great results in compacting.

Subgrade repair areas at Naturewalk Blvd between manholes #6 and 9.
