Date : 03/23/2026  
Project No : 2026C103  
Client Company : Artisan  
Arrival Time : 03/23/2026 10:00  
Onsite Hours : 08:00

ASEC Report ID : 91585  
Name of the Project : NW PH 2, UNIT 4  
Project Location : Dallas  
Weather : sunny  
Departure Time : 03/23/2026 18:00  
ASEC Technician Name : Clyde Smith

As requested, the site was visited by our AS Engineering and Consulting (ASEC) representative for the purpose of providing quality control inspection and testing services. Visual observation techniques were employed to verify compliance with project drawing/specifications, applicable codes, and materials submittals. The following observations were observed on site this day.

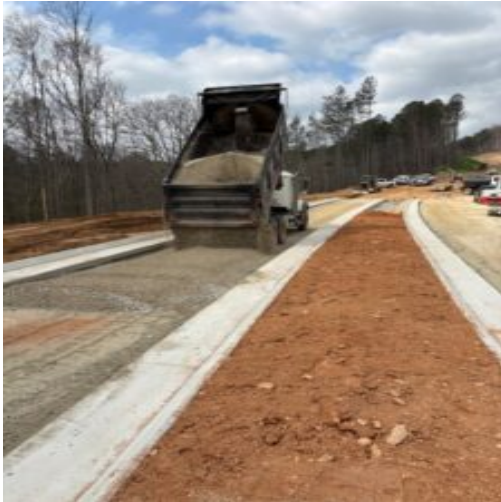
Adding additional base stone at repair areas

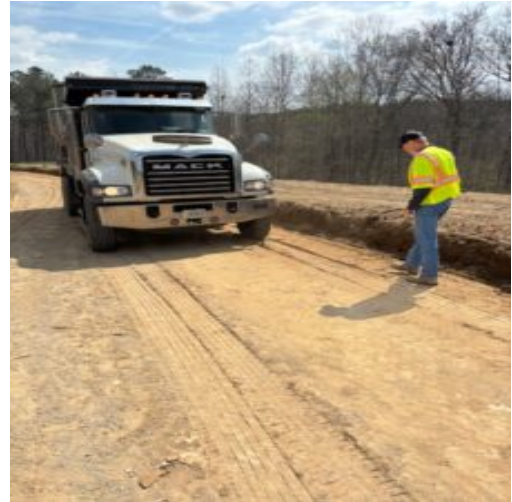
Proof rolling sub grades

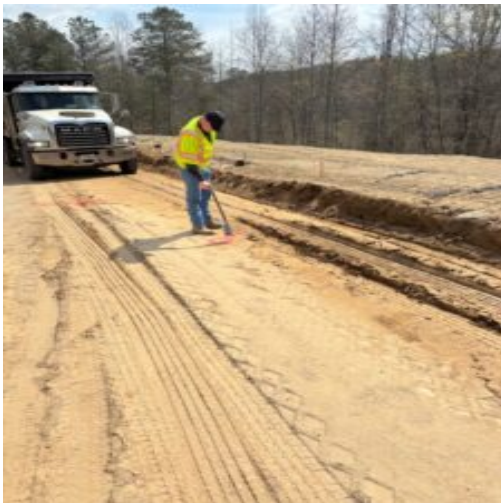
The paving contractor was on site and continued subbase stone placement and subgrade repairs between sanitary sewer manholes #9 and 6. The contractor bladed and compacted base stone wetting and compacting using a vibratory smooth drum roller. The contractor also performed subgrade preparation between sanitary sewer manholes #6 and 4 to observe for proof-rolling. The subgrade was proof-rolled using a loaded tandem dump truck loaded with 18 tons of base stone. Several isolated areas were observed having slight to moderate movement under traffic and was recommended for clipping -2" to -8" and replacing with additional base stone and geotextile fabric as needed. All areas were identified by spray paint and will be observed during clip removal.

Proof roll observation of moderate movement

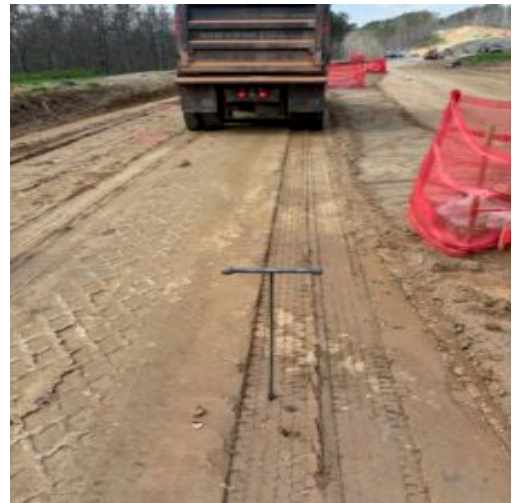
Proof roll observing slight movement

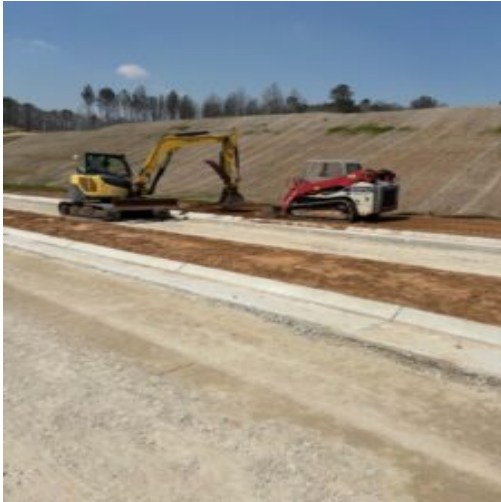
The grading contractor worked at Nature Walk Boulevard backfilling outside curbing and inside island curbing.

Grading contractor backfilling curb

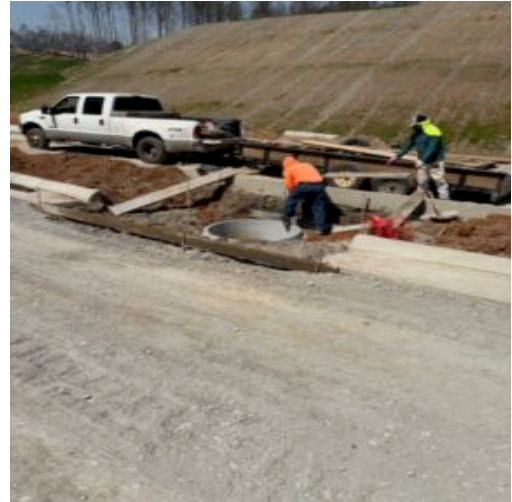
The curbing contractor was on site and formed and poured bases for single and double wing curb inlets at Nature Walk Boulevard between sanitary sewer manholes #9 and 6.

Curbing contractor forming base for inlets pour

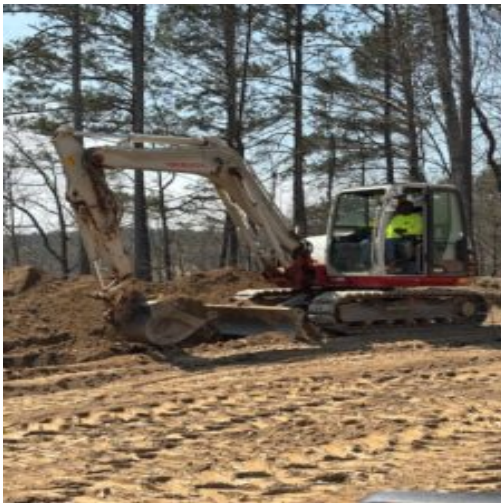
The water line contractor was also on site and continued installing and backfilling 8" ductile iron water line between sanitary sewer manholes #9 and 10.

Water line contractor installing 8" water d.i.p. line

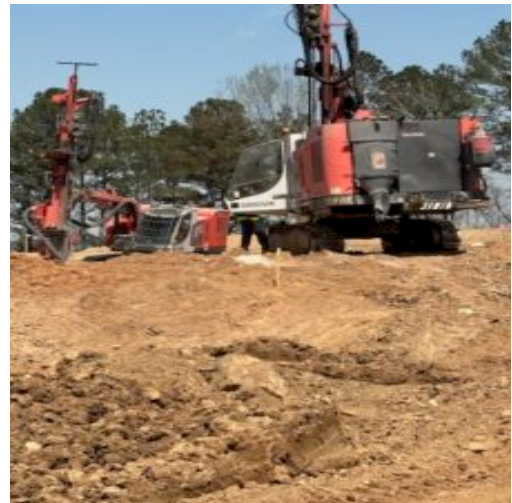
The drilling contractor (Advance) was on site and continued drilling at Lot #37 using two drill rigs.

Drill rigs at lot #37

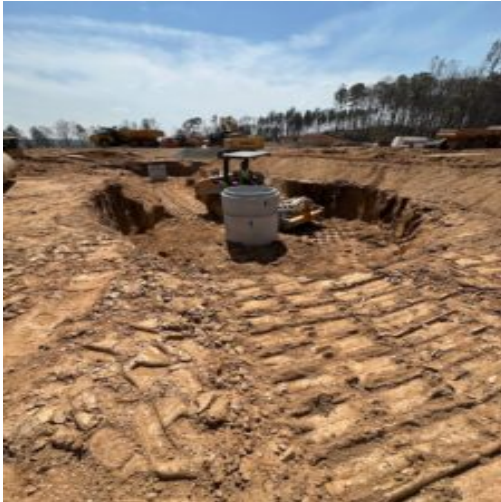
On the above our representative was on site to observe the pipe contractor continue backfilling 30" RCP storm line between manholes #B6, B7 and B10. The backfill was observed by probing in-place compacted fill using a rounded end steel rod. Compacting efforts observed were suitable for required job specifications.

Backfill and compacting r.c.p. 30" storm line

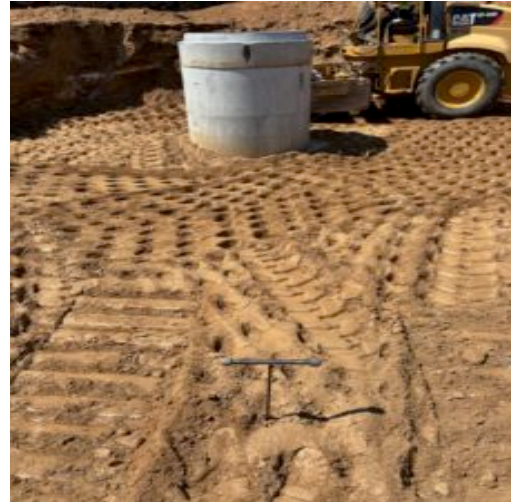
Back fill observation and probe testing

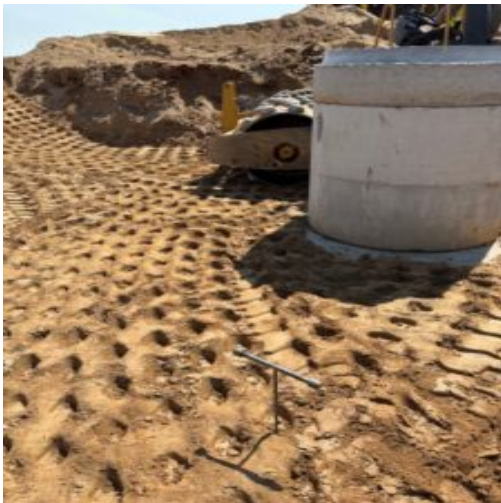
Backfill observations and probe testing  
recommended for additional compacting

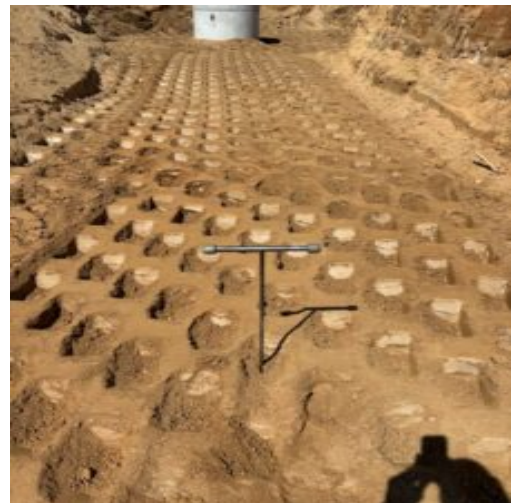
Backfill observation probe testing

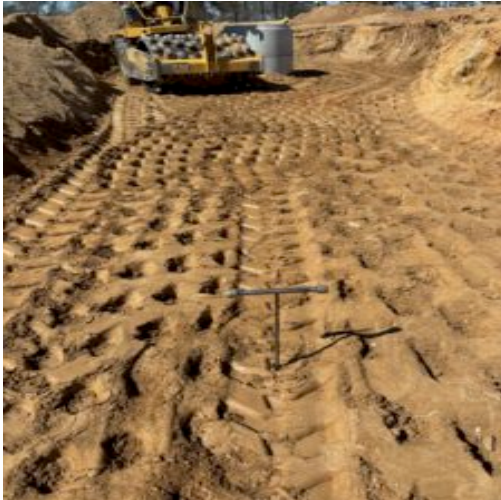
Backfill observations probe testing recommended additional testing

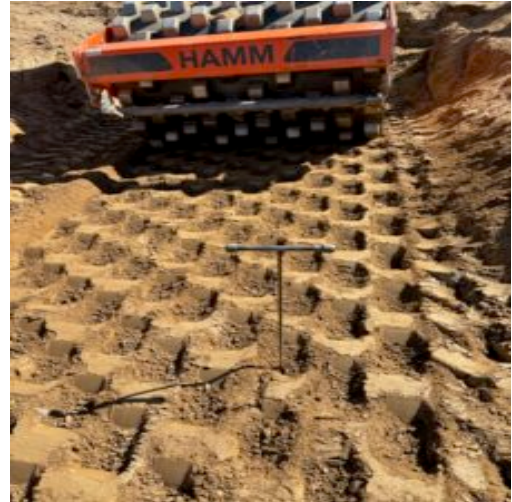
Backfill observations probe testing, all compacting efforts after additional rolling was suitable for compaction requirements.

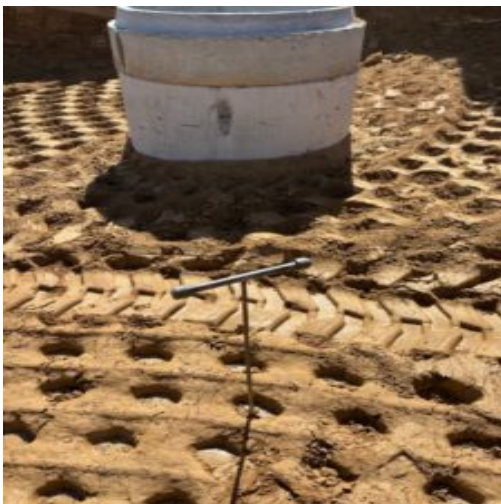
Backfill observation probe testing.
