Date : 04/21/2026
Project No : 2026C103
Client Company : Artisan
Arrival Time : 04/21/2026 14:30
Onsite Hours : 03:00

ASEC Report ID : 93314
Name of the Project : NW PH 2, UNIT 4
Project Location : Dallas
Weather : Sunny
Departure Time : 04/21/2026 17:30
ASEC Technician Name : Clyde Smith

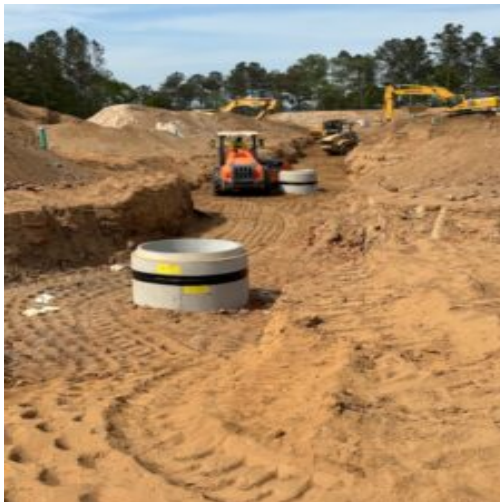
On the above date our representative was on site to observe the pipe contractor continue backfilling the 8" ductile iron sanitary sewer line and laterals between manholes #B12 thru B14. The backfill materials consisted of a small size blast rock with soil mixture. The materials are very dry and were being placed in two-foot lifts and compacted using two vibratory sheep-foot rollers. It was recommended to the contractor to blade the fill materials down to one foot. The backfill was reobserved by probing using a rounded end steel rod and was approved for suitable compaction efforts at elevation plus three feet to four feet over top of pipe.

Rock backfill at sanitary sewer line between B12 and B14

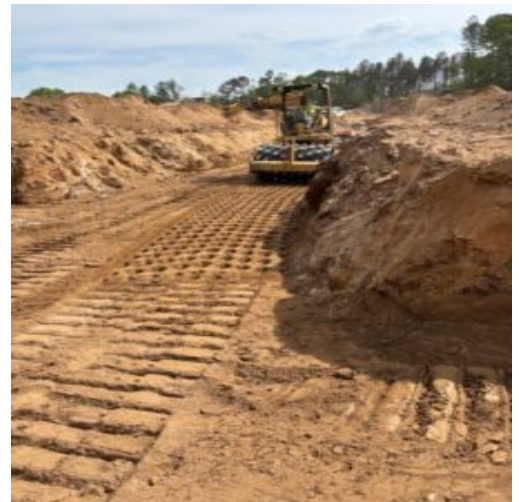
Compacting in place fill

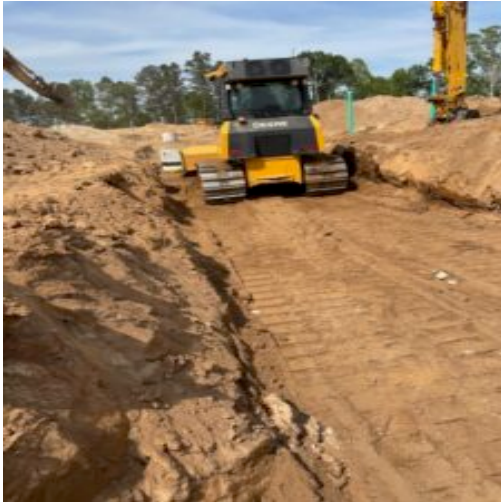
Placement lift recommended to blade down to one foot

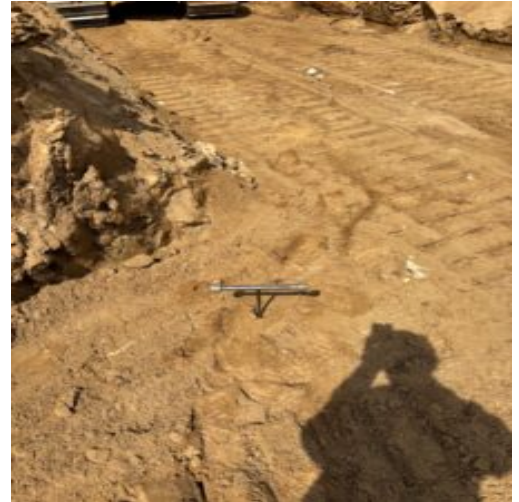
showing two feet lift prior to blading down

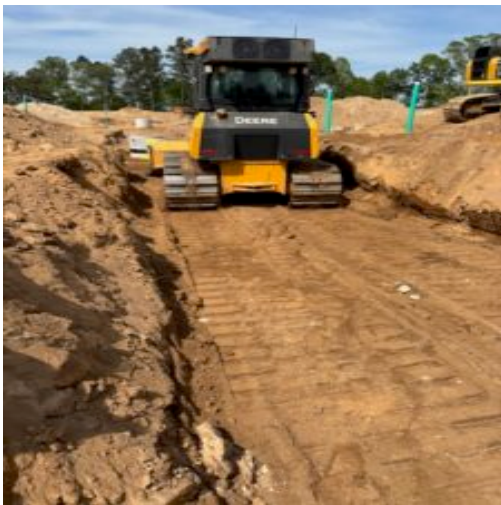
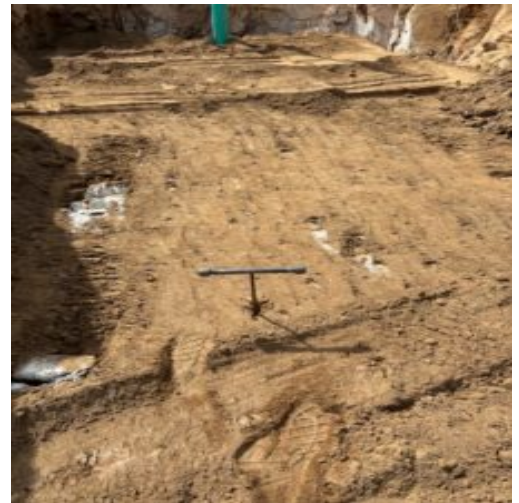
Showing two feet lift prior to blading down
