Date : 04/24/2026
Project No : 2026C103
Client Company : Artisan
Arrival Time : 04/24/2026 11:00
Onsite Hours : 03:00

ASEC Report ID : 93527
Name of the Project : NW PH 2, UNIT 4
Project Location : Dallas
Weather : Sunny
Departure Time : 04/24/2026 14:00
ASEC Technician Name : Sean Willett

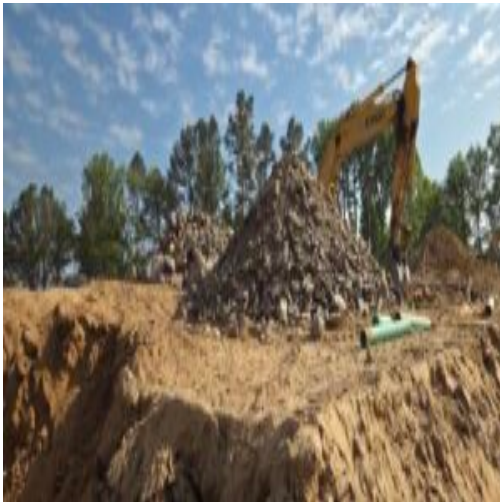
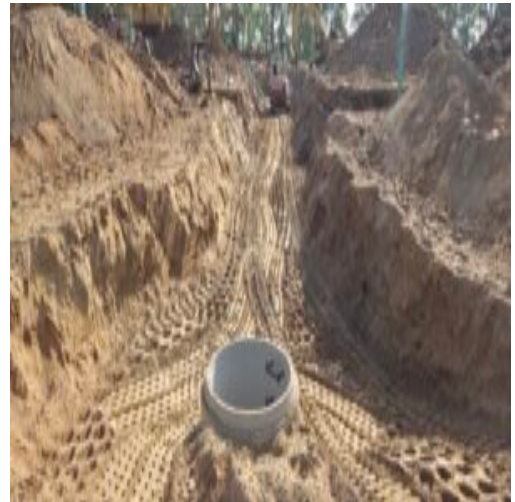
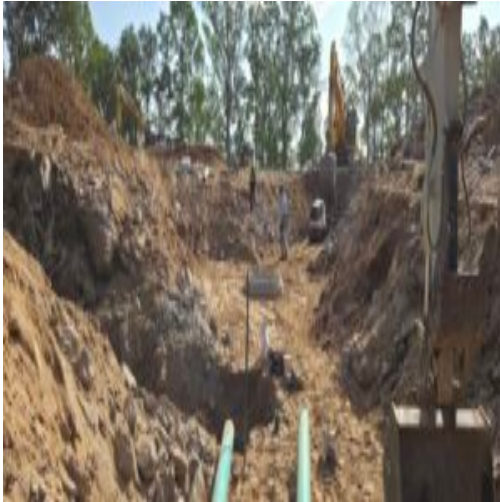
Our ASEC representative was on site to observe the contractor and for the observation/testing of the placement of fill/backfill. The pipe crew is continuing the backfill of B-15 to B-16. This area appears to have a large quantity of hard rock present. The contractor is placing soil lifts of approximately 1 to 2 feet in size and compacting using a vibrating sheep-foot roller. It was recommended to reduce the lift size to less than 12 inches to aid with the compaction process. Density testing was performed, and test results were provided to the contractor.
