Date : 04/25/2026  
Project No : 2026C103  
Client Company : Artisan  
Arrival Time : 04/25/2026 08:30  
Onsite Hours : 03:30

ASEC Report ID : 93477  
Name of the Project : NW PH 2, UNIT 4  
Project Location : Dallas  
Weather : cloudy  
Departure Time : 04/25/2026 12:00  
ASEC Technician Name : Clyde Smith

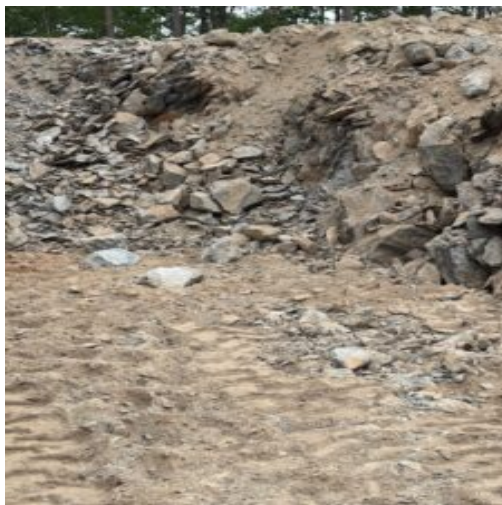
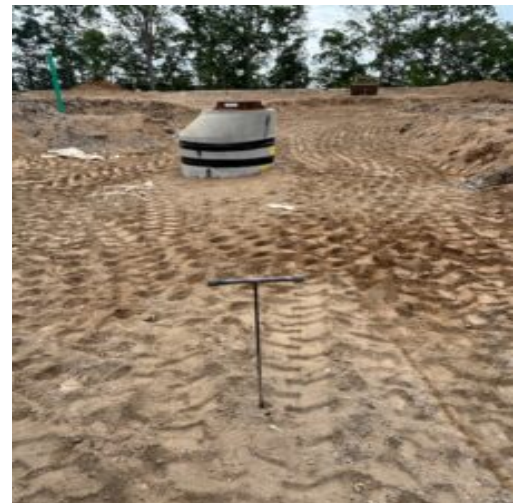
Rockfill placement placement backfill at 8" pvc sanitary sewer line B between #14 and 16.
