Date : 04/23/2026
Project No : 2026C125
Client Company : Lewis Contracting
Arrival Time : 04/23/2026 14:00
Onsite Hours : 02:00

ASEC Report ID : 93447
Name of the Project : Pittman Park - Garibaldi St. Stormwater
Project Location : Atlanta
Weather : Sunny
Departure Time : 04/23/2026 16:00
ASEC Technician Name : Sean Willett

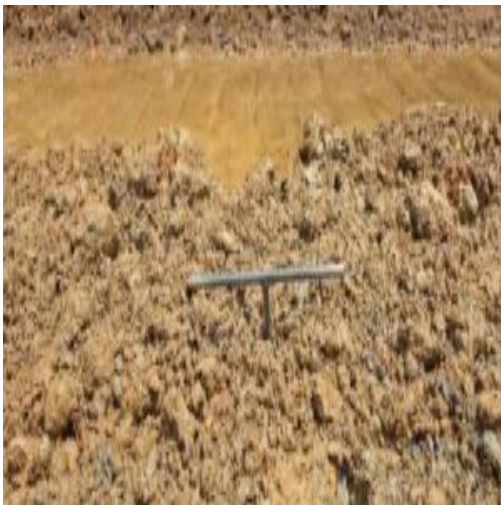
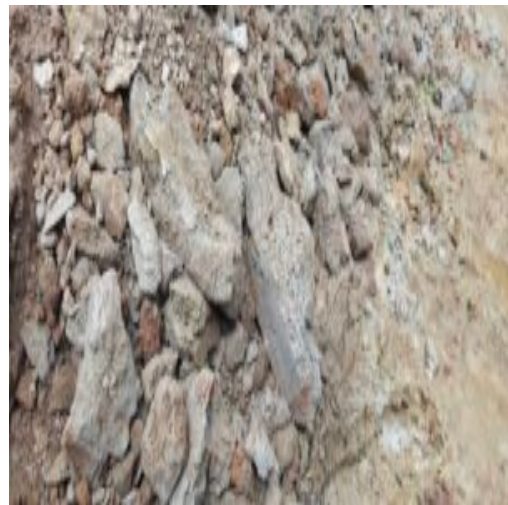
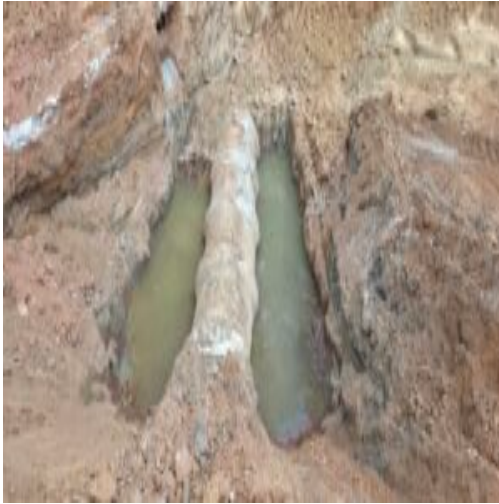
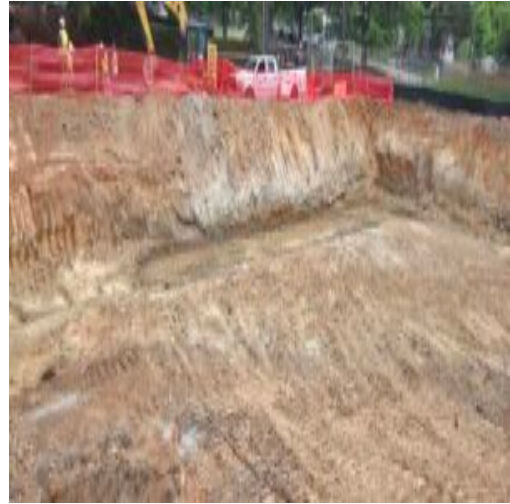
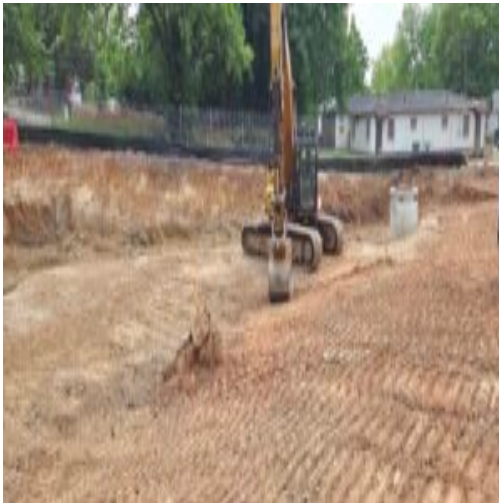
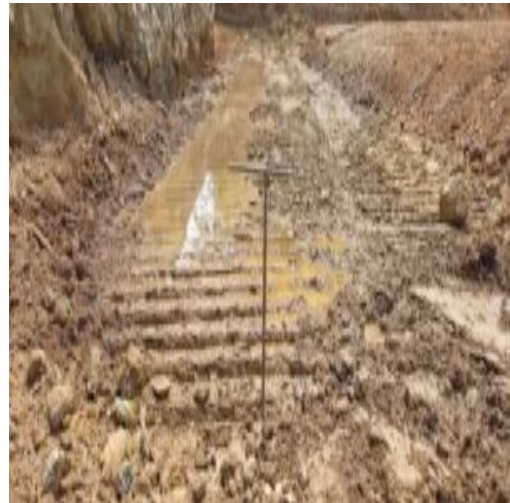
Our ASEC representative was on site to observe the contractor (Lewis Contracting) and for the observation/testing of the placement of fill/backfill. The contractors excavated out the footing for the concrete wall for the pond. There was ground water seepage observed approximately to 2 to 3 inches deep in a large section of the footing. Probe rod testing was performed and the probe rod indicated very low bearing. DCP testing was then performed. ASEC recommended to excavate approximately 3 to 4 feet in depth and replace with No. 57 stone placed in "compacted" lifts. It was recommended to have the rock onsite before excavation, and to use pumps to manage the ground water below the bottom of the footing. ASEC requested that the contractor notify ASEC when they plan to do this remediation.
