Date : 04/15/2026
Project No : 2026C133
Client Company : Artisan
Arrival Time : 04/15/2026 11:00
Onsite Hours : 02:30

ASEC Report ID : 92963
Name of the Project : Salacoa (AKA Boone Ford Rd) Robert's
Dam
Project Location : Calhoun
Weather : Sunny
Departure Time : 04/15/2026 13:30
ASEC Technician Name : Clyde Smith

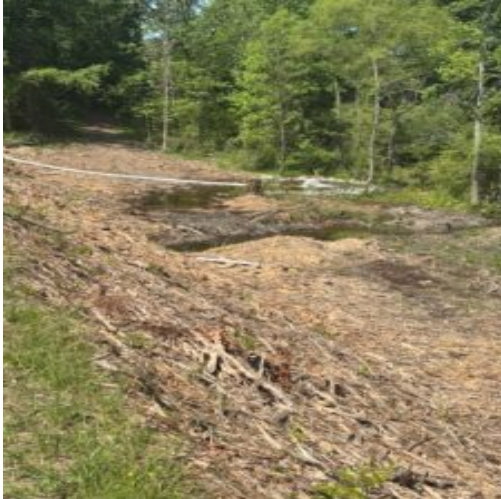
On the above date our representative was on site to meet with Mr. Calvin McShan of Artisan and Mr. Hugh Rountree to observe standing water conditions at north side of the lake outside the toe of the dam embankment. The current conditions observed were that all vegetation had been removed and stumps had been grinded into mulch and left in place. A few stumps were still visible at ground surface with one noticeable to be about 24" to 30" in diameter. At the bottom of the slope approximately twenty feet from the toe, a wet area was observed. The objective of the visit was to determine if there was a leak in the dam or if this was a ground water issue and to make recommendations for repair prior to placing additional fill to fortify existing slope conditions building to a 3:1.

Wet area at toe of slope

Recommendations made were to re-visit the site after the lake water level had been lowered and the orifice was sealed up.

1. All existing mulch would be removed from slope embankment to observe moisture conditions of slope embankment soils to observe for saturated conditions indicating a possible leak.
2. If no possible leaks are detected test pits could be excavated at the area of standing water to determine if this is a ground water issue.
3. Recommendations can be made after visual observations.
4. It is possible that tree stumps can be left in place where they do not disturb the integrity of the in-place fill.
5. If it is ground water issues, it may be necessary to install a french drain.

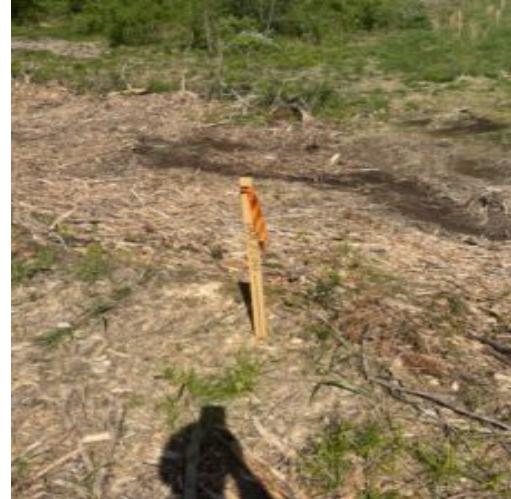
grade stack showing fill amount

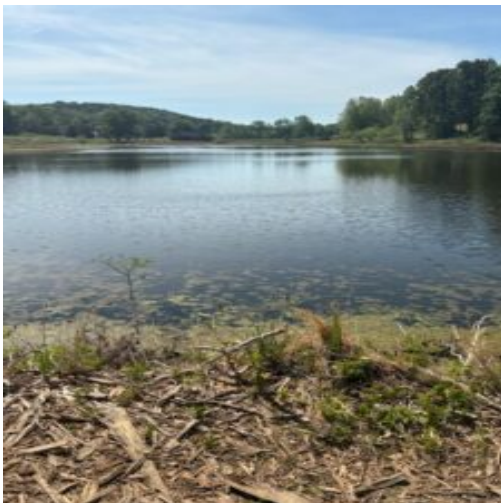
View of lake

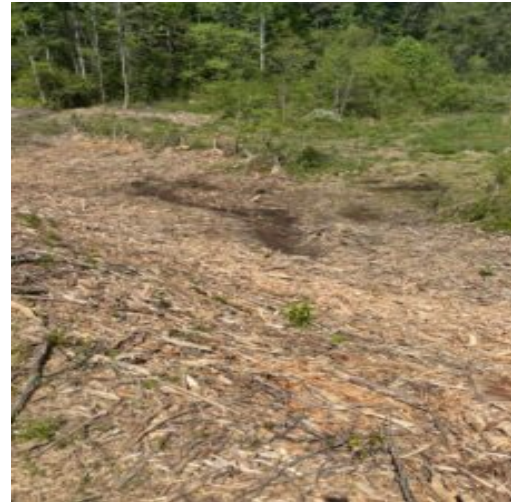
Outside slope embankment looking west with mulch covering

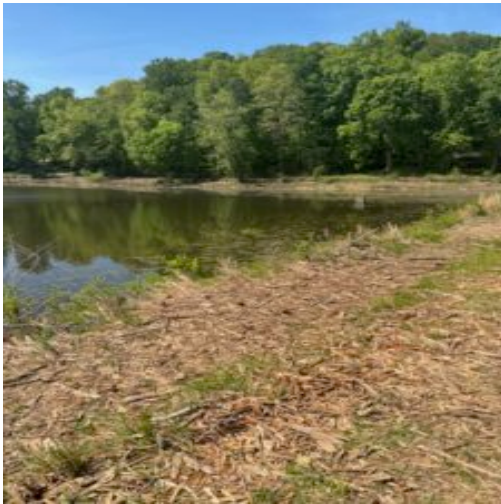
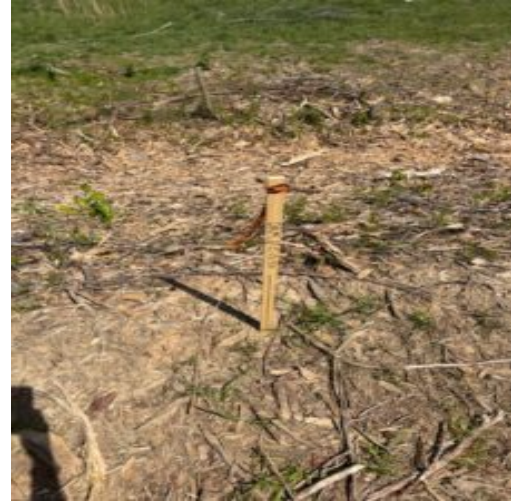
Cut fill stake

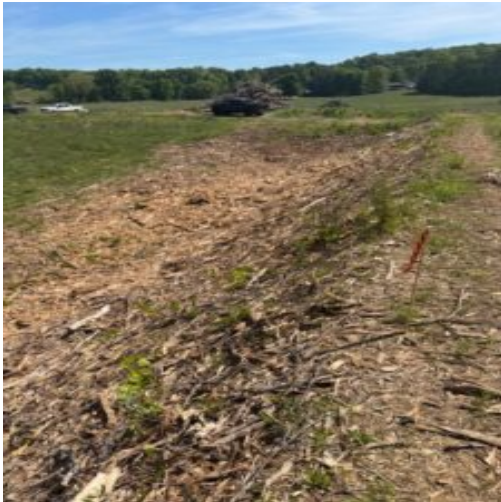
Outside slope embankment looking east with mulch covering

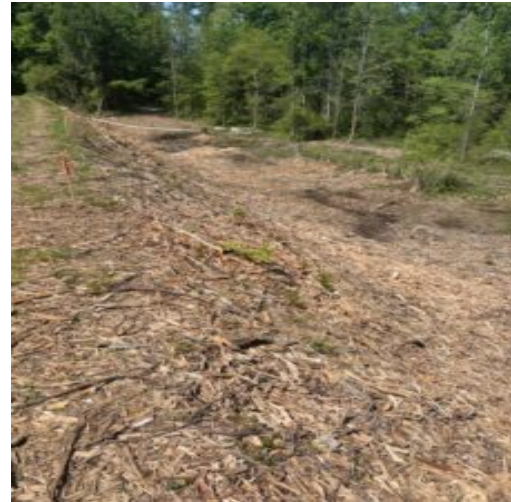
Looking from east to west full length
