Date : 04/22/2026
Project No : 2026C133
Client Company : Artisan
Arrival Time : 04/22/2026 08:00
Onsite Hours : 07:00

ASEC Report ID : 93326
Name of the Project : Salacoa (AKA Boone Ford Rd) Robert's
Dam
Project Location : Calhoun
Weather : Sunny
Departure Time : 04/22/2026 15:00
ASEC Technician Name : Clyde Smith

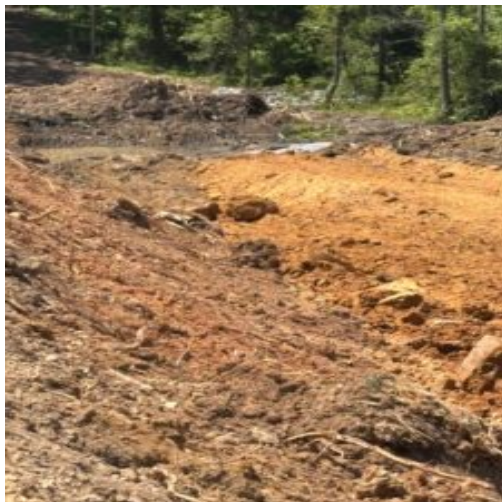
Plowing in place fill placed on 4/21/26 allowing to dry

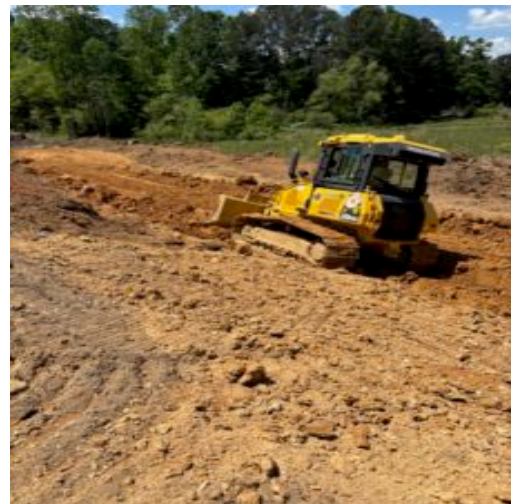
Spreading structure fill over installed drainage system

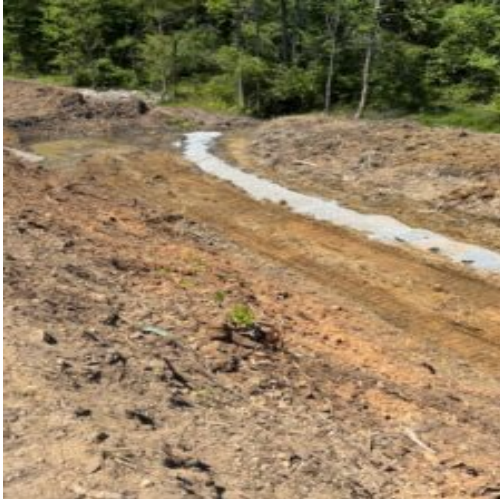
Installed drainage system approximately 105' long with #57 stone placed over top of wrapped filter fabric.

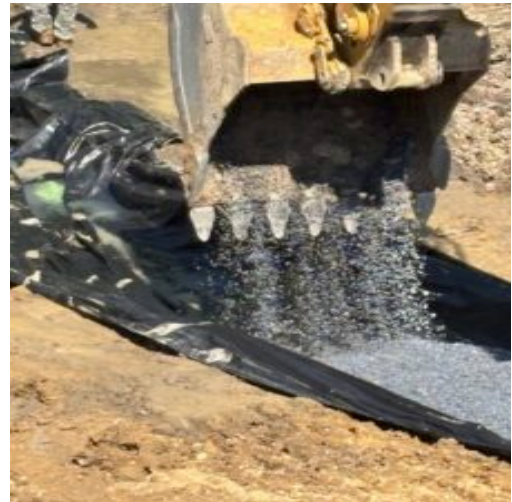
Placing #57 stone onto filter fabric

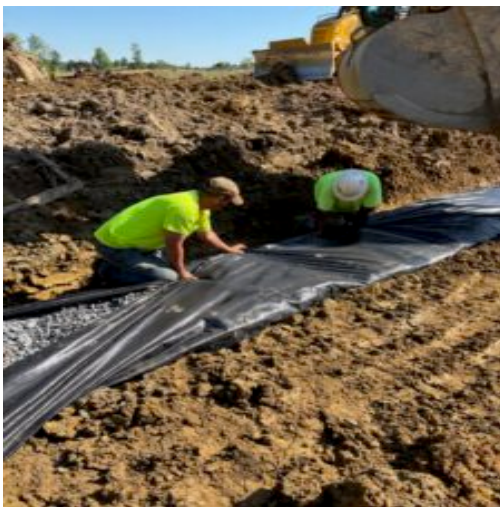
wrapping # 57 stone

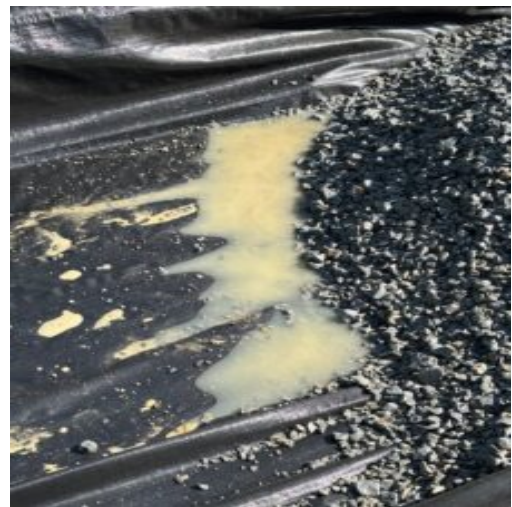
Showing water entering into drain system

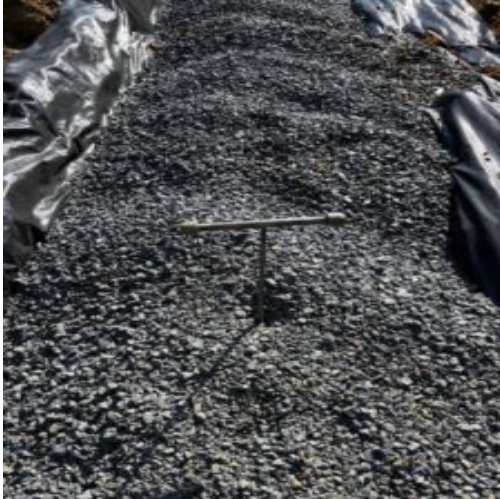
Showing approximately 18" depth of # 57 stone in place

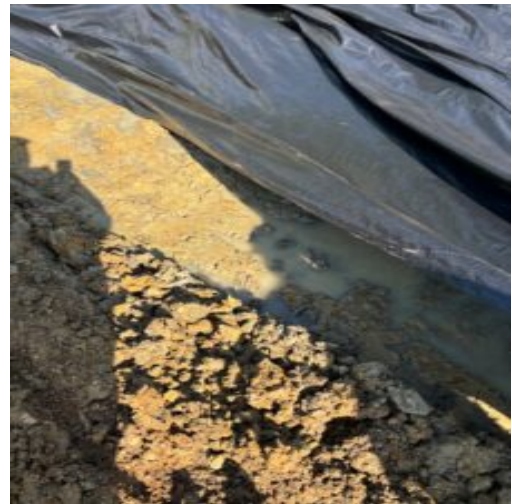
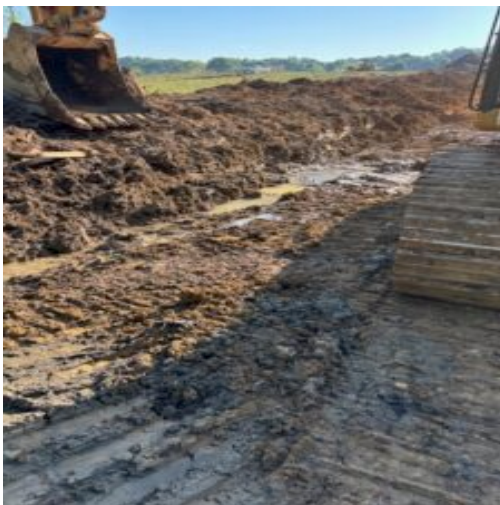
Existing subgrade prior to installing drainage system
