Date : 04/24/2026  
Project No : 2026C133  
Client Company : Artisan  
Arrival Time : 04/24/2026 09:30  
Onsite Hours : 07:00

ASEC Report ID : 93467  
Name of the Project : Salacoa (AKA Boone Ford Rd) Robert's  
Dam  
Project Location : Calhoun  
Weather : Sunny  
Departure Time : 04/24/2026 16:30  
ASEC Technician Name : Clyde Smith

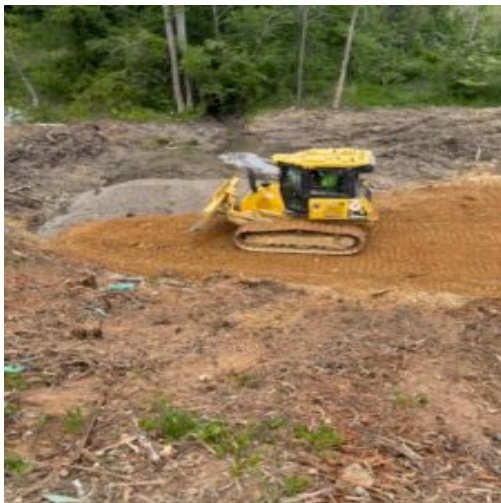
Placing structural fill over #57 stone and filter fabric for subgrade drainage

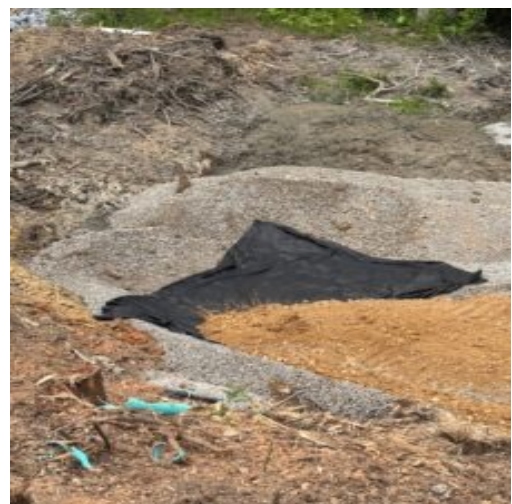
Showing filter fabric over # 57 stone

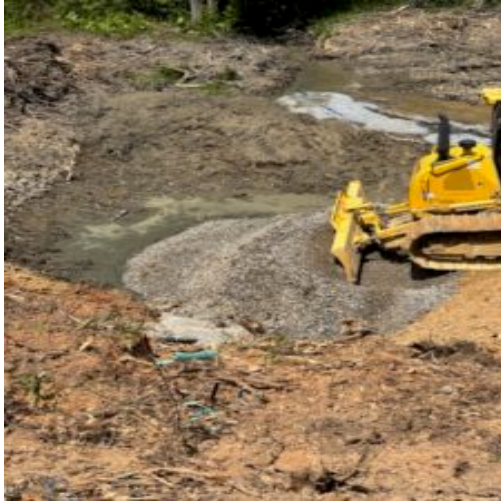
Pushing #57 stone over saturated subgrade for drainage and stabiziation

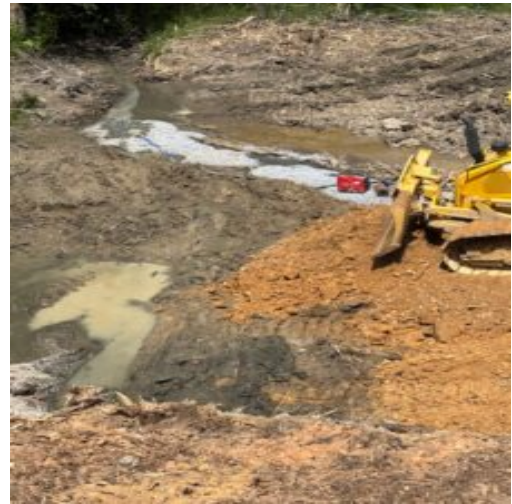
Pushing structural fill over fabric

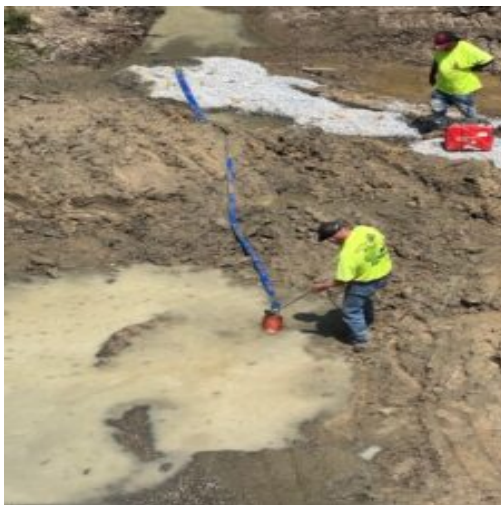
Pumping water prior to placing #57 stone

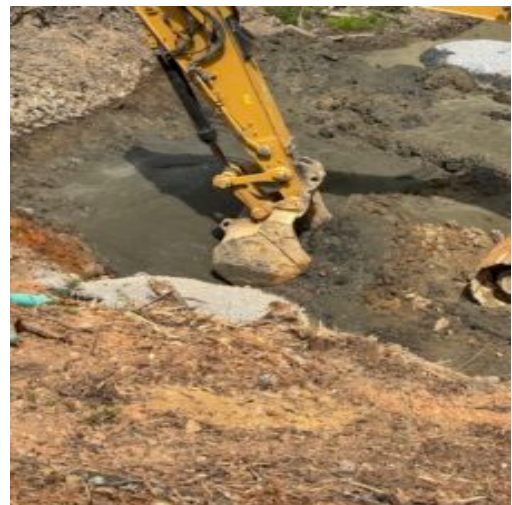
On the above date our representative was onsite to observe the grading contractor continue demucking existing subgrade soils at the west side toe of the existing dam. Groundwater was present during excavation and the contractor pumped most of the water out prior to placing two loads of No. 57 stone after excavation with filter fabric over stone as recommended. Structural fill was then placed over fabric and drainage stone in which the stone was tied into the northside drainage trench. The contractor also continued placing fill at the toe of the slope embankment starting at the east end using excavated recommended materials from the existing haul road that was drier than the onsite stockpiled materials that the contractor continues to blade for aeration. The writer performed density tests using a Troxler Nuclear gauge model 3430, serial no. 91643. The writer also performed a standard field proctor for in-place fill compacted materials. Compaction results were suitable for the requirement of 95%. It was recommended to seal off in place fill with empty off road dump truck at end of day for an anticipated rain event and to recompact with a sheep-foot roller prior to placing additional fill for surface bonding purposes.

De mucking subgrade prior to placing #57 stone

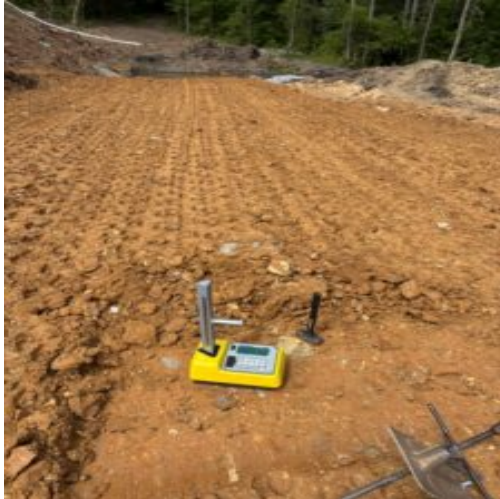
Performing density tests using Troxler Nuclear gauge

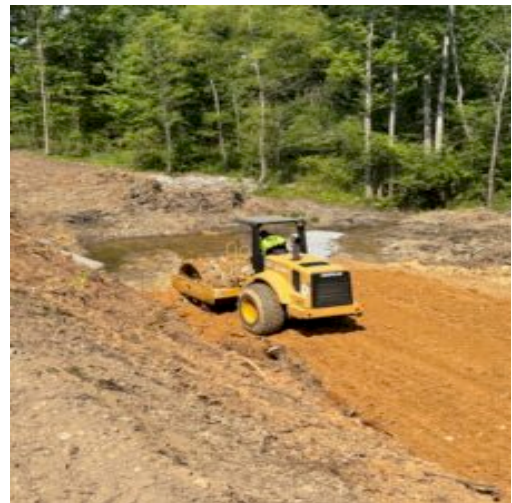
Compacting in place fill using sheet foot roller
